United Illuminating – English Station
Grand Avenue
New Haven, Connecticut

Bulkhead Inspection Report

**United Illuminating
Orange, Connecticut**

December 27, 2017

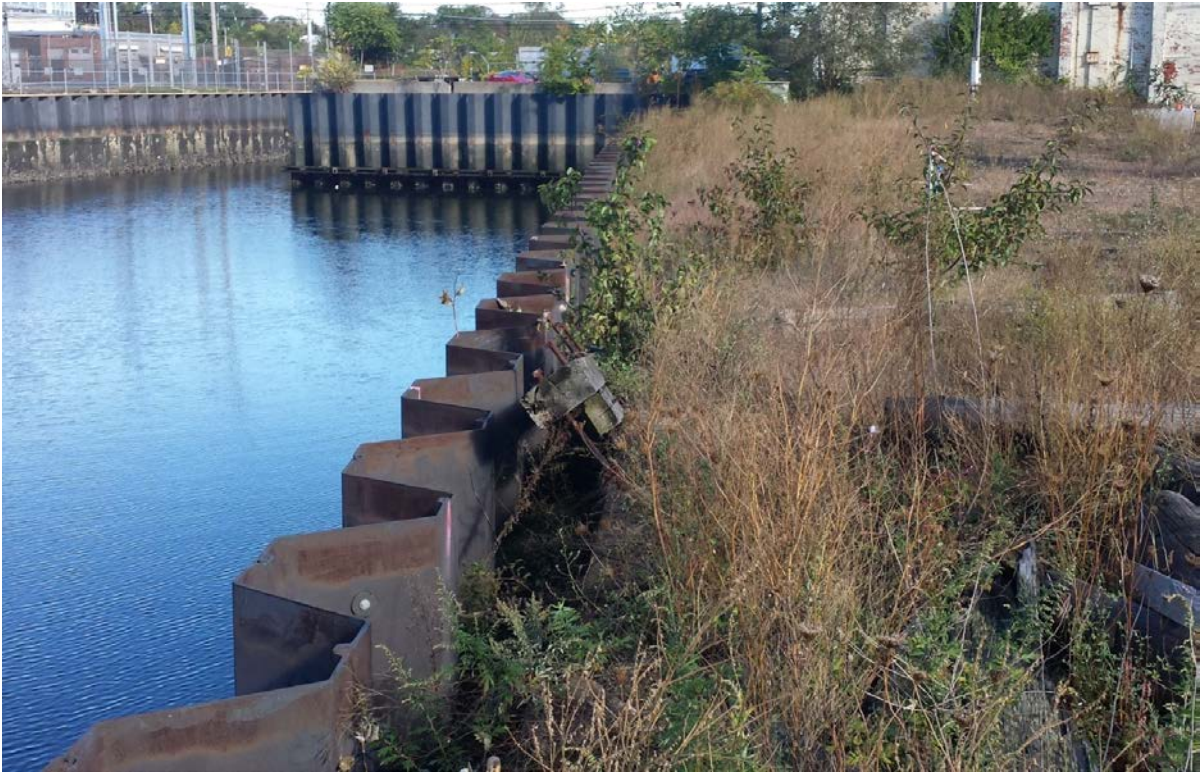
As was mentioned in 2.2 above, the coating showed some signs of localized coating loss in isolated areas, as expected for a structure of this age in a marine environment.

Photo 1 Phase 1 Bulkhead, minor coating deterioration inshore face

The localized coating deterioration is an ongoing maintenance item. With the coating deterioration and onset of corrosion occurring in the upper tide zone to splash zone, cathodic protection is not an option. The best approach would be grit blasting the affected areas and recoating with a surface tolerant epoxy within the same low tide cycle. Due to environmental permitting considerations, we expect this would be performed from a float or platform fit to the bulkhead to catch the grit and coating debris, and a natural organic blast grit, such as walnut shells, may be necessary. Mechanical tool surface preparation would be a lesser alternative if grit blasting is not permitted.

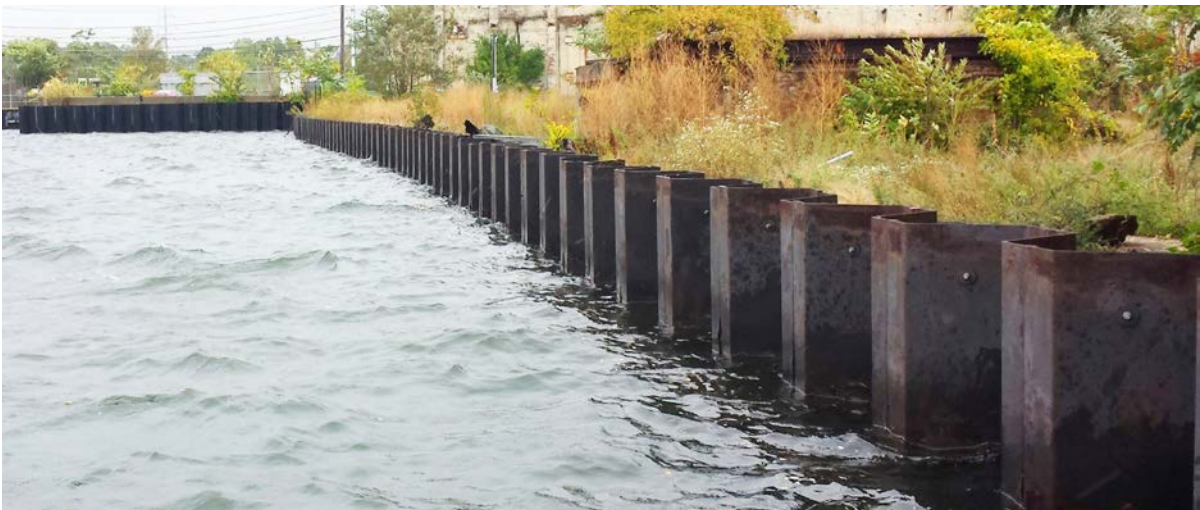
Photo 2 Phase 1 Bulkhead, minor coating deterioration offshore face

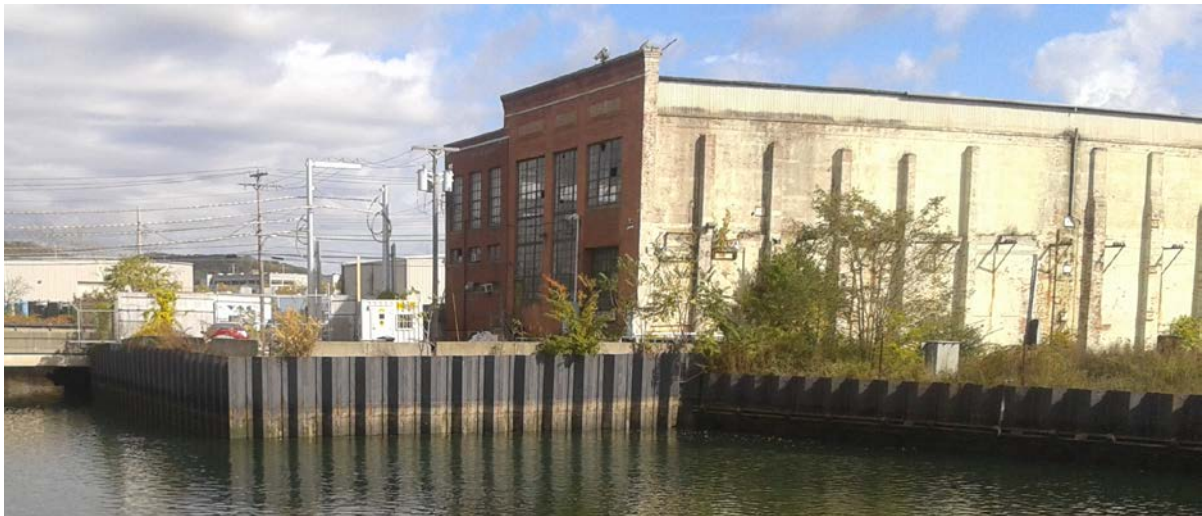
Photo 3 Phase 2 West, corner

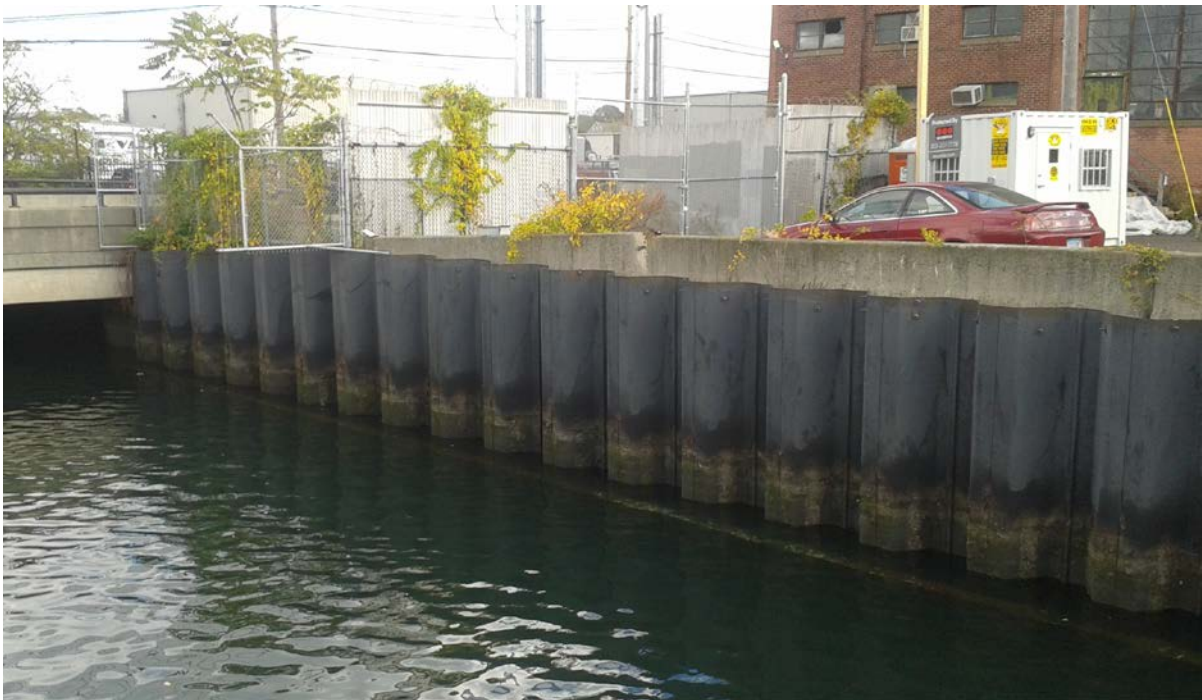
Photo 4 Phase 2 West at Grand Avenue

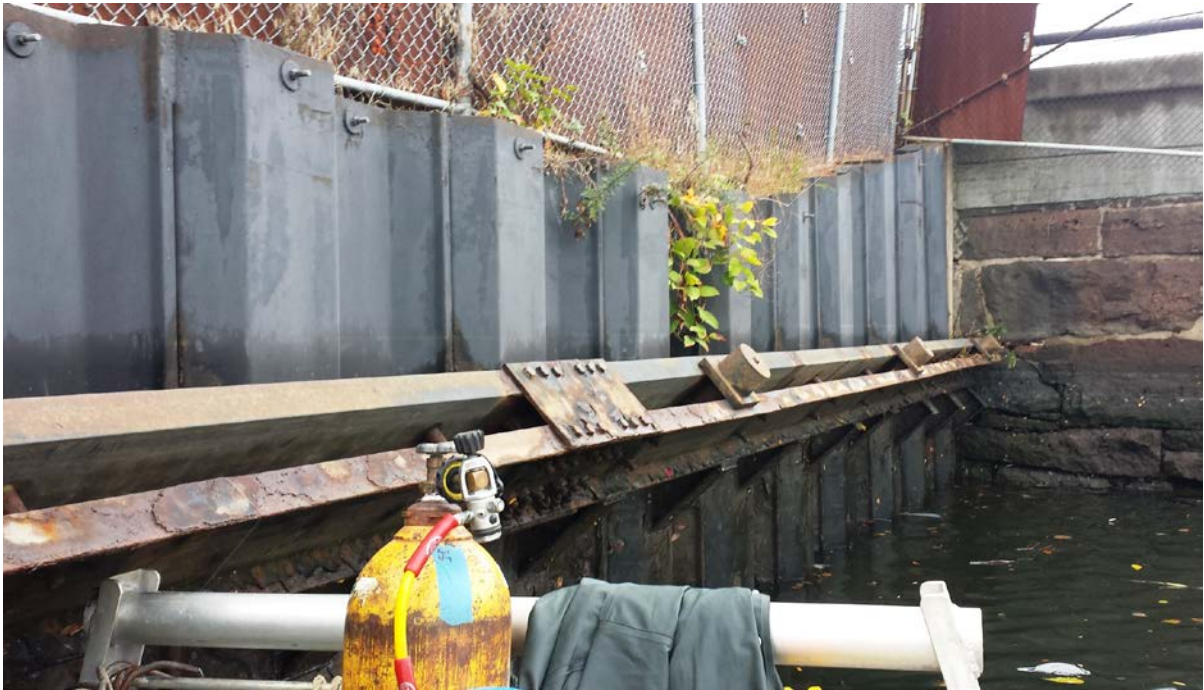
The East Bulkhead, however, has some bulkhead coating loss in the tidal and splash zones. There are more widespread coating losses, especially in the area closest to Grand Avenue.

Photo 5 Phase 2 East at Grand Avenue, note coating deterioration on wale

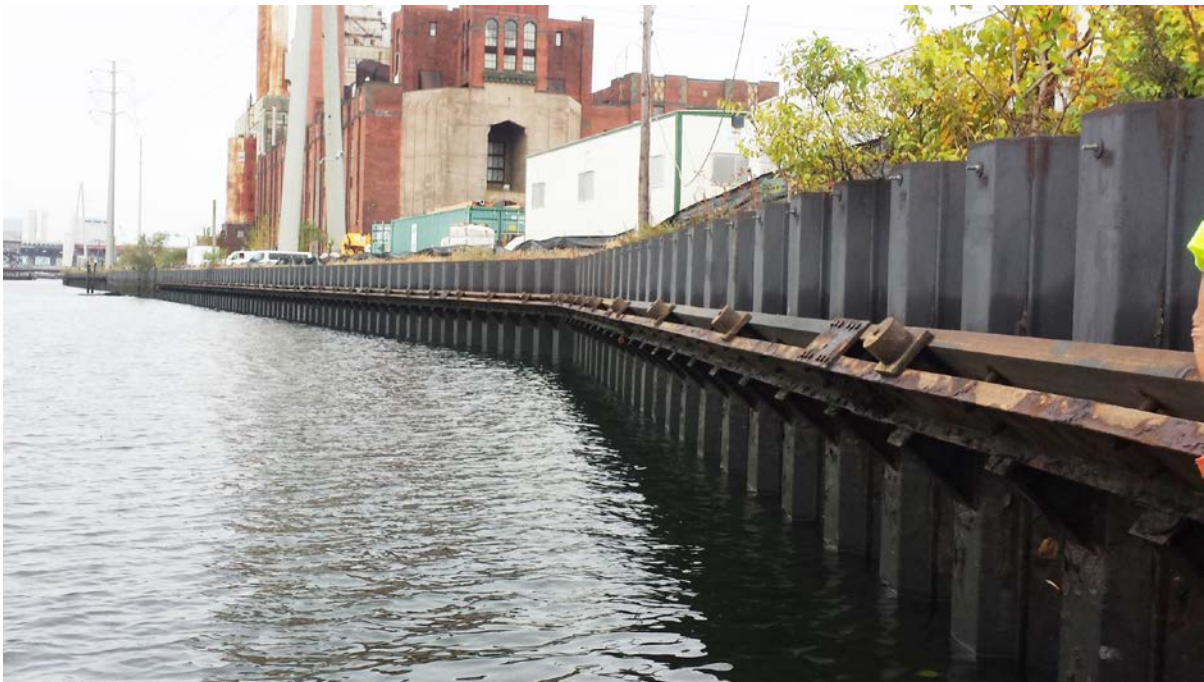
Photo 6 Phase 2 East looking south, note coating deterioration on wale

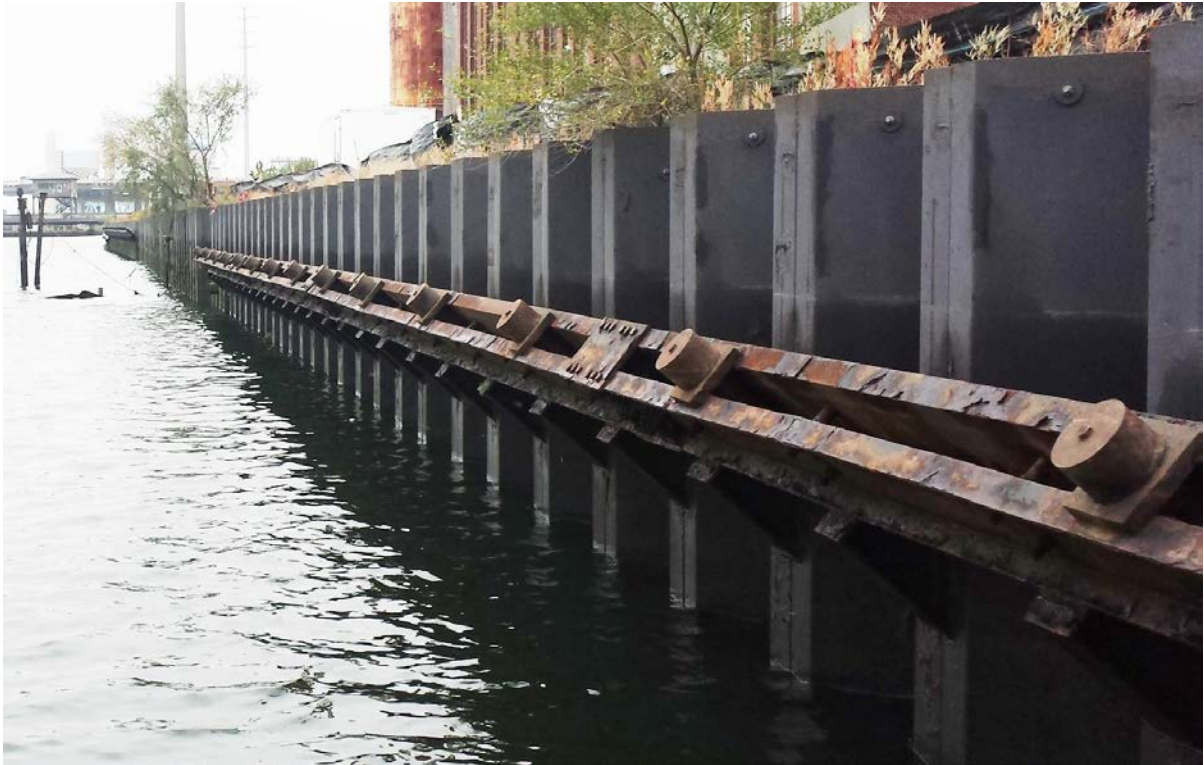
foundation for the high-tension wires and continuing to the L.P. Discharge Channel, where horizontal tiebacks connect to the relieving platform that was strengthened in some areas. There is no evidence of failure along the length of the Phase 2 East Bulkhead, but the wale coating shows signs of deterioration. Based on the UT thickness tests, the sheet piles are still very close to full sectional area.

Photo 7 Phase 2 East, looking south, note coating deterioration on wale

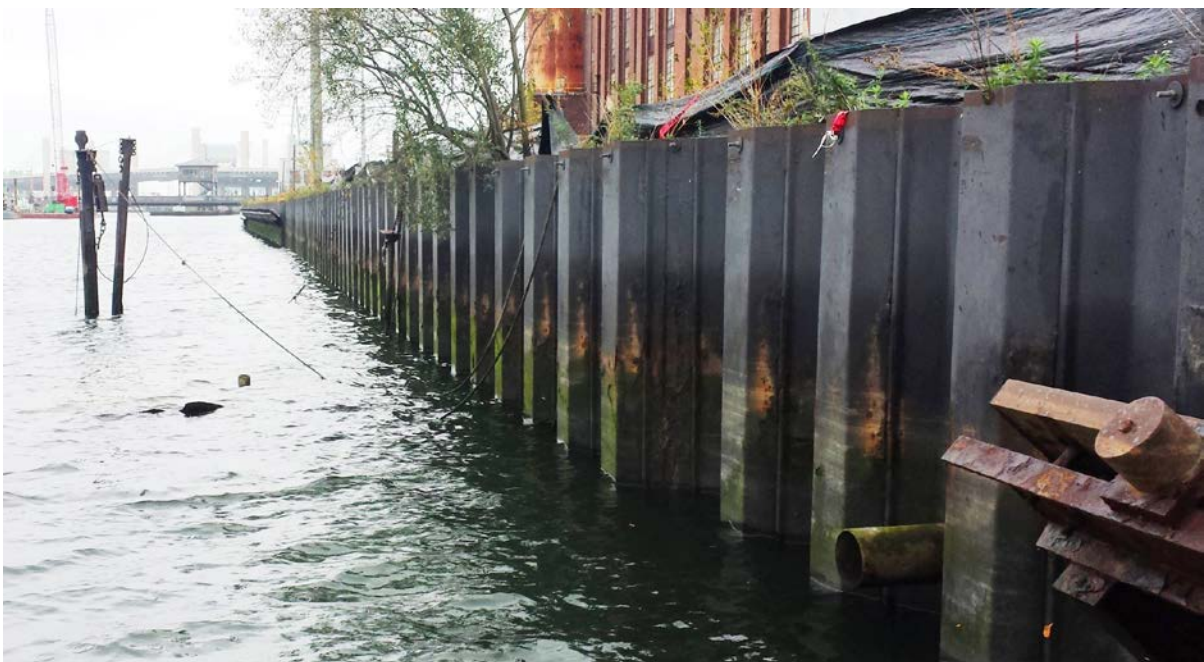
Photo 8 Phase 2 East, south end with sunken boat adjacent to bulkhead

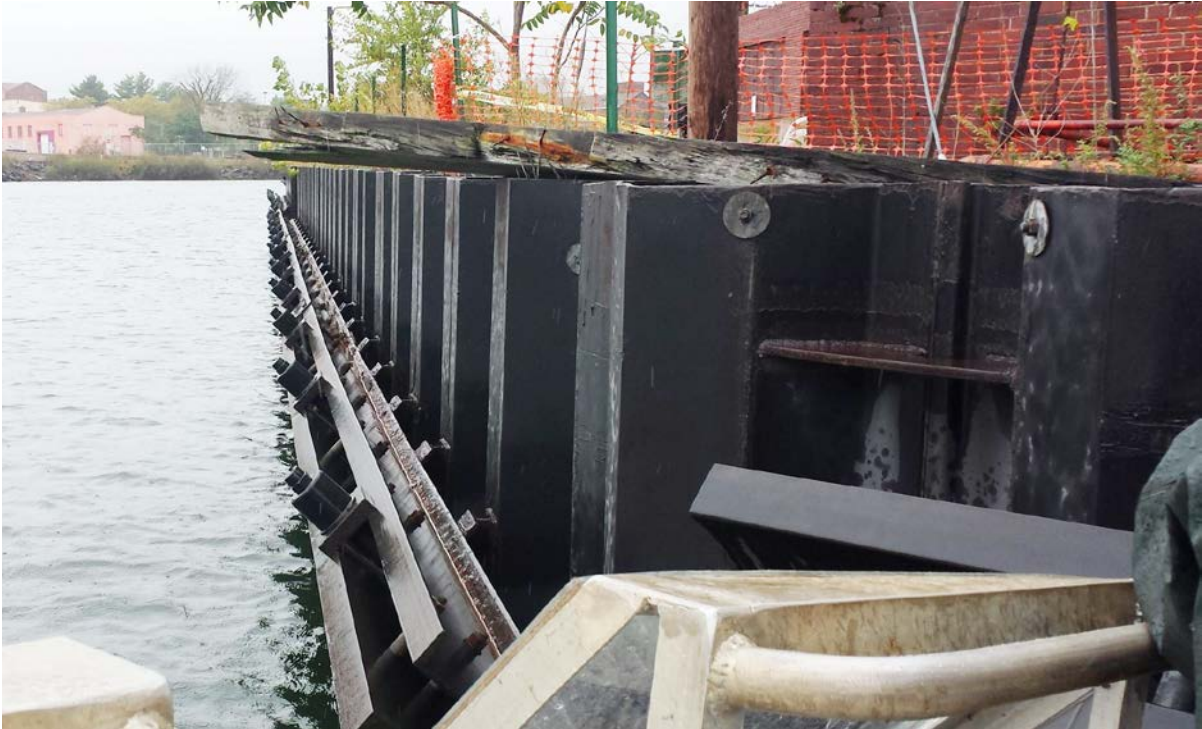
Photo 9 Typical Phase 3 angles down ground anchors with Phase 3 grease caps

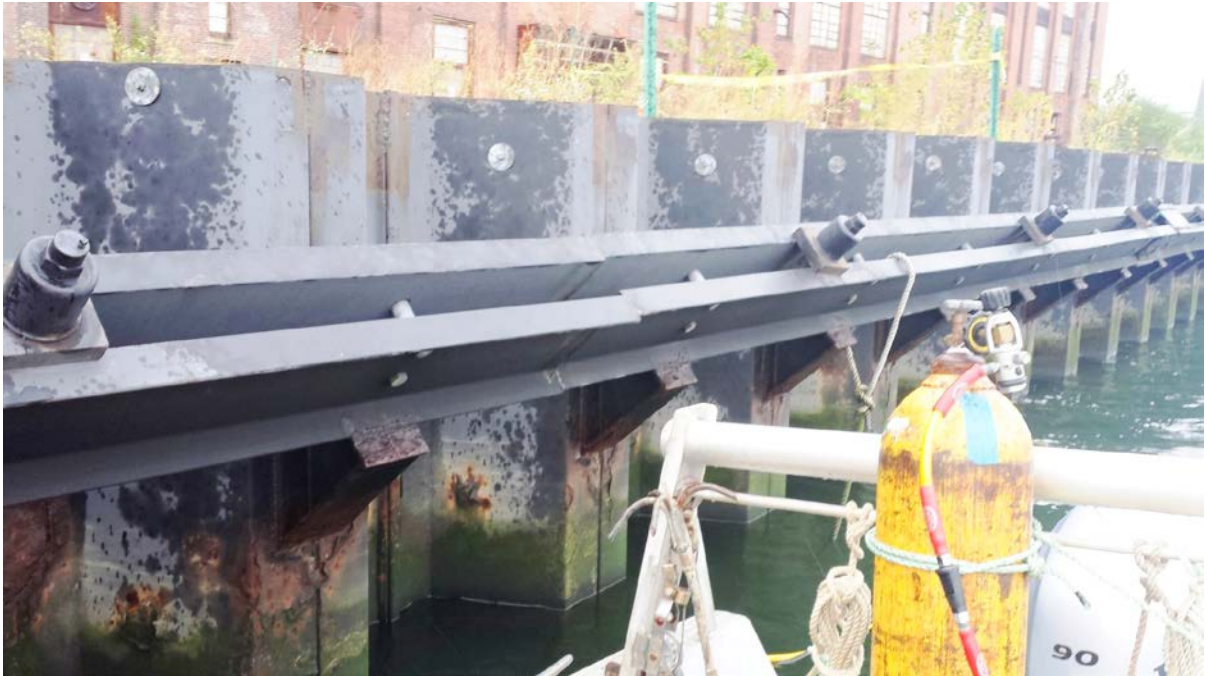
The condition of the coating in the Phase 3 bulkhead is similar to the rest of the bulkhead with localized coating deterioration and onset of corrosion on the sheet piling, wales and tiebacks to vary degrees, primarily in the tidal and splash zones. There are small isolated areas of coating loss and slight corrosion, but the UT thickness testing shows full sectional area.

Photo 10 Phase 3 East typical coating deterioration localized in the splash zone, primarily at field welds with coating touch-ups

The coating deterioration observed is localized in the tidal and splash zones, primarily at locations of field welding and field coating touch up. Corrosion has started at these areas, but has not progressed to the point where measurable steel losses can be established. This coating deterioration is consistent with the age of the bulkhead and the location in the upper tidal zone and splash zone. Currently, the sheet piles are at, or close to, full original thickness and it is expected that the piles were selected with some additional steel thickness as a corrosion allowance. Confirmation with the engineer of record, or from a basis of design document, may be possible if available.

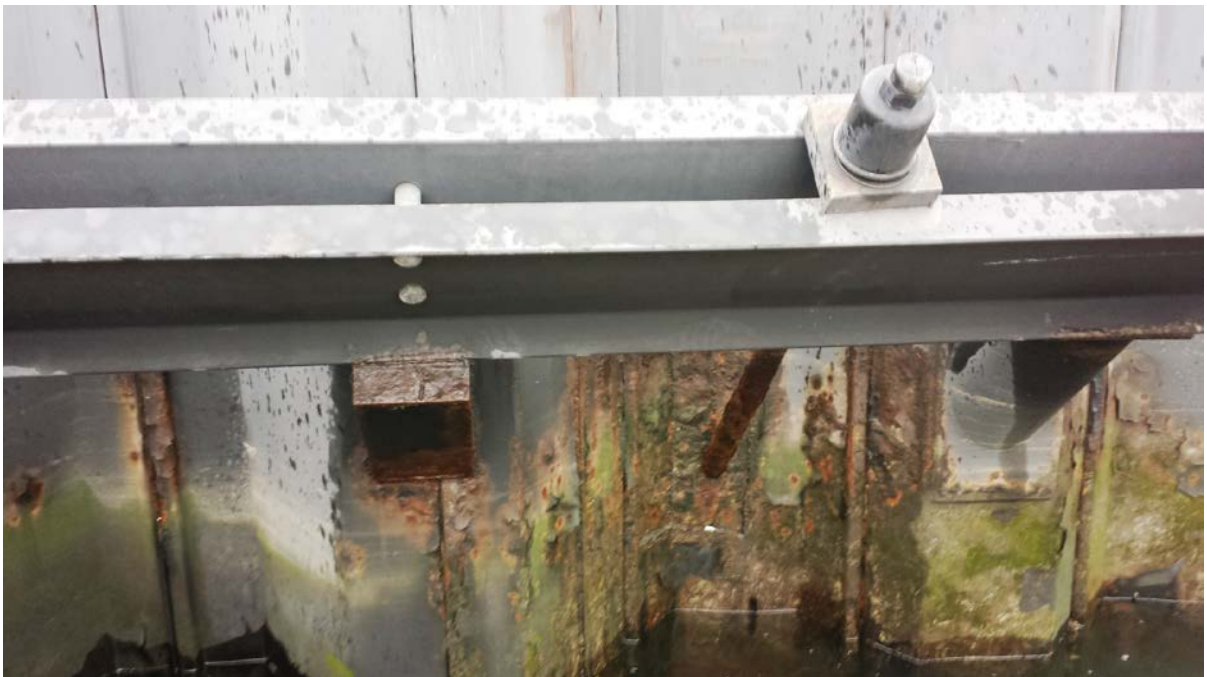
Photo 11 Phase 3 East, typical coating deterioration localized in the splash zone, primarily at field welds with coating touch-ups

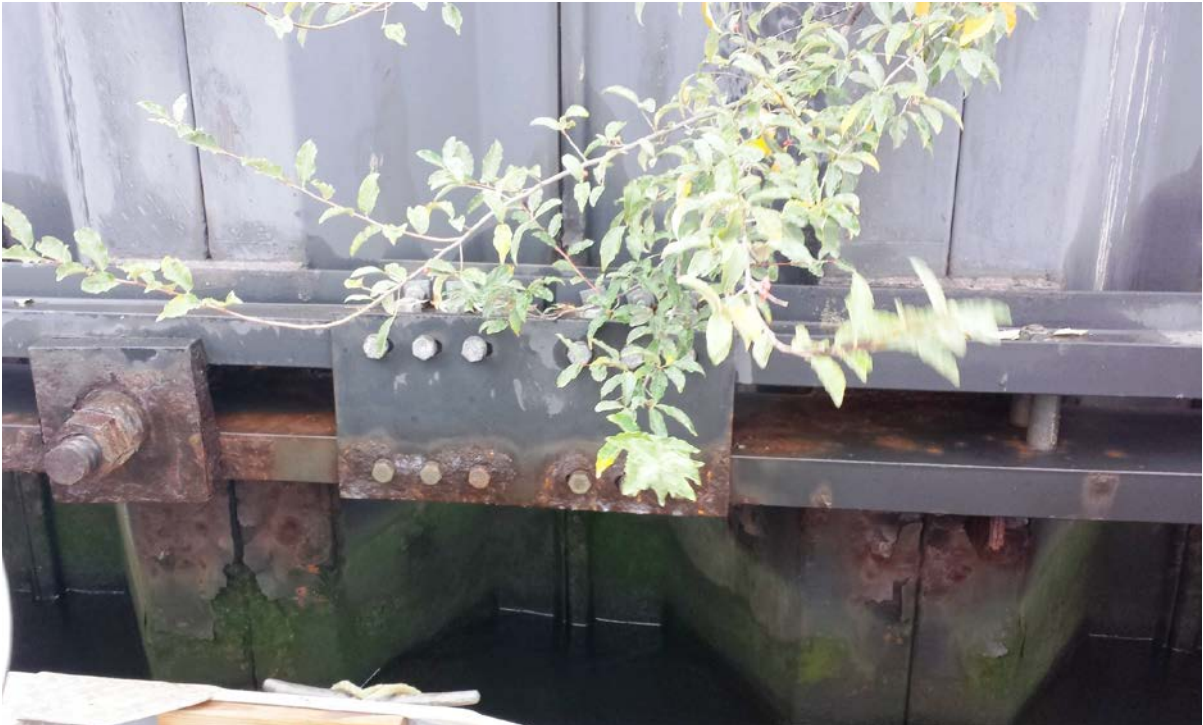
Photo 12 Typical Phase 3 bulkhead coating deterioration and corrosion onset in the tidal and splash zones – note horizontal tiebacks at southeastern high tension pole area do not have corrosion protection end caps

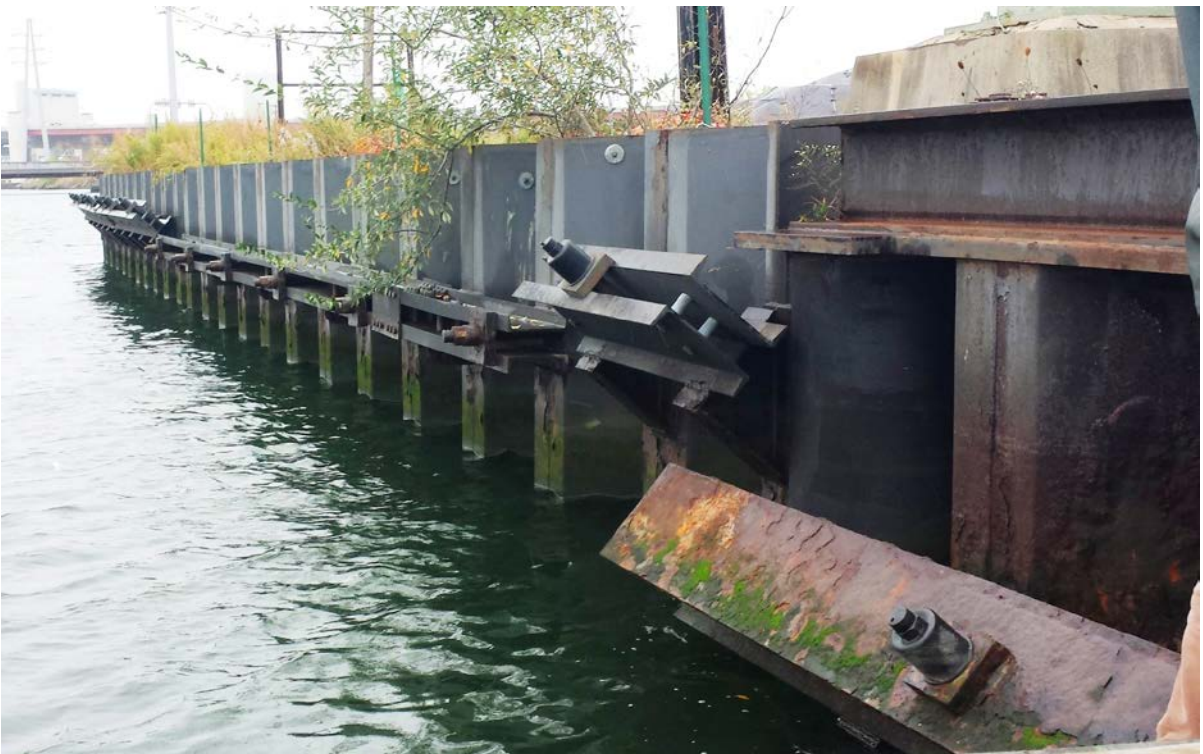
Photo 13 Phase 3 Southeastern area with varying configurations and degrees of coating deterioration, Unit 8 discharge area bulkhead (right side) appears to have had minimal coating with more extensive coating loss

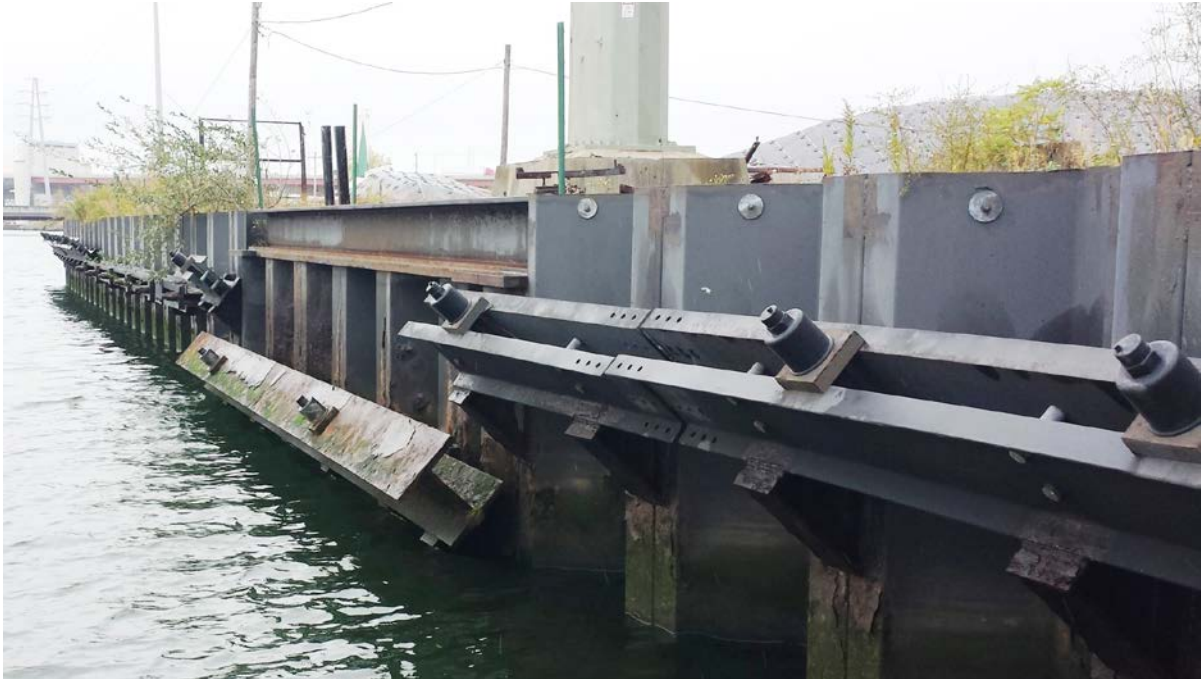
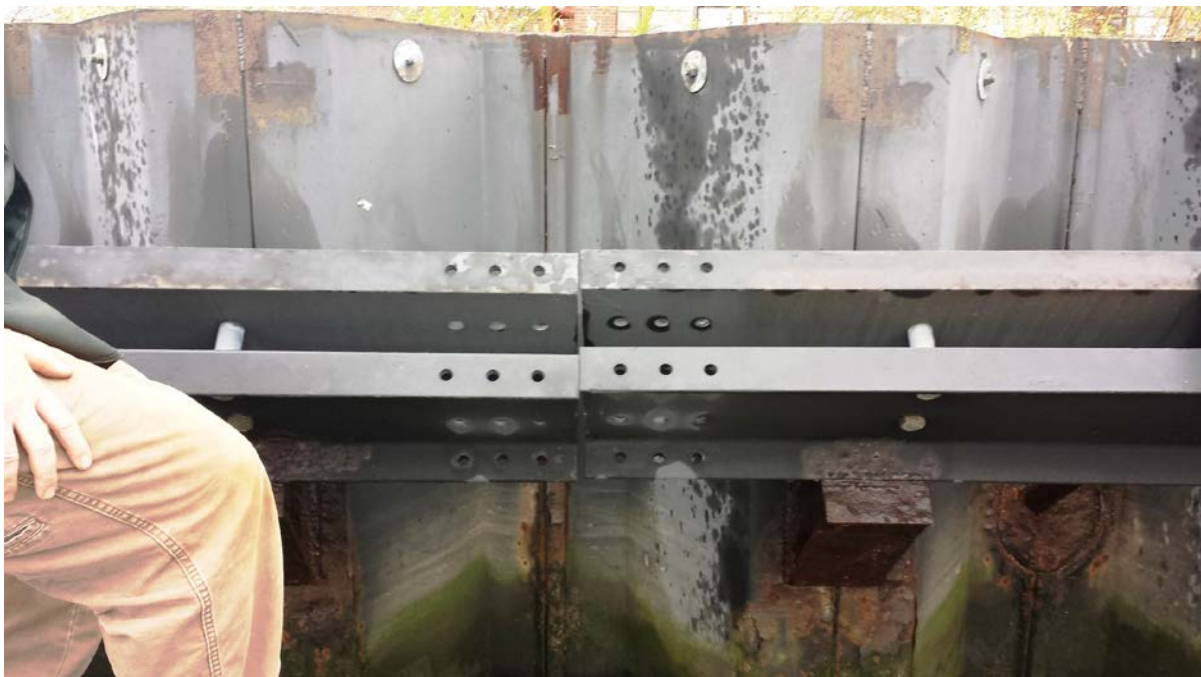
The short length of bulkhead in between Unit 7 and Unit 8 discharge structures has a wale missing splice plates. Observation of the wale coating suggests the wale splice plates were never installed. The wale is welded to the angled mounting brackets on both sides of the splice, and this is not noted in the As-Built drawings, suggesting it was accepted by the engineer of record.

Photo 14 Phase 3 wale missing splice plates between Unit 7 and 8 discharge structures

Photo 15 Phase 3 wale missing splice plates between Unit 7 and 8 discharge structures

Based on the visual above and underwater observations the English Station bulkhead appears to be structurally sound with only some minor localized deterioration. The separated HZ pile interlocks are not noted on As-Built drawings but likely did happen during pile driving. The Phase 3 wale missing splice plates is atypical. These do not appear to be structural issues, or an apparent soil loss issue, however follow ups with the contractor and/or engineer of record might provide additional insight into the construction assessment and field repairs performed.

The Phase 3 wale missing splice plates is atypical, but easily repaired with a custom fabricated set of splice plates to fit the misaligned wale bolt holes.

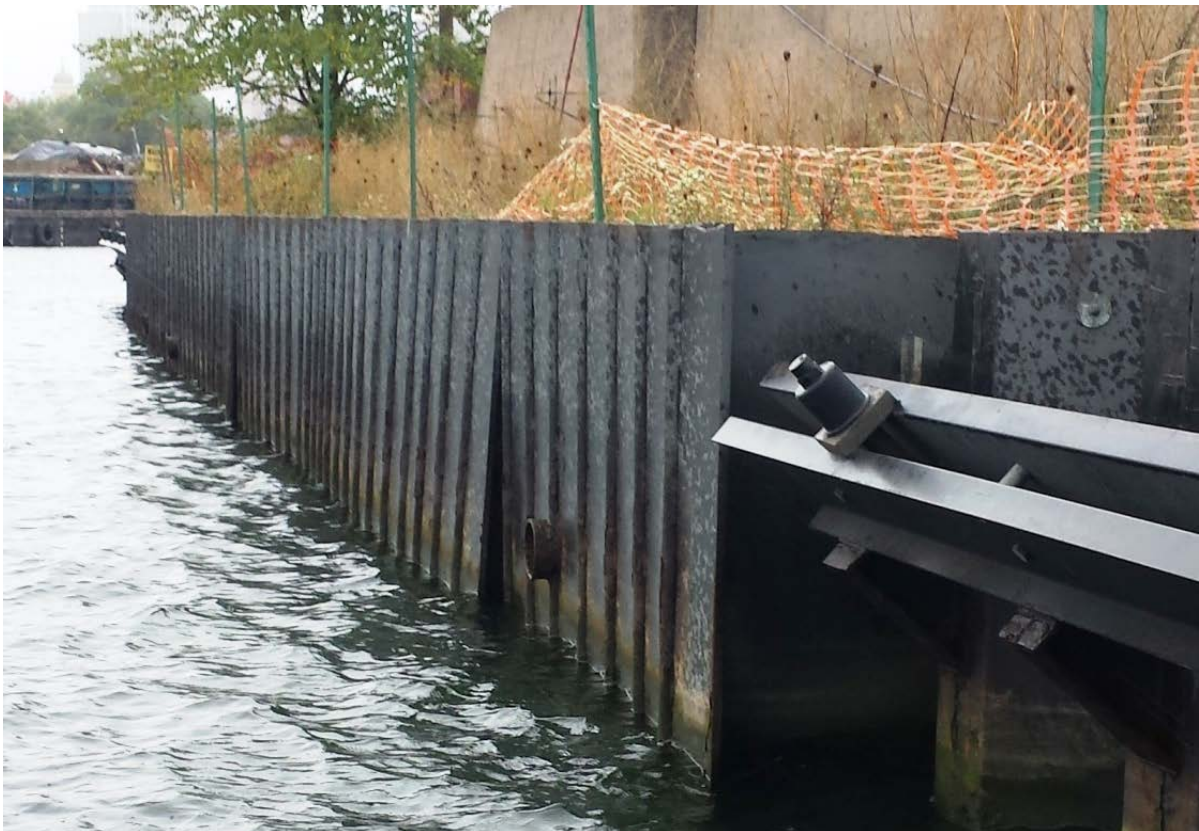
On the south facing bulkhead, there are 2 locations along the section of cantilevered HZ-piles where the interlocks have split. At the top, the interlocks are touching, but are not threaded together. At the bottom near the mudline, the interlocks have been pushed out of alignment by approximately 12". This most likely happened during construction, perhaps when the pile was being driven, there may have been an obstruction that caused the pile tip to kick out of alignment. Review of the archive As-Built drawings indicated that HZ piles D44, D45 and D53 encountered refusal or were terminated above design tip elevations with D53 being the most extreme with actual tip elevation of -26.3' versus a design tip elevation of -66.5'. The interlock separations found, do not correspond with the early terminated HZ piles noted, and the As-Built notes do not mention separated interlocks or field repairs. The diver reached into the interlock separations and found hard surfaces, not soil, it appears that repairs were inserted into the web pockets between these piles. The easternmost HZ pile, D1, was driven slightly outward and overlapping pile D2, but the gap had been sealed and may have just been an end termination transition fit.

Photo 16 Phase 3 Southern bulkhead cantilevered HZ piles with separated interlocks at two locations

The separated HZ pile interlocks are not noted on As-Built drawings but likely did happen during pile driving. Follow ups with the contractor and/or engineer of record might provide additional insight into the construction assessment and field repairs performed. If repairs are needed to eliminate these gaps, this might be performed with welded plates and web pocket grouting.

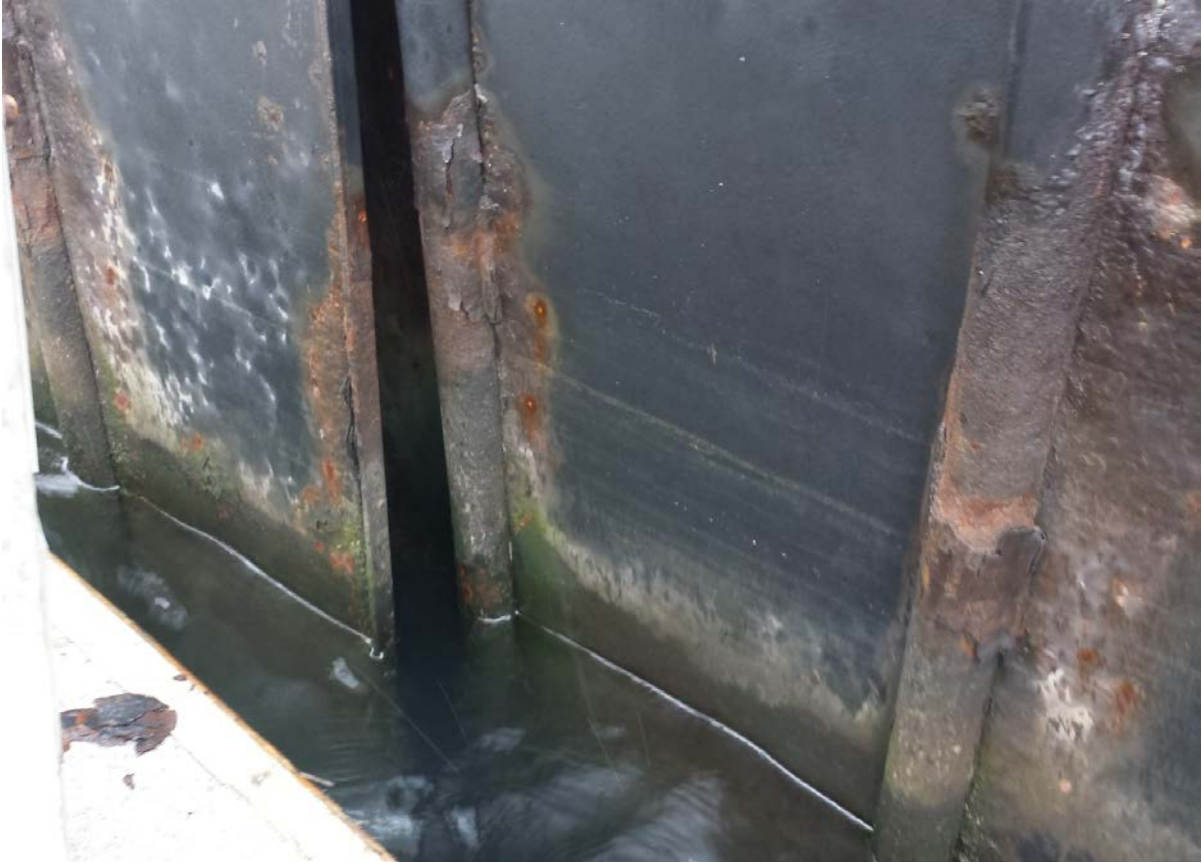
Photo 17 Phase 3 Separated interlock at water surface between piles D7 and D8

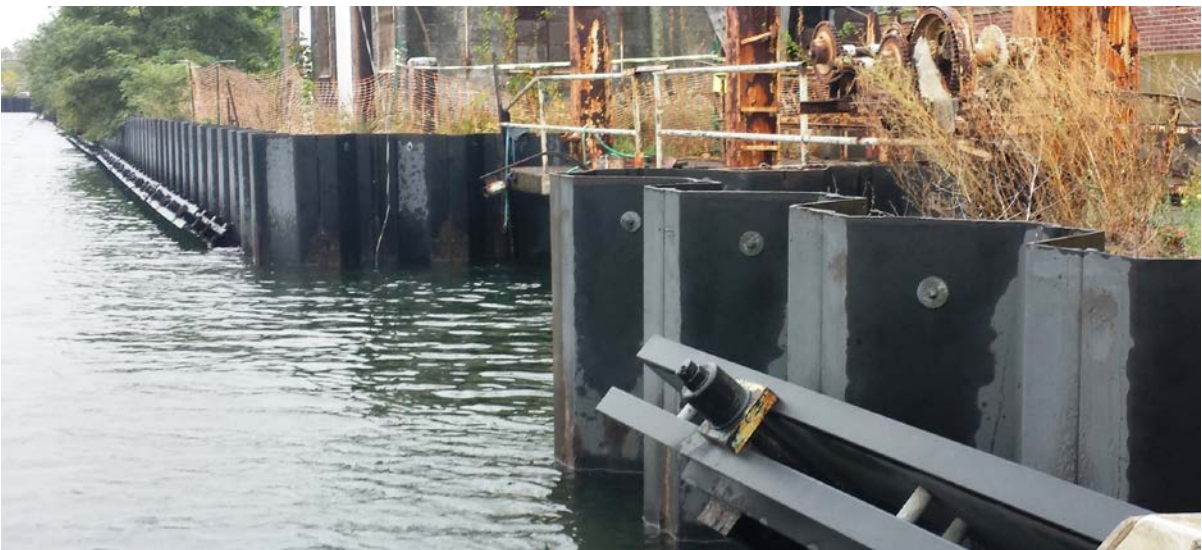
The western length of Phase 3 bulkhead has similar conditions with localized coating deterioration and onset of corrosion on the sheet piling, wales and tiebacks to vary degrees, primarily in the tidal and splash zones. There are small isolated areas of coating loss and slight corrosion, but the UT thickness testing shows full sectional area.

Photo 18 Phase 3 Western bulkhead at intake tunnel with localized coating deterioration and corrosion onset in the tidal and splash zones

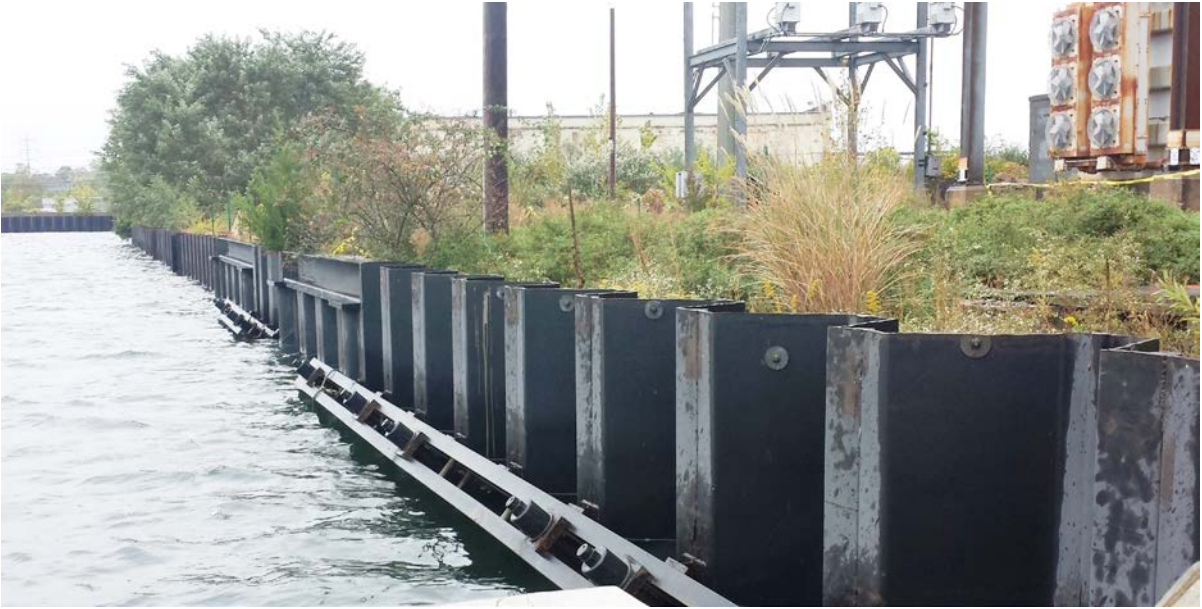
Photo 19 Phase 3 Western bulkhead at underwater cable crossing area (wales at the top of the bulkhead)
