PLAN PREPARED FOR
UNITED ILLUMINATING COMPANY
 ENGLISH STATION
 NEW HAVEN, CONNECTICUT

English Station - Interior Survey of Potential PCB Containing Equipment (Aug/Sep, 2011)
Sheet No. 1

**INSPECTION FOR HAZARDOUS BUILDING MATERIALS – BOILER 1-
12 INTERIOR (AUGUST 2018)**

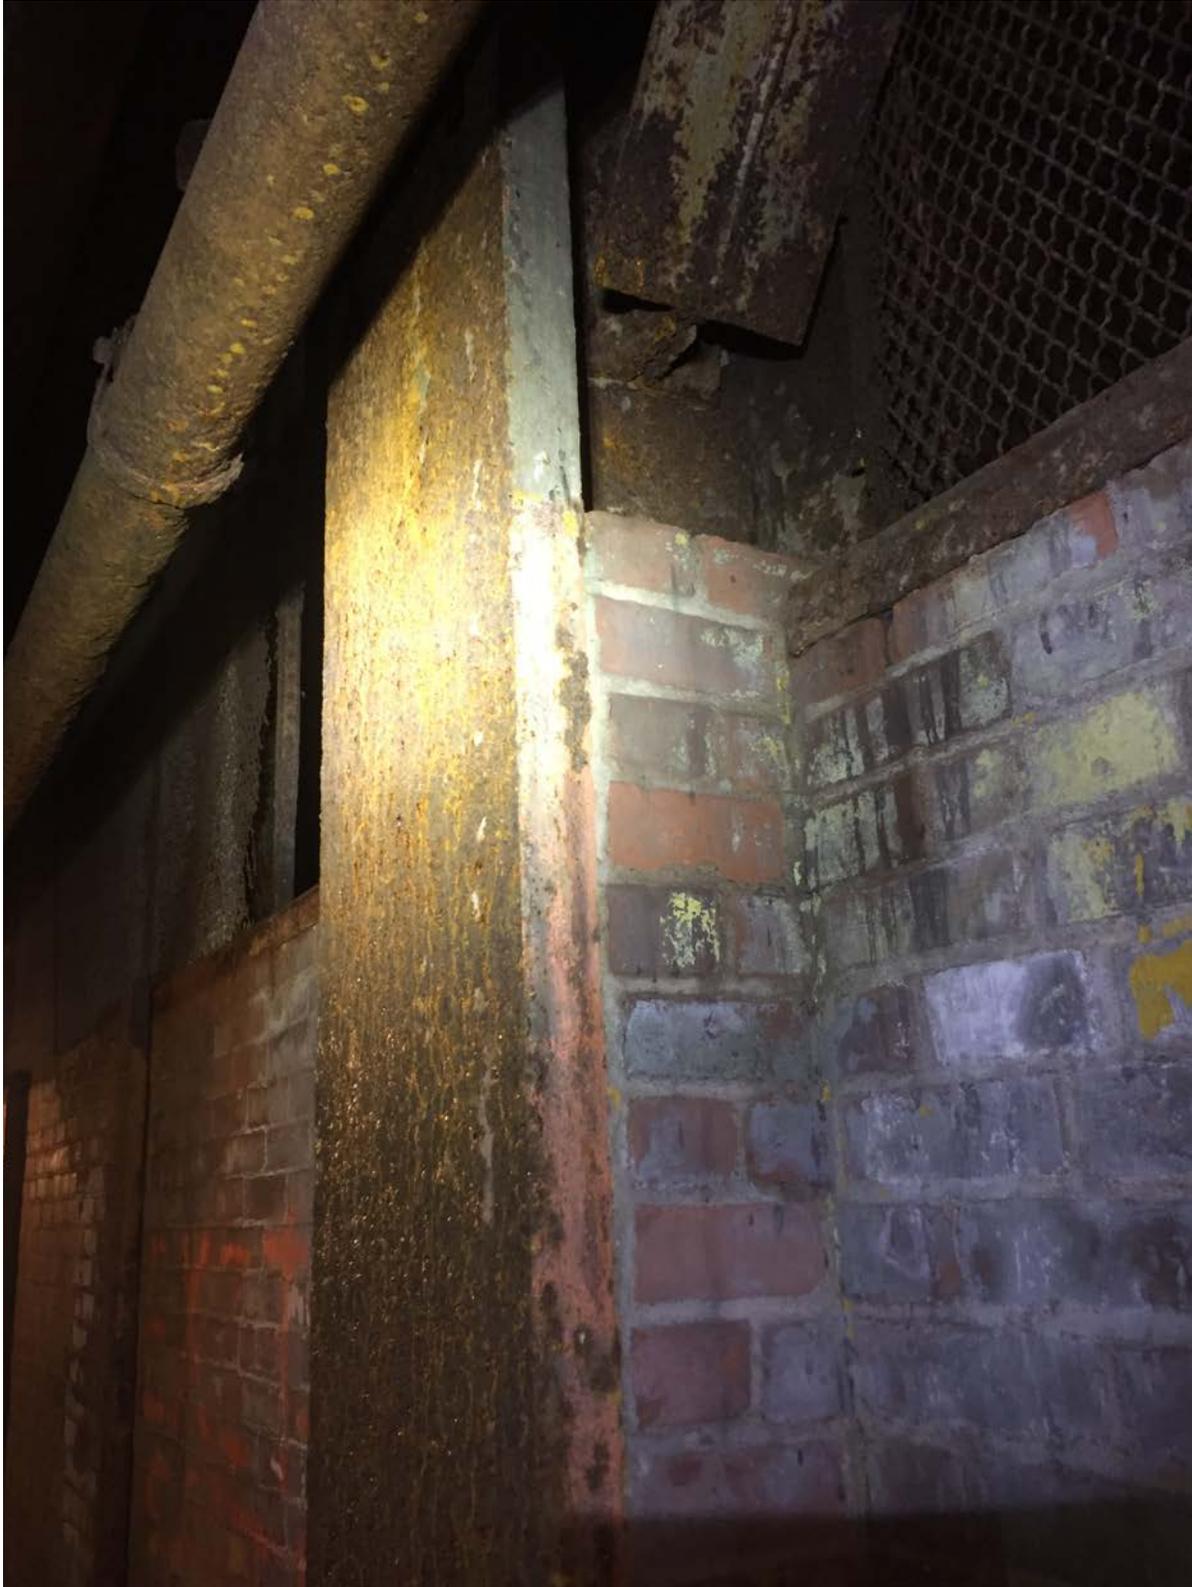
The silver/orange paint (P5) on structural steel is found throughout the first floor. Only 1 out of the original 8 - P5 samples collected was found to contain PCB's greater than 50 mg/kg (ppm) and this was sample P5F (113 ppm PCBs) collected in the Fan Room. An additional 6 bulk building material samples of the P5 paint were later collected in the Fan Room and of these samples, only a second sample (#P5J - 309 ppm PCBs) collected on the same column as P5F had PCB's greater than 50 mg/kg (ppm). Based on the two rounds of sampling of similar paints in this area, only the silver/orange paint (P5) on this column in the Fan Room will be classified as **PCB bulk product waste**. Future planned sampling of the Fan Room and specifically this column, will be performed to assess for possible liquid PCB releases that may have impacted various surfaces. If appropriate, the waste characterization may be modified if the source of the PCBs is from a liquid release.

PHOTO 11 – 1st Floor Fan Room – Silver/Orange Paint (P5) on Column with PCB Bulk Sample Results >50 ppm

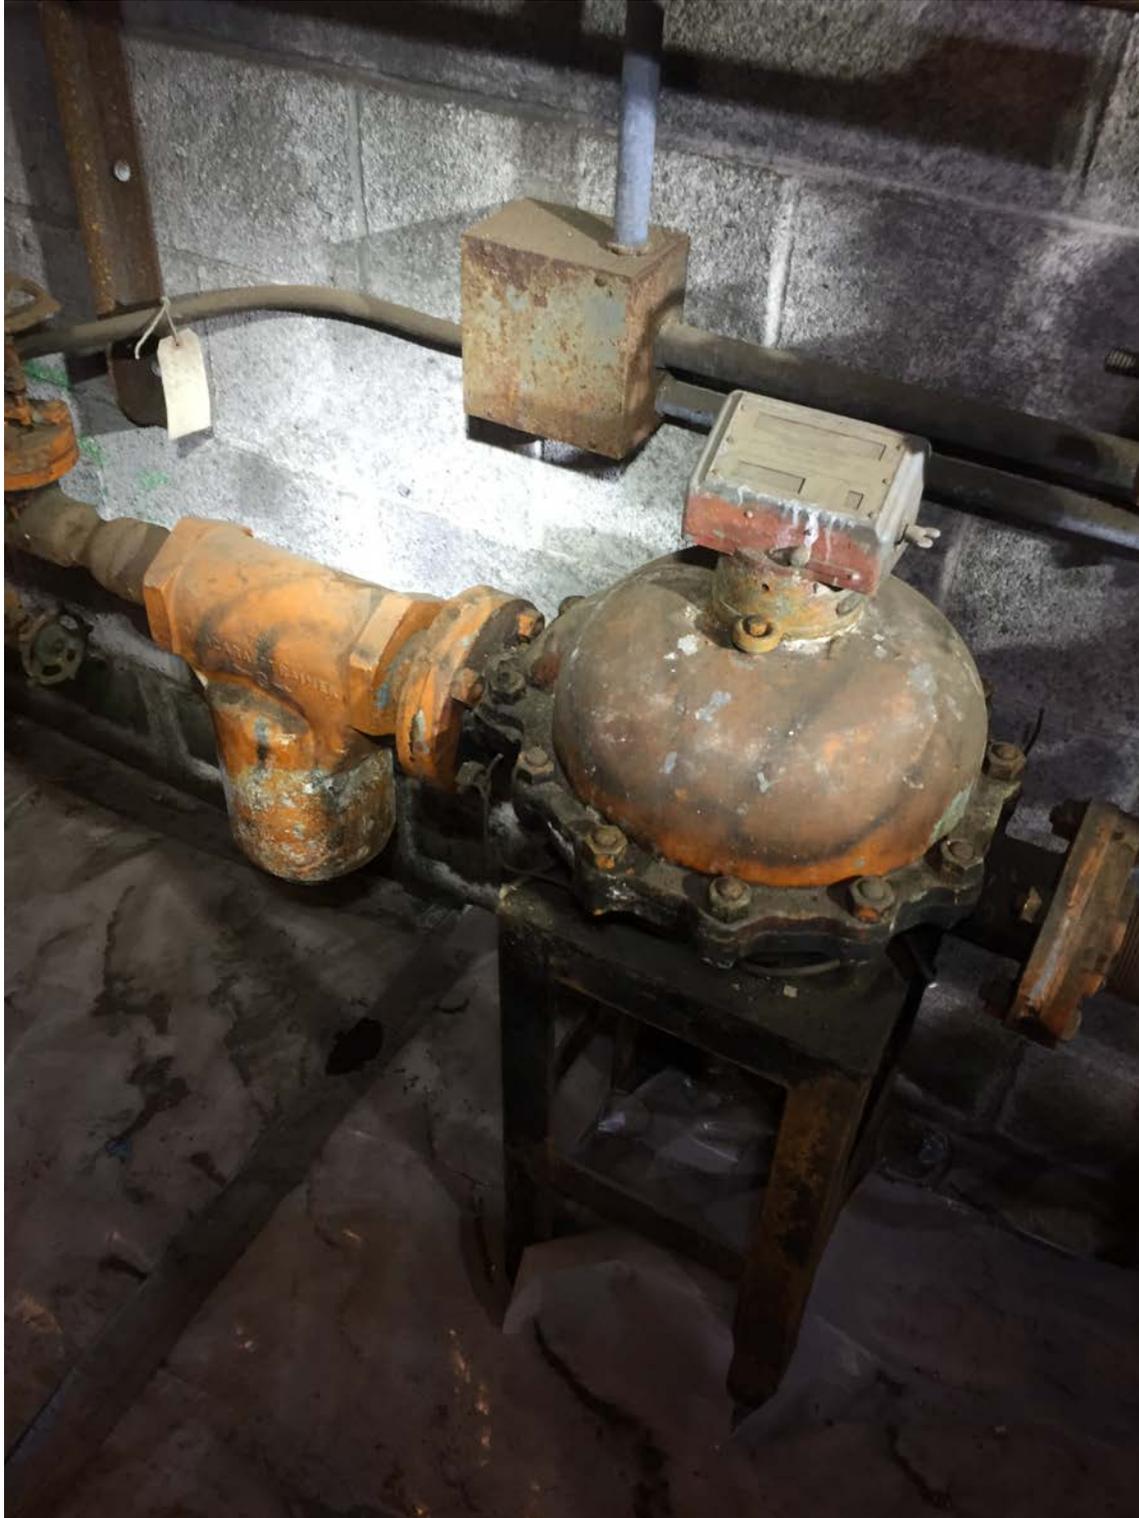
Residual oil/oil staining was noticed on and around the orange painted pump valves (P38) and at other locations within the Fuel Oil Pump Room #2. For now, this paint will be classified as **PCB bulk product waste**; however, the characterization for liquid PCB releases (which has not been performed yet) in conjunction with the bulk building material sampling will ultimately determine the disposal characterization.

PHOTO 12 – 1st Floor Fuel Oil Pump Room #2 – Orange Paint (P38) on Pump Valves with PCB Bulk Sample Results >50 ppm

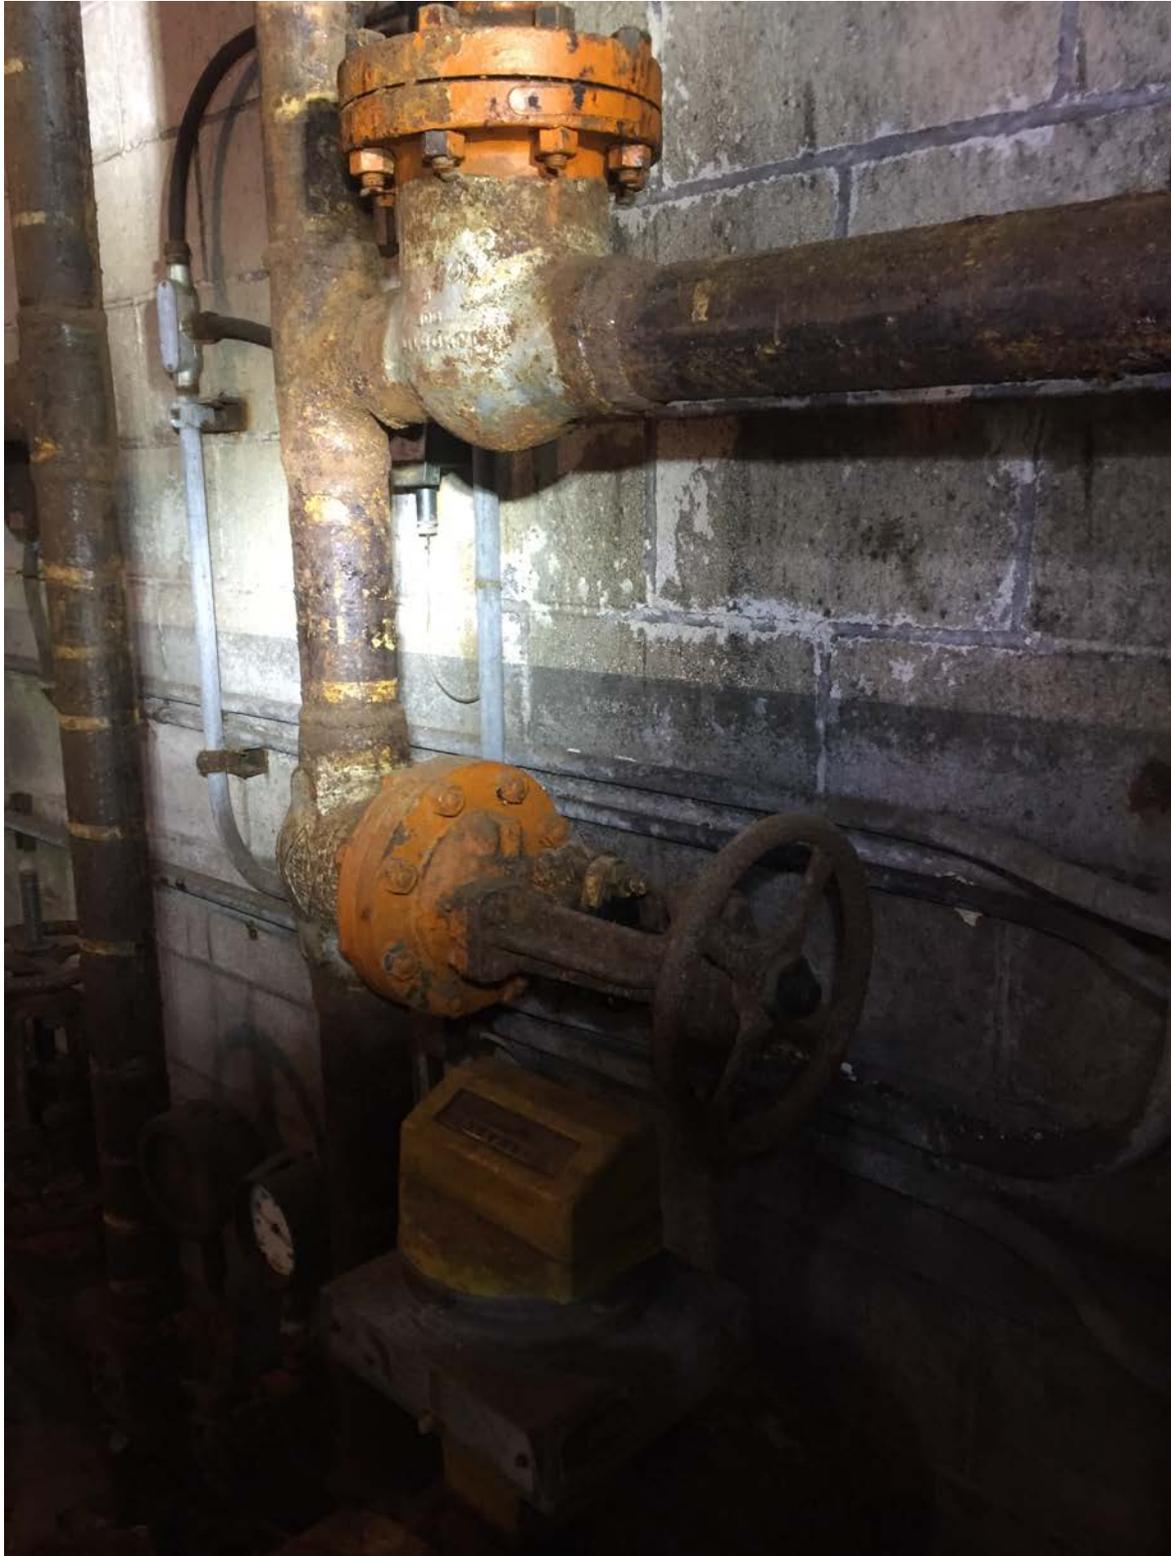
PHOTO 13 – 1st Floor Fuel Oil Pump Room #2 – Orange Paint (P38) on Pump Valves with PCB Bulk Sample Results >50 ppm
