APPENDIX O
Detailed Project Timeline

Detailed Project Timeline – Station B Abatement and Demolition

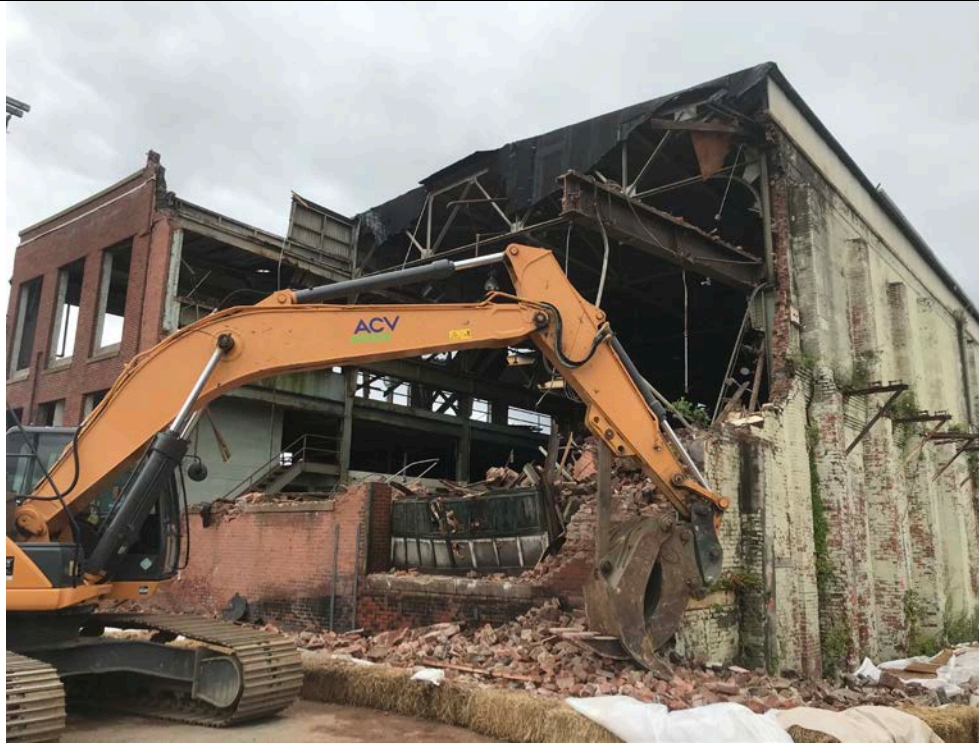
Photo 17: 7/23/2019, Demolition and consolidation of demolition debris at the southwestern corner of Station B.

- 7/22/2019 thru 7/24/2019 – Demolition starting with the western wall of Station B.
- 7/24/2019 thru 8/8/2019 – Stopped demolition of Station B and began consolidation and containerization of demolition debris waste for off-site disposal.

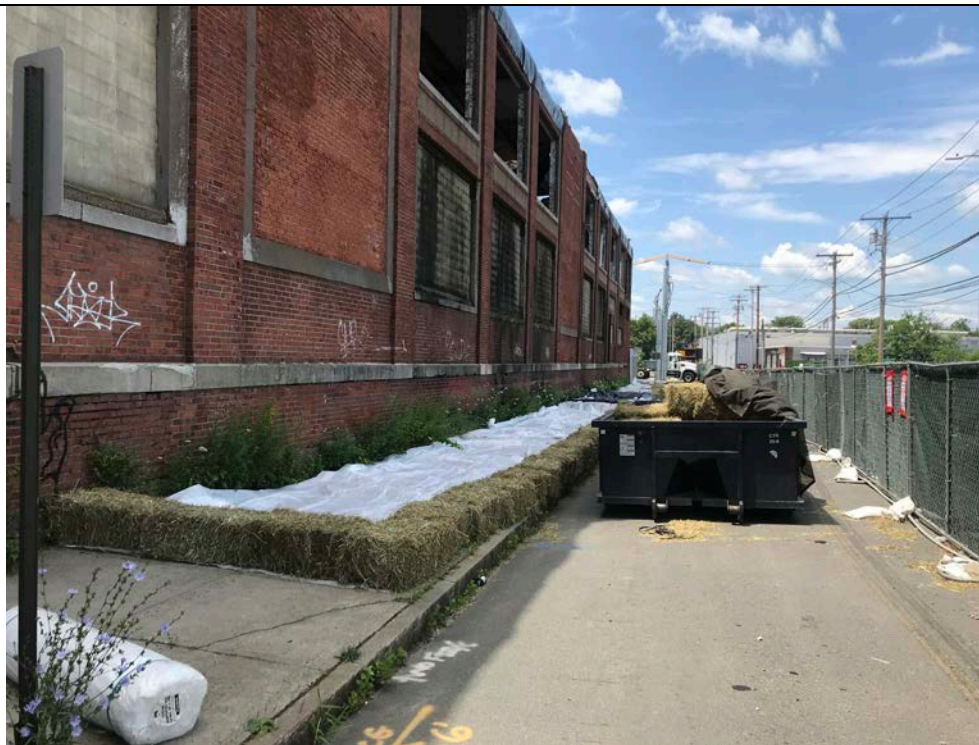
Photo 18: 7/24/2019, Regulated area for demolition debris on the northern side of Station B.

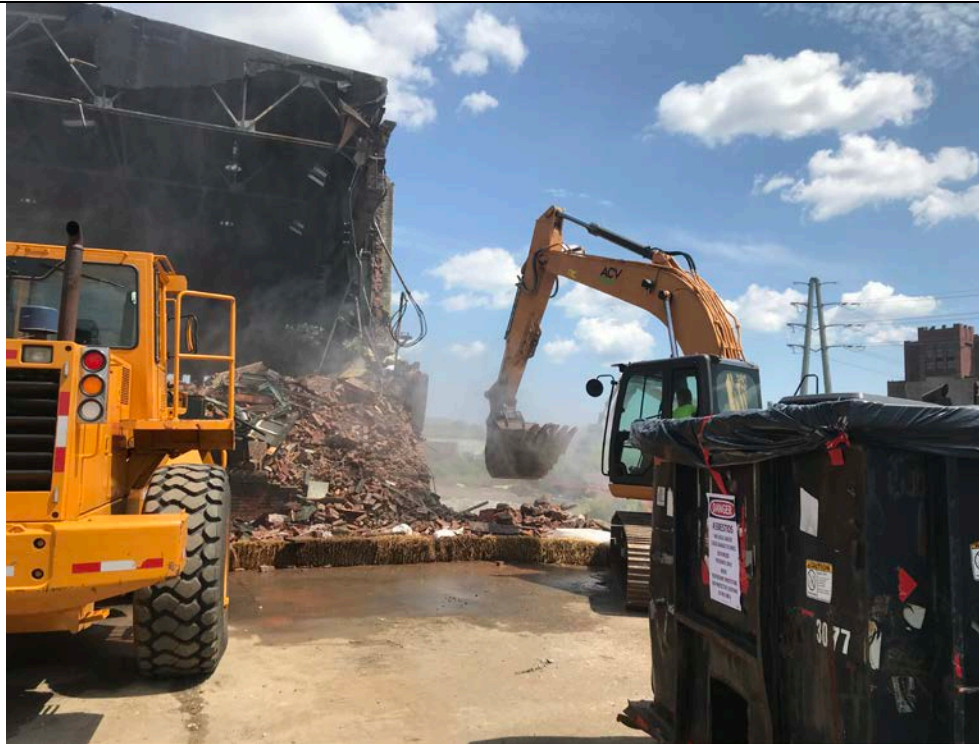
Photo 19: 7/24/2019, Consolidation of demolition debris waste near the southwestern corner of Station B.

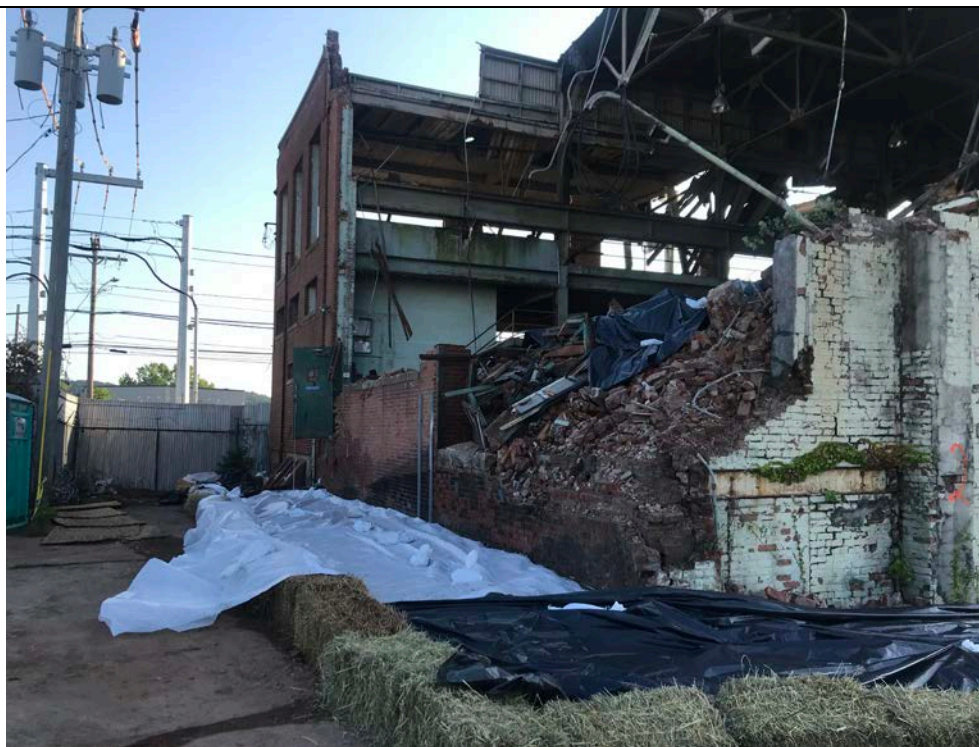
Photo 20: 7/25/2019, Regulated area for demolition debris at the southwestern corner of Station B.

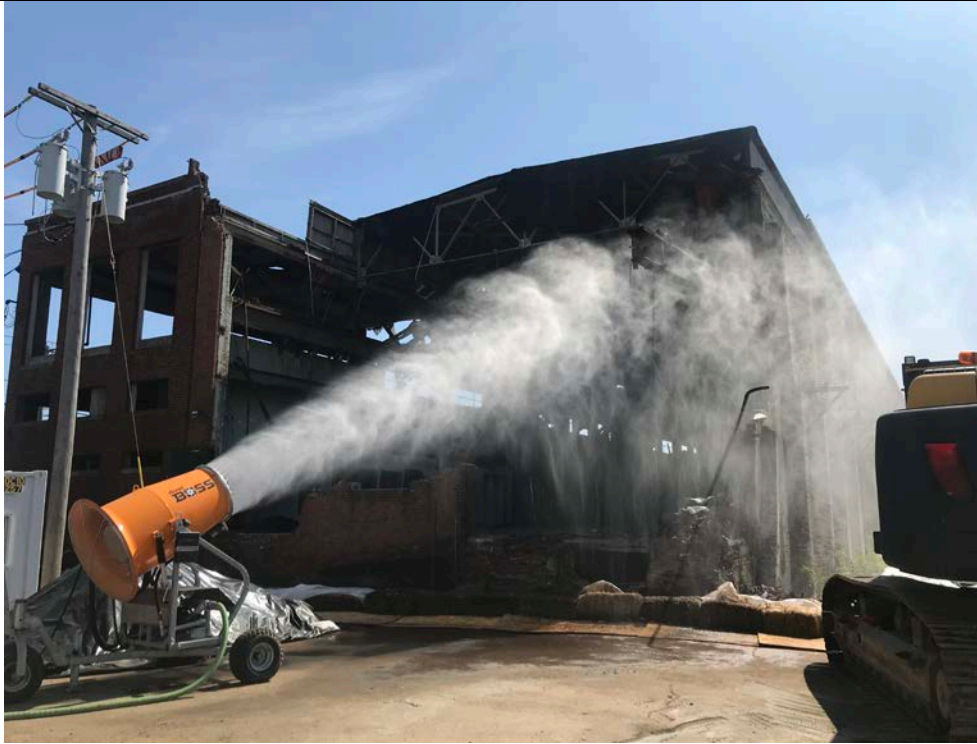
Photo 21: 8/9/2019, DustBoss® 60 (DB-60) water miser pre-wetting the work area at the southwestern corner of Station B for dust suppression.

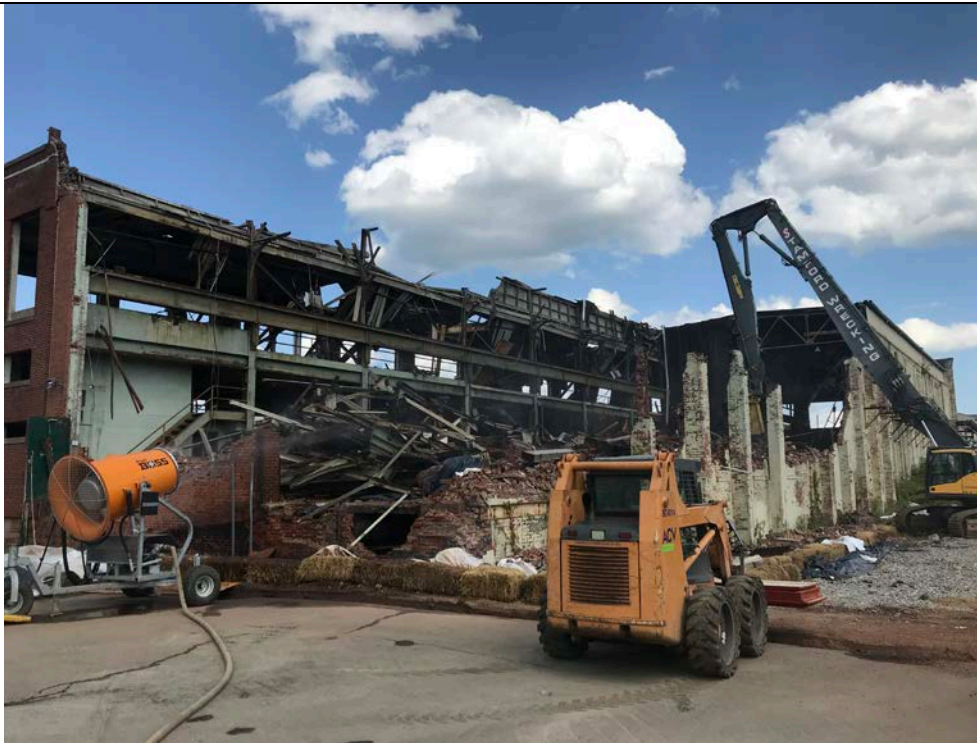
Photo 22: 8/9/2019, Demolition of the southern portion of Station B.

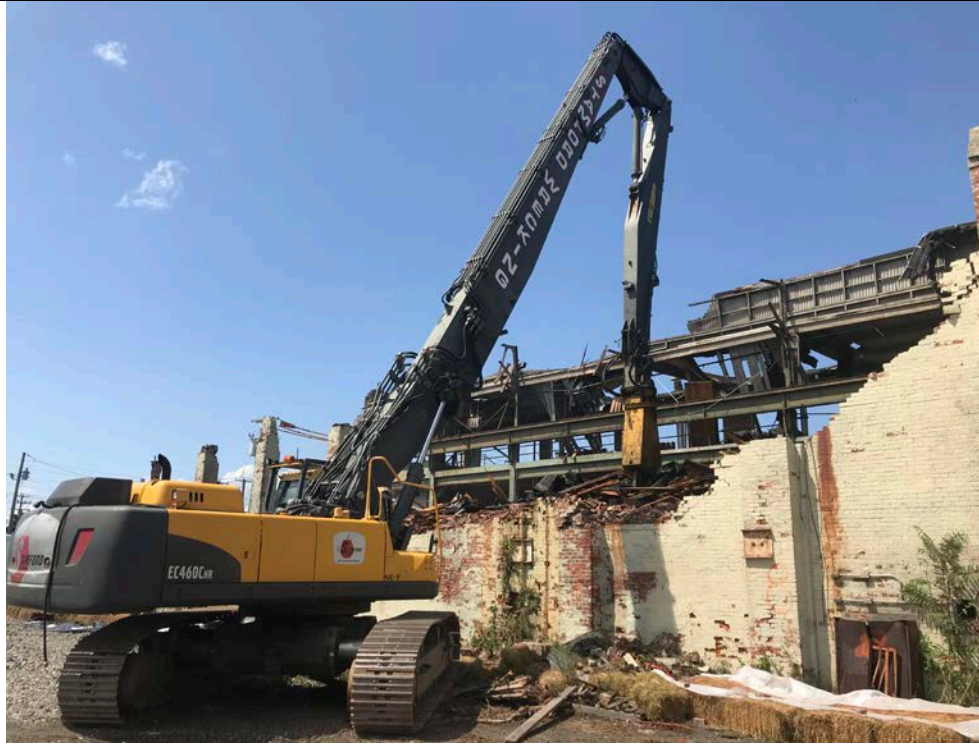
Photo 23: 8/9/2019, Demolition of the southern portion of Station B.

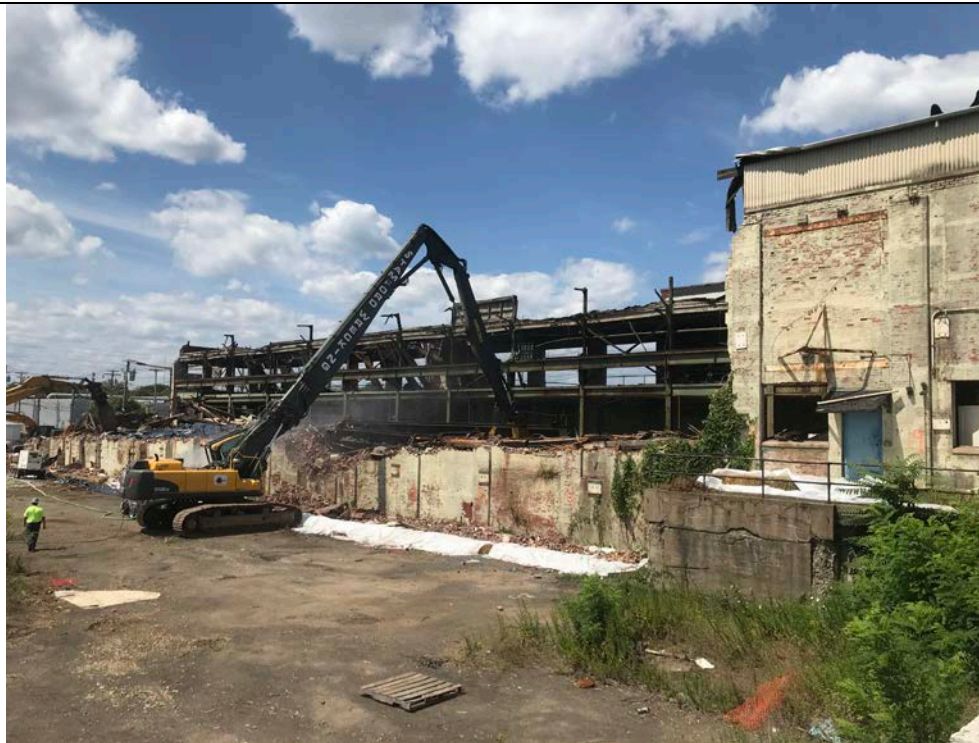
Photo 24: 8/9/2019, Demolition of the southern portion of Station B.

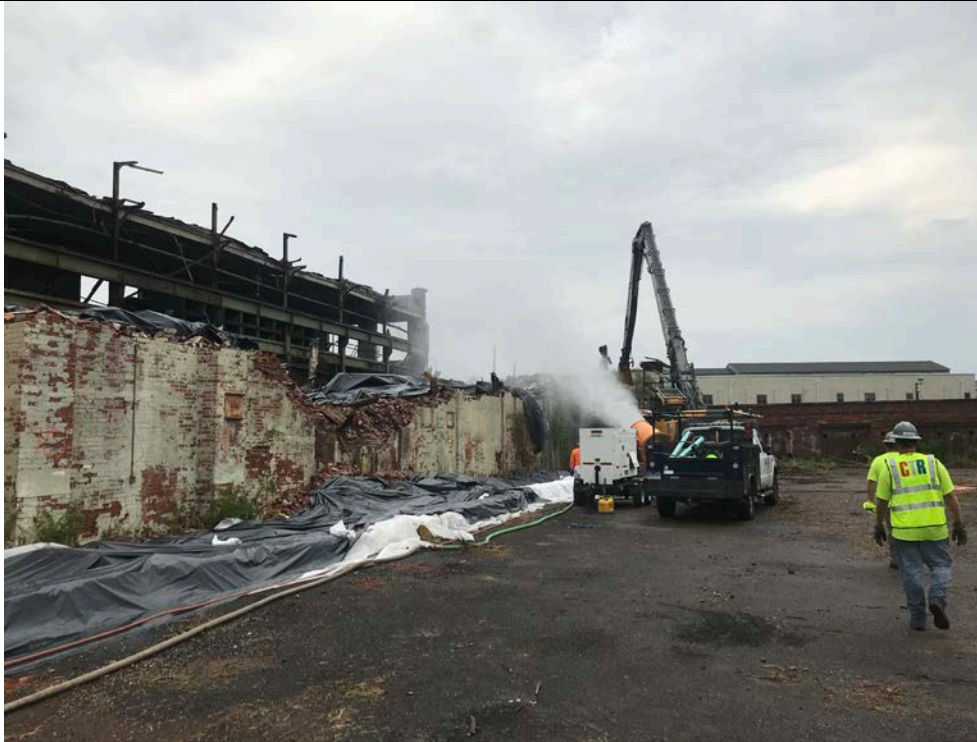
Photo 25: 8/13/2019, Demolition of the southeastern corner of Station B.

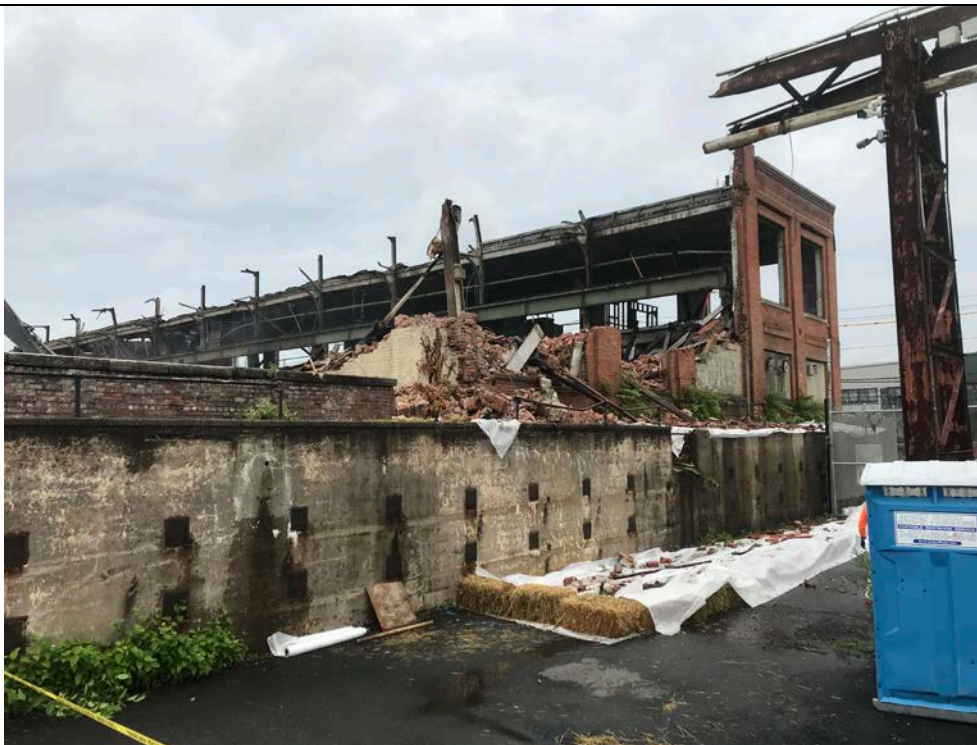
Photo 26: 8/13/2019, Regulated area for demolition debris on the eastern side of Station B.

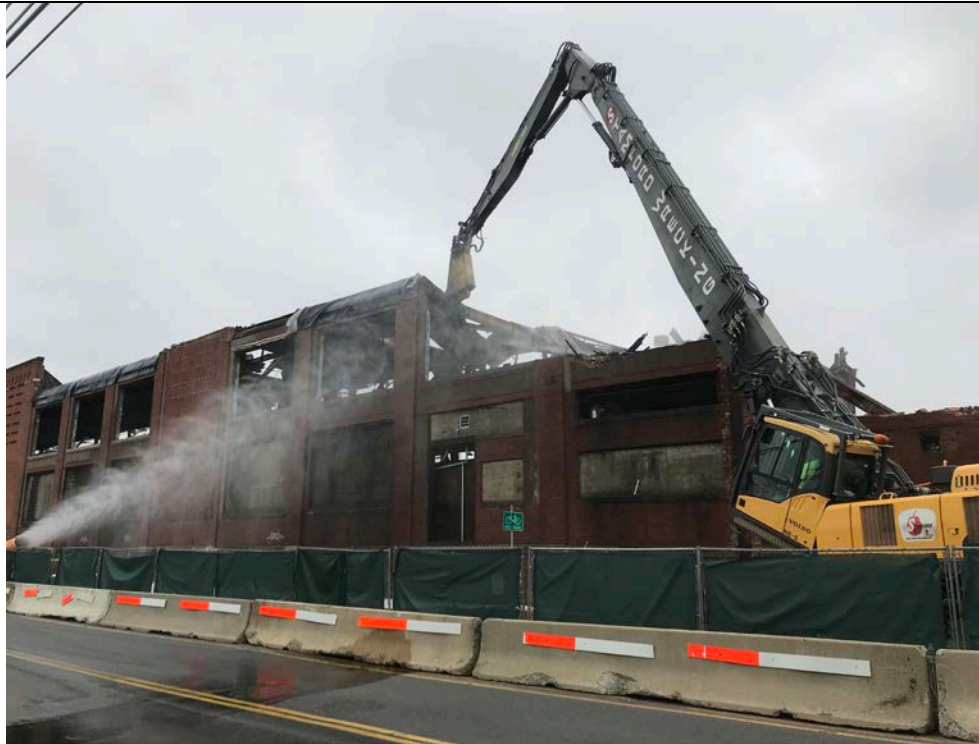
Photo 27: 8/14/2019, Demolition of the second-floor mezzanine on the northern side of Station B.

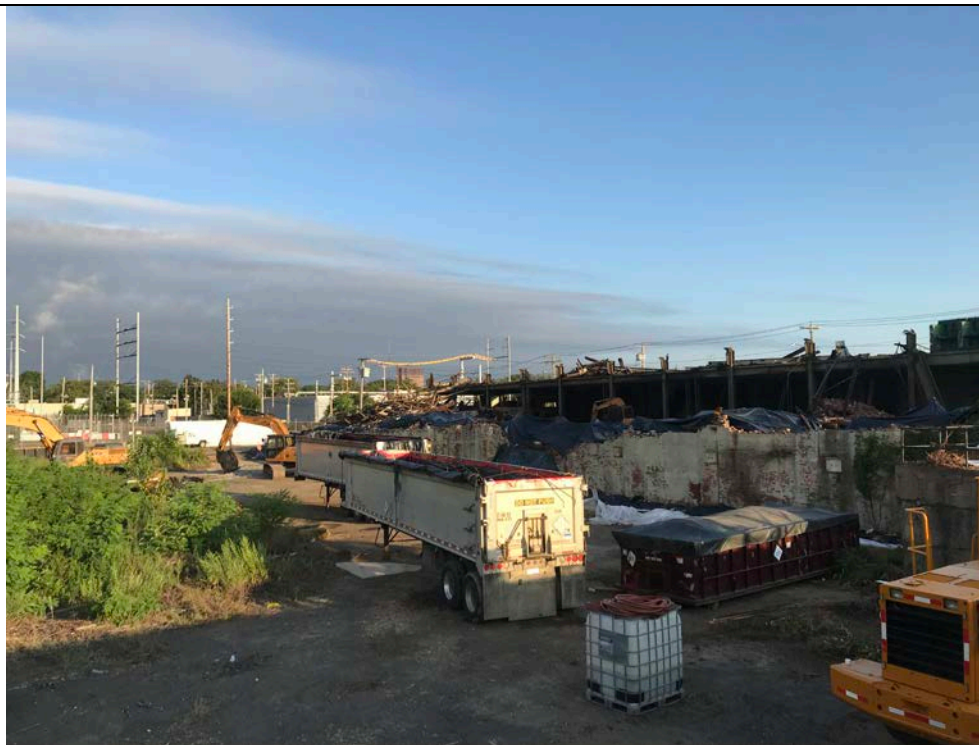
Photo 28: 8/16/2019, Station B demolition debris waste load out area on the southern side of Station B.

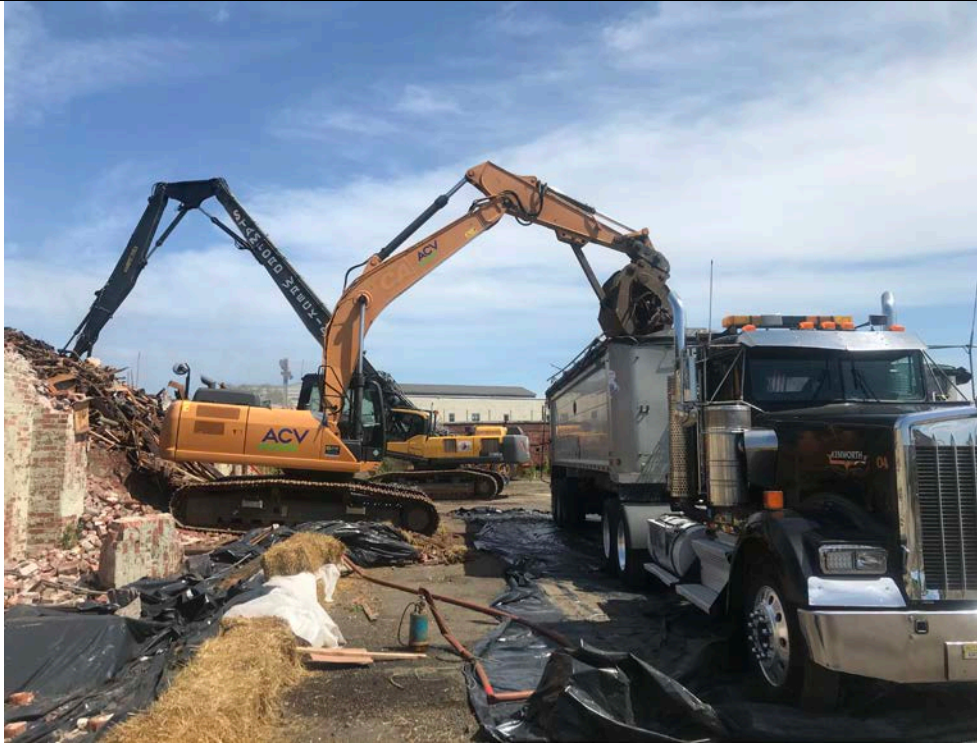
Photo 29: 8/20/2019, Station B demolition debris waste load out.

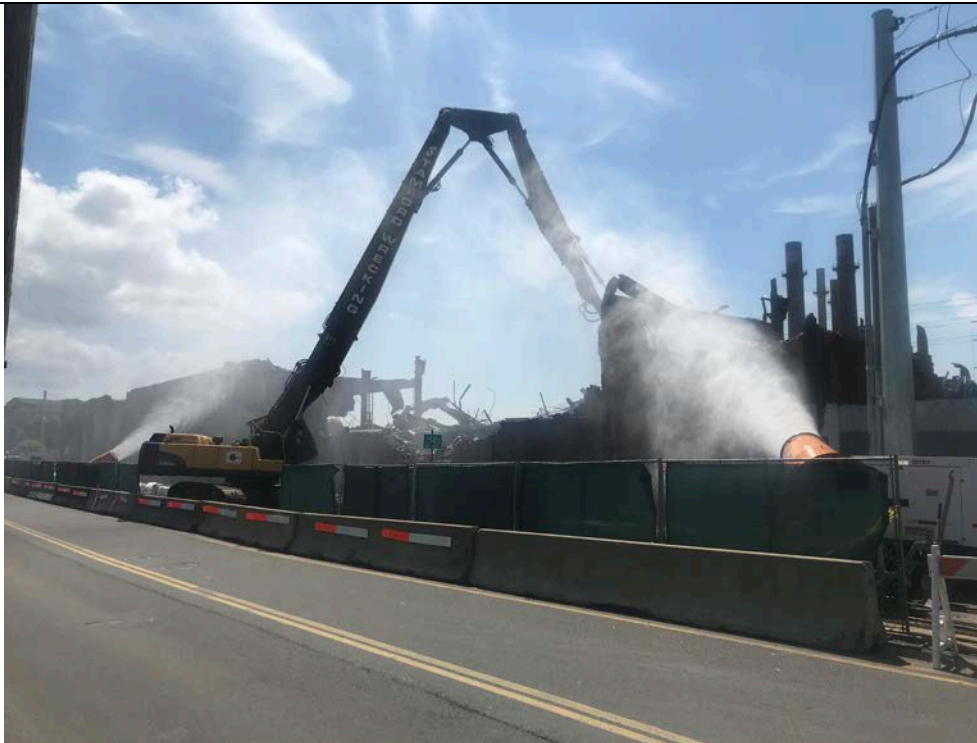
Photo 30: 8/22/2019, Demolition of the northern side of Station B.

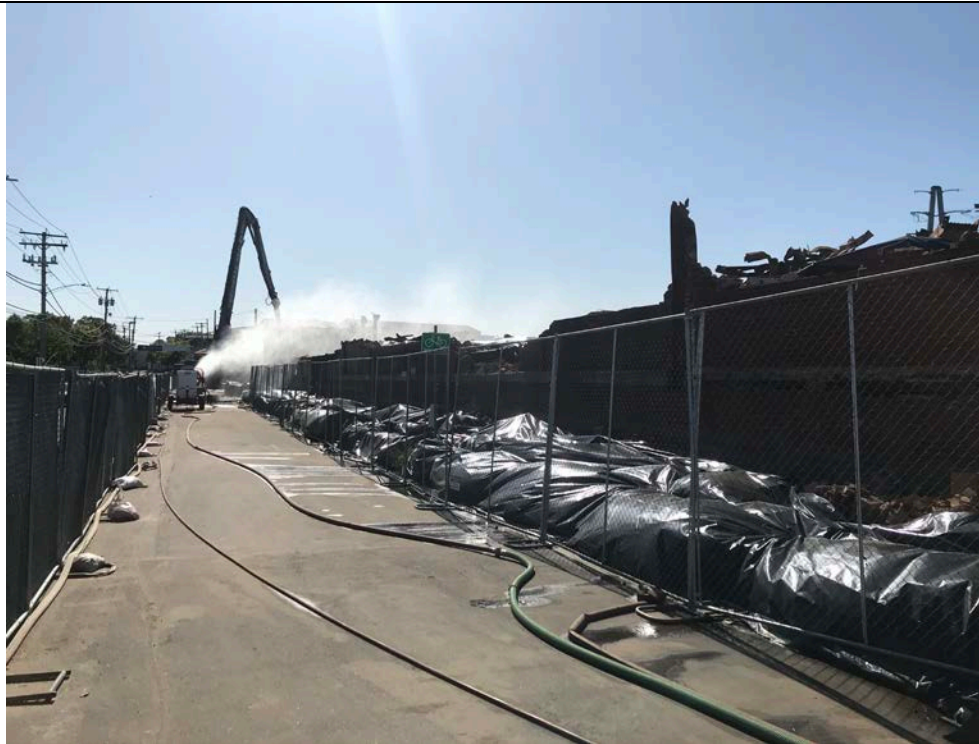
Photo 31: 8/26/2019, Regulated area for demolition debris on the northern side of Station B.

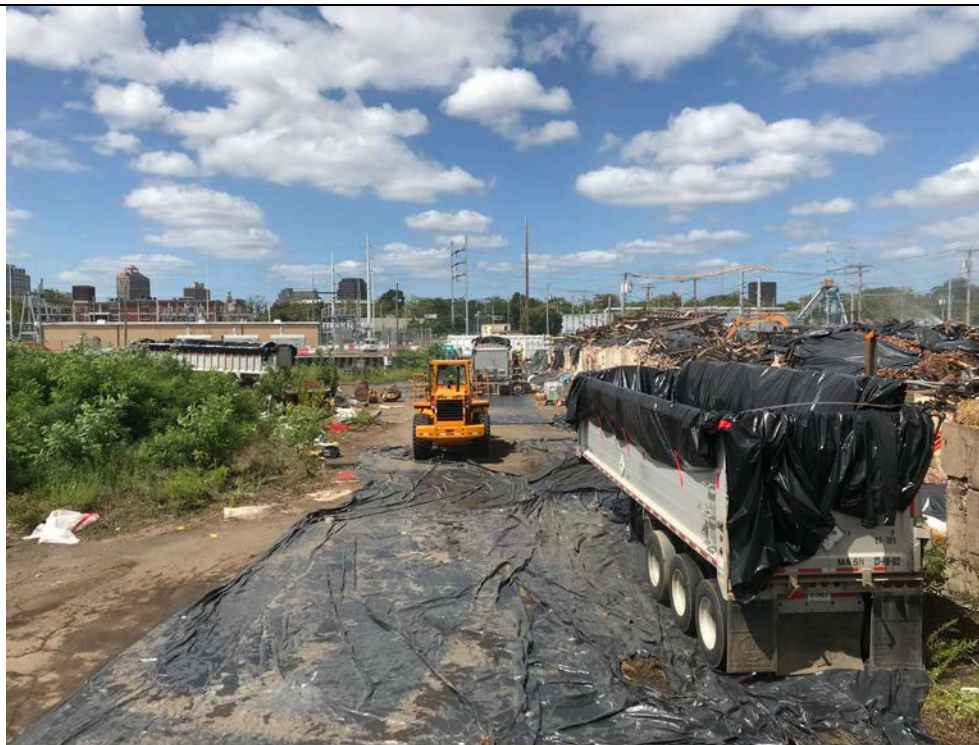
Photo 32: 8/26/2019, Station B demolition debris waste load out.

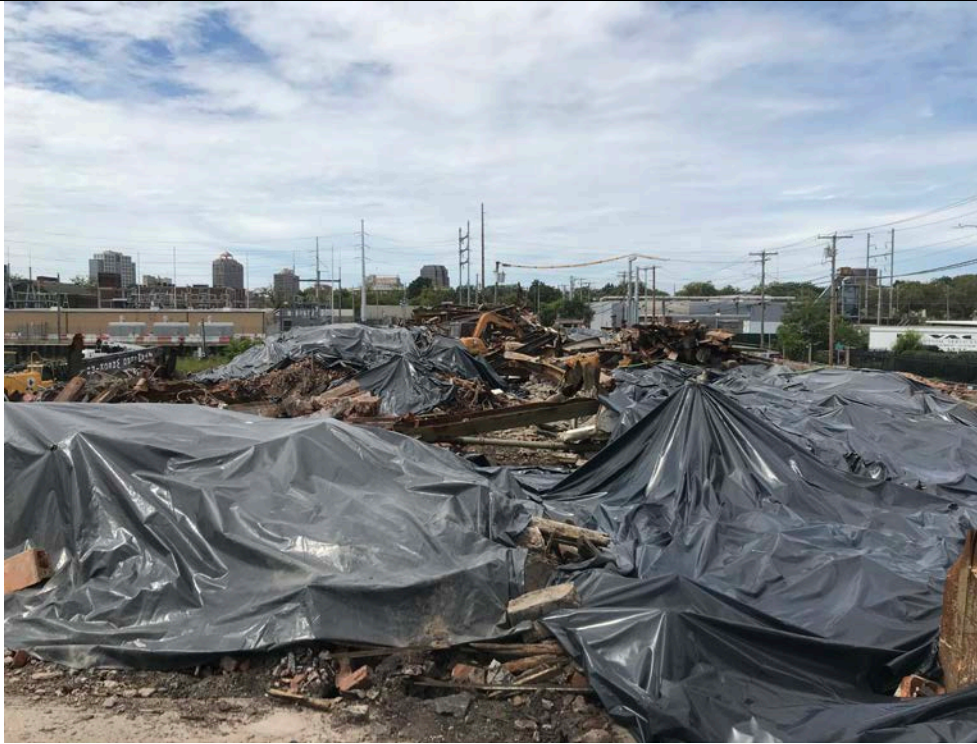
Photo 33: 8/27/2019, Poly sheeting used to cover debris piles at the end of each workday.

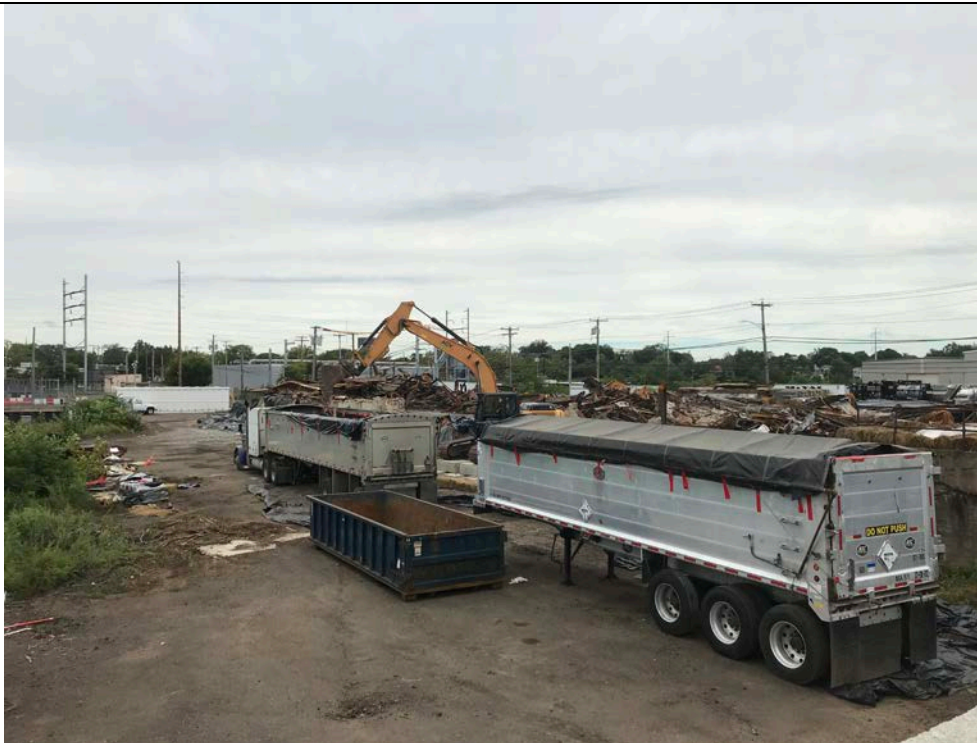
Photo 34: 9/6/2019, Station B demolition debris waste load out.

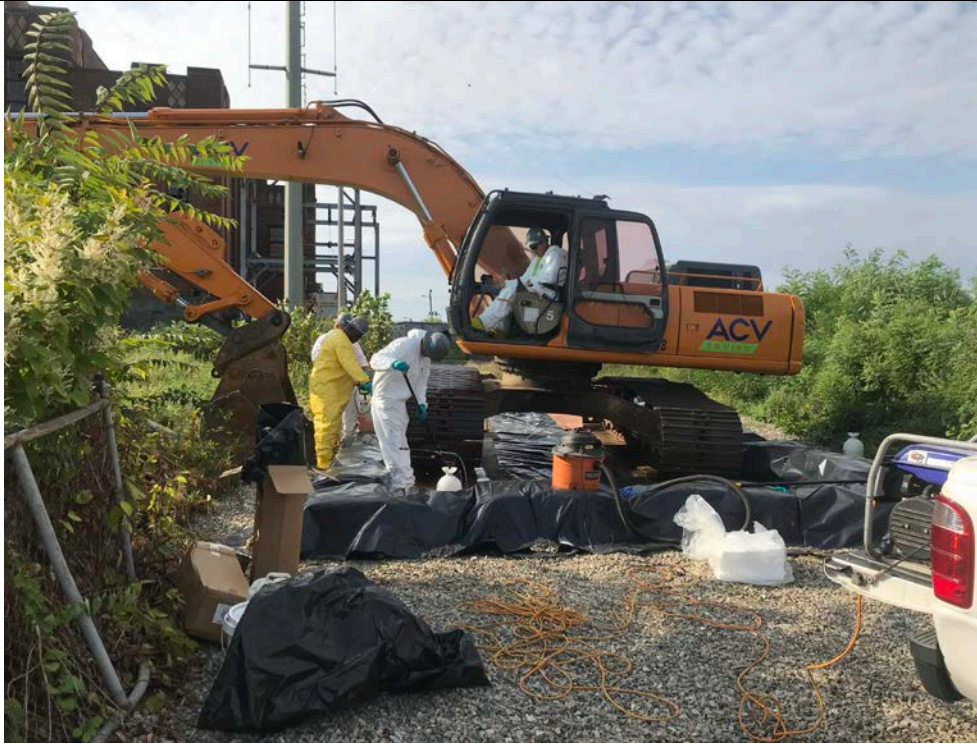
Photo 35: 9/9/2019, Decontamination of an excavator used during demolition activities, prior to being transported off-site.

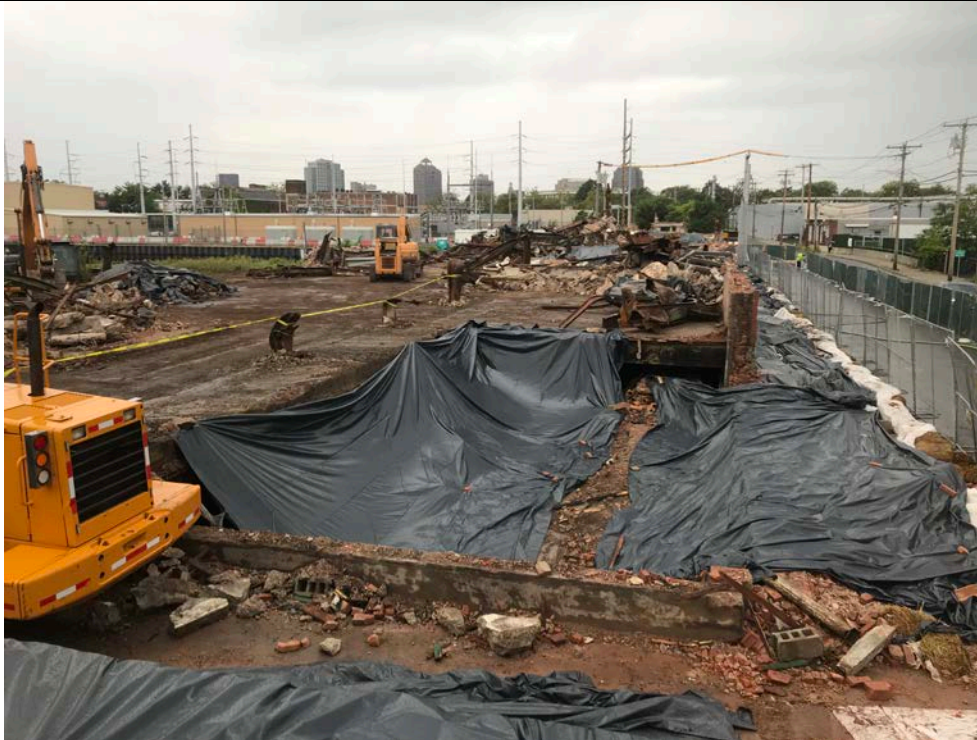
Photo 36: 9/12/2019, Poly sheeting used to cover consolidated concrete and brick debris piles at the end of each workday.

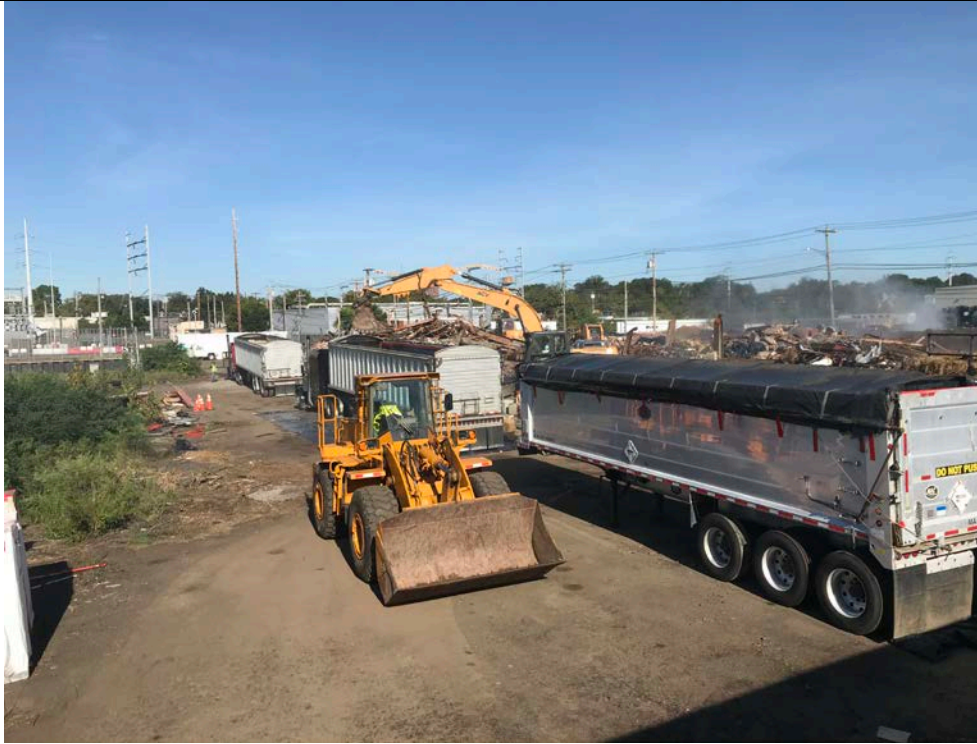
Photo 37: 9/13/2019, Station B demolition debris waste load out.

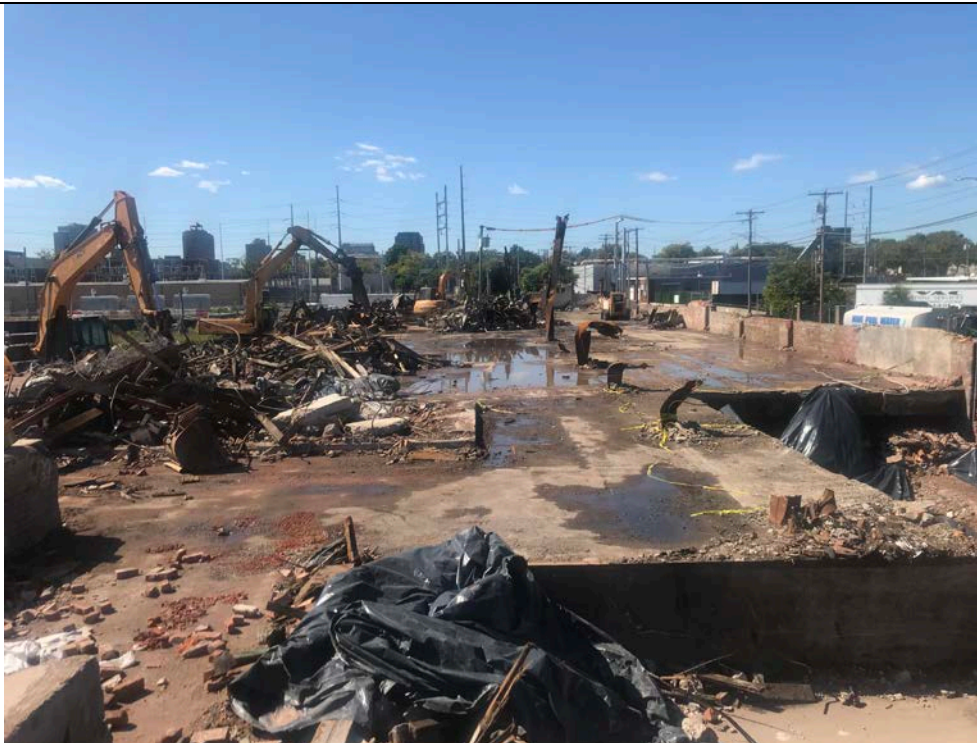
Photo 38: 9/17/2019, Consolidation and load out of Station B demolition debris.

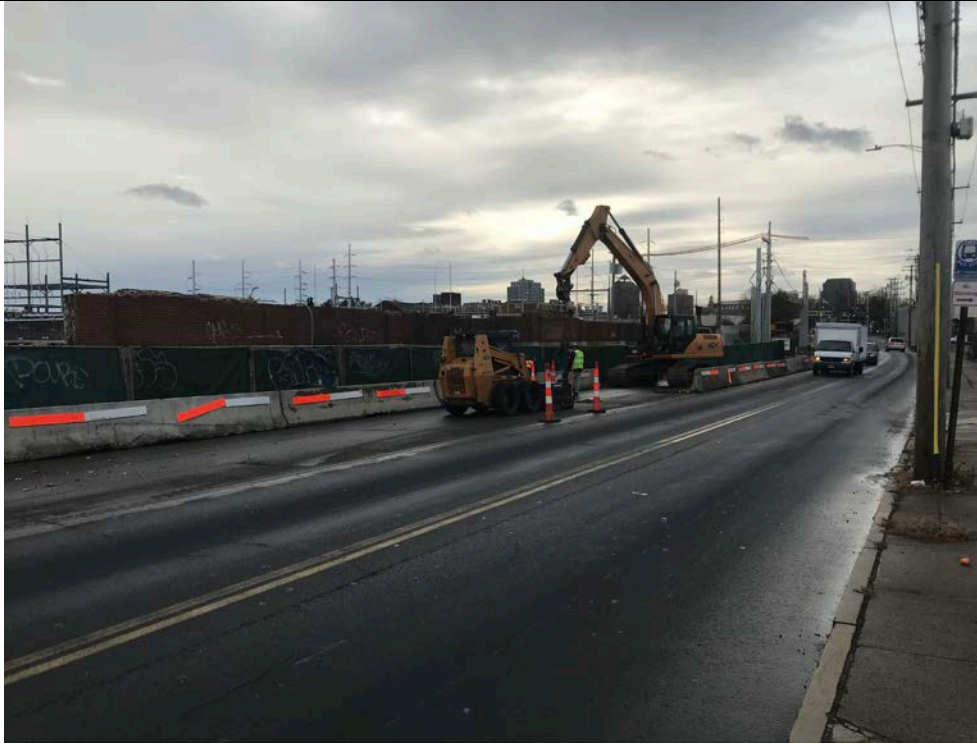
Photo 39: 11/20/2019, Realignment of Grand Ave traffic controls to allow pedestrian foot traffic on the south side of Grand Ave.

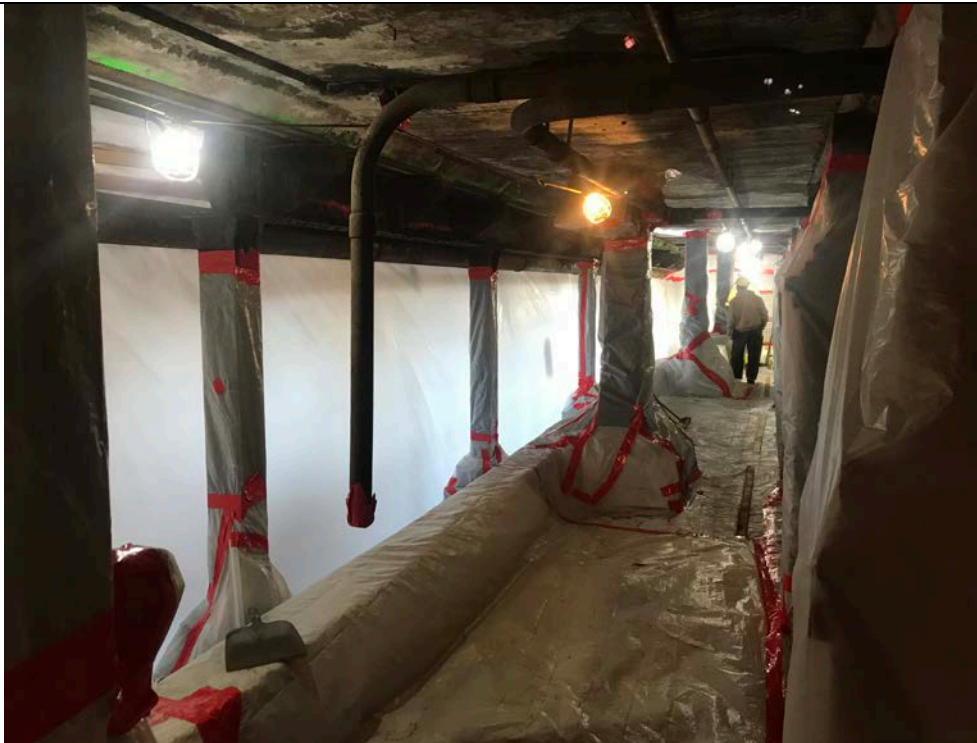
Photo 40: 11/21/2019, Station B basement, inside an asbestos abatement containment during preparation.

- 10/18/2019 thru 11/25 – Stoppage of demolition work.
- 11/18/2019 thru 11/25/2019 –Performed asbestos abatement in the building basement of friable asbestos discovered after demolition activity uncovered new areas. TRC performed project monitoring activities during asbestos abatement work, including pre-commencement inspection of containment areas, air monitoring during asbestos removal, and post abatement re-occupancy inspection and air monitoring of containment areas following completion of asbestos removal.

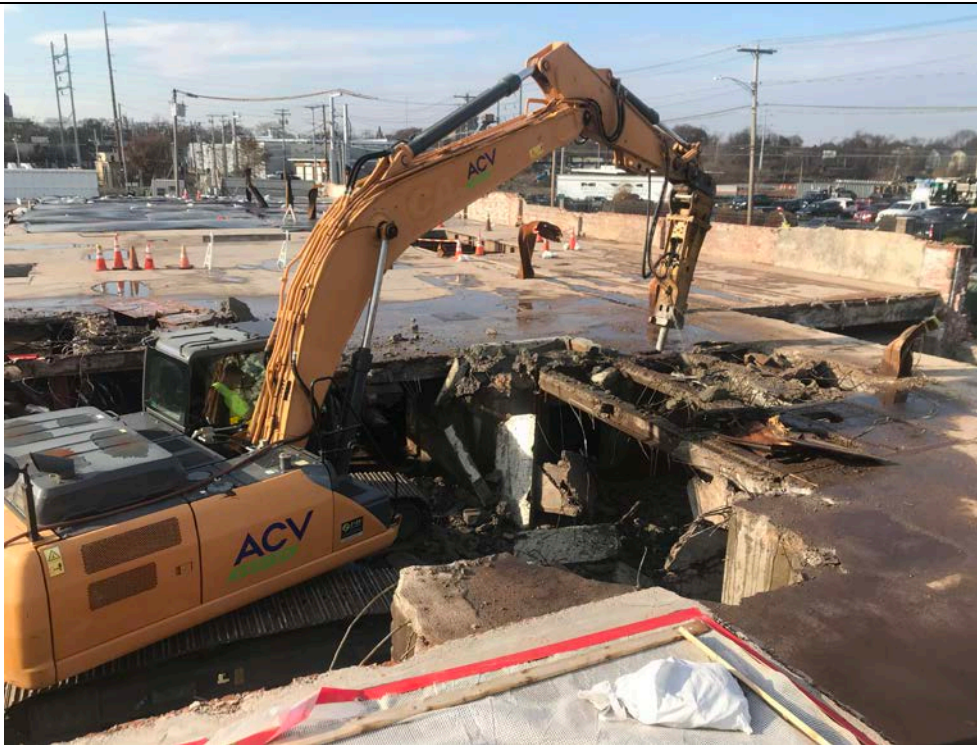
Photo 42: 11/25/2019, Demolition of the Station B first floor slab.

- 11/26/2019 thru 12/15/2019 – Demolition of the Station B northern wall remnant and first floor slab.
- 11/27/2019 through 04/02/2020 – Load-out of Station B demolition debris waste.

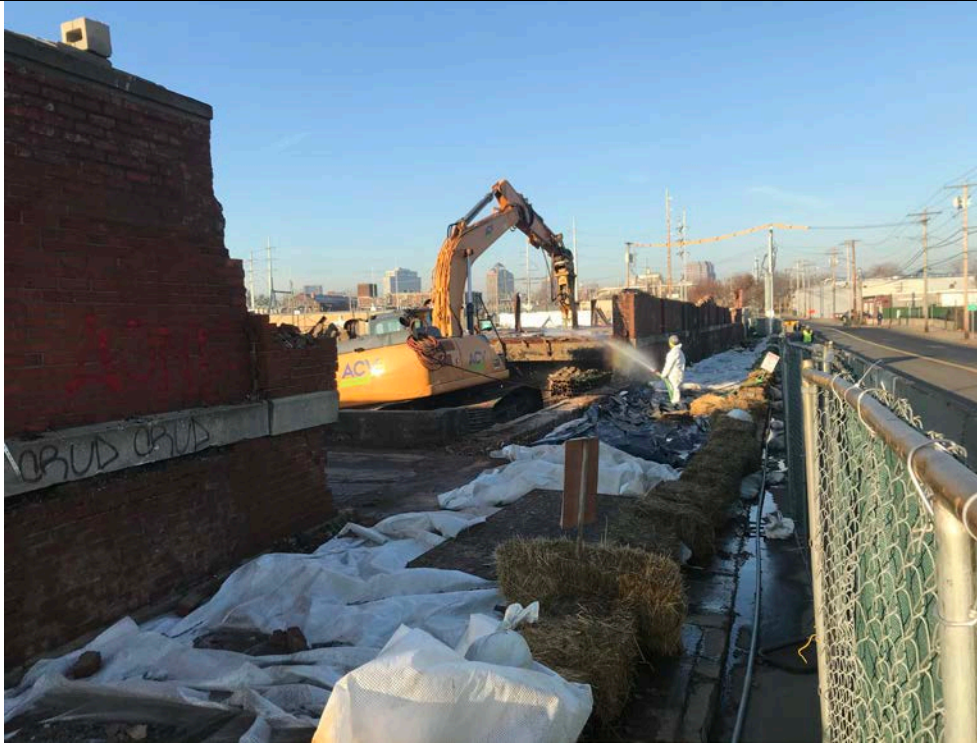
Photo 43: 11/26/2019, Demolition of the northern portion of the Station B first floor slab.

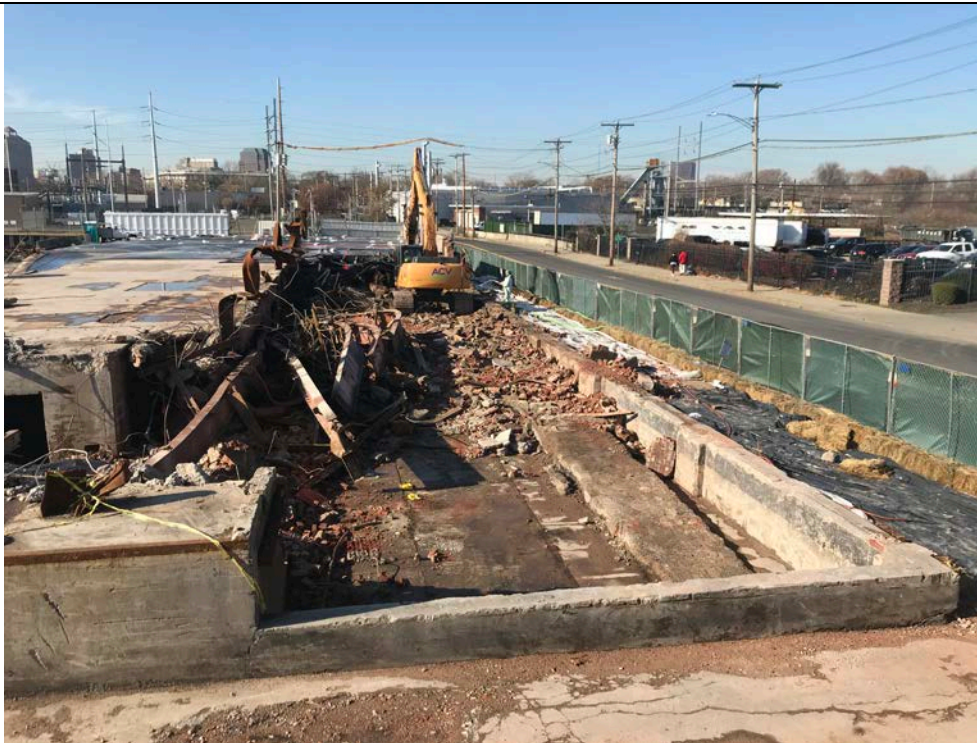
Photo 44: 11/26/2019, Demolition of the northern portion of the Station B first floor slab.

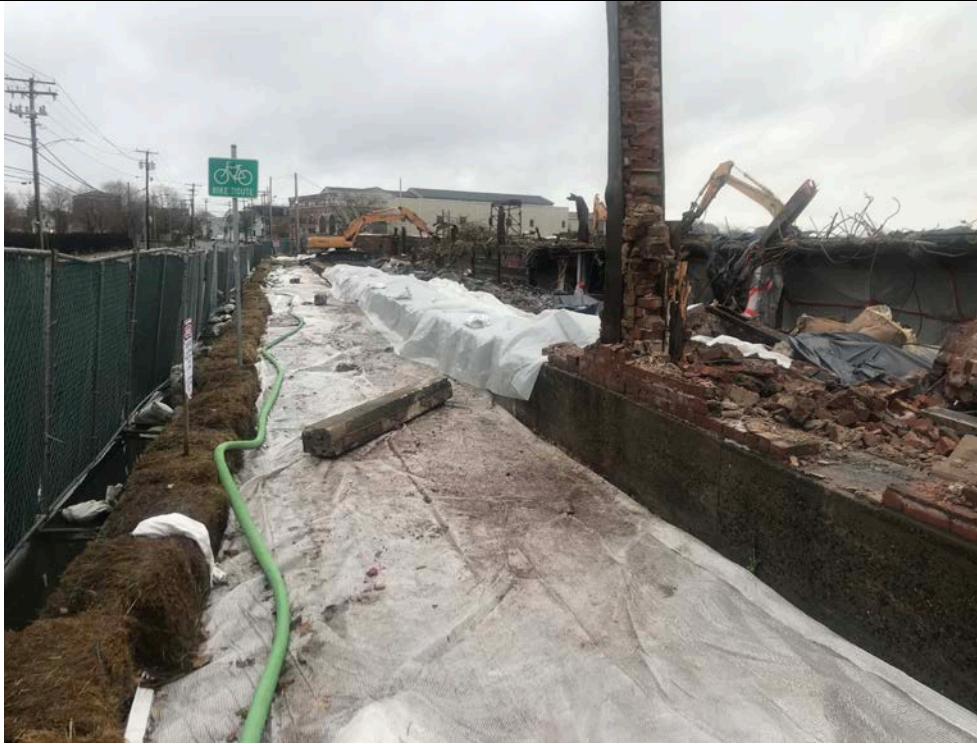
Photo 45: 12/2/2019, Regulated area for Station B demolition debris.

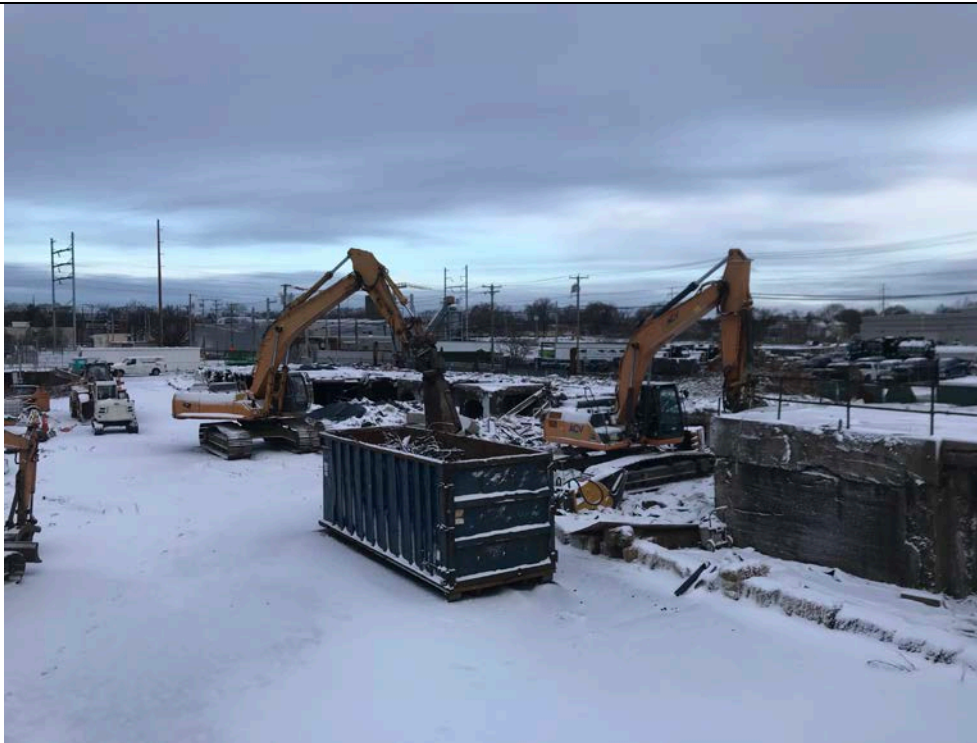
Photo 46: 12/3/2019, Station B demolition debris waste consolidation and load out.

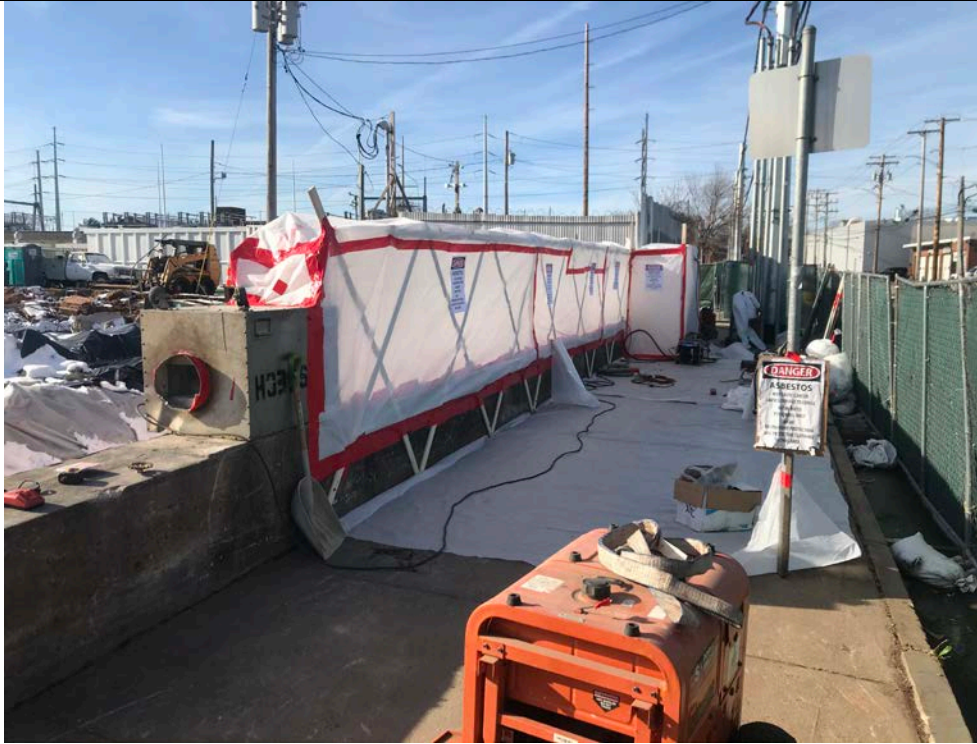
Photo 47: 12/12/2019, Asbestos abatement containment for the removal of asbestos containing material on the Station B permanent northern foundation wall.
