APPENDIX O
Detailed Project Timeline

Detailed Project Timeline – Station B Abatement and Demolition

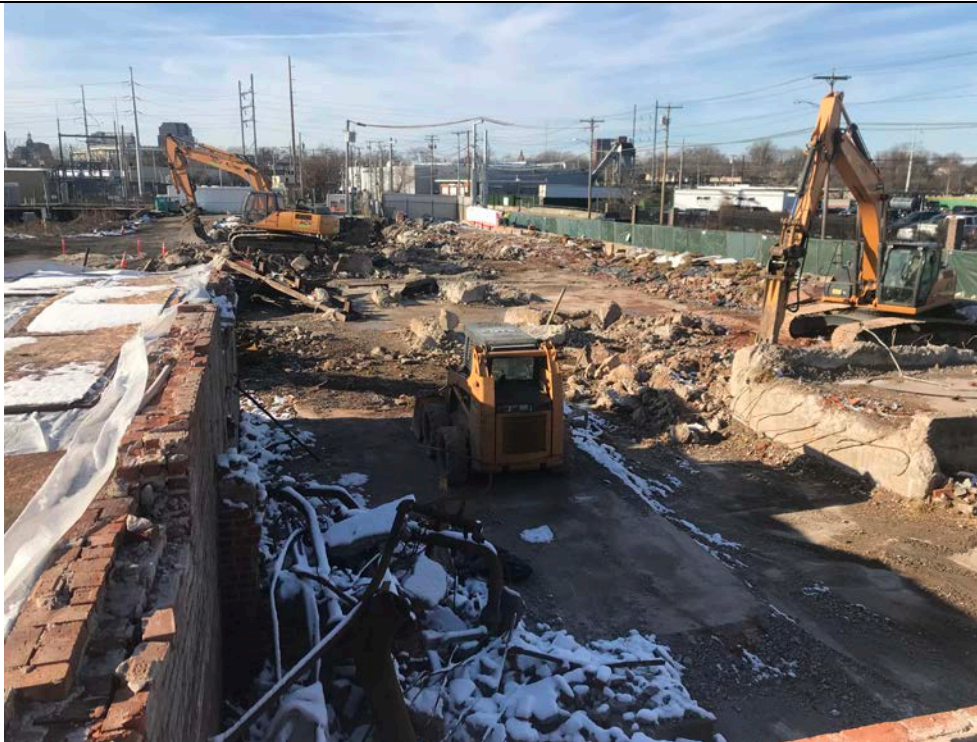
Photo 48: 12/12/2019, Station B demolition debris consolidation.

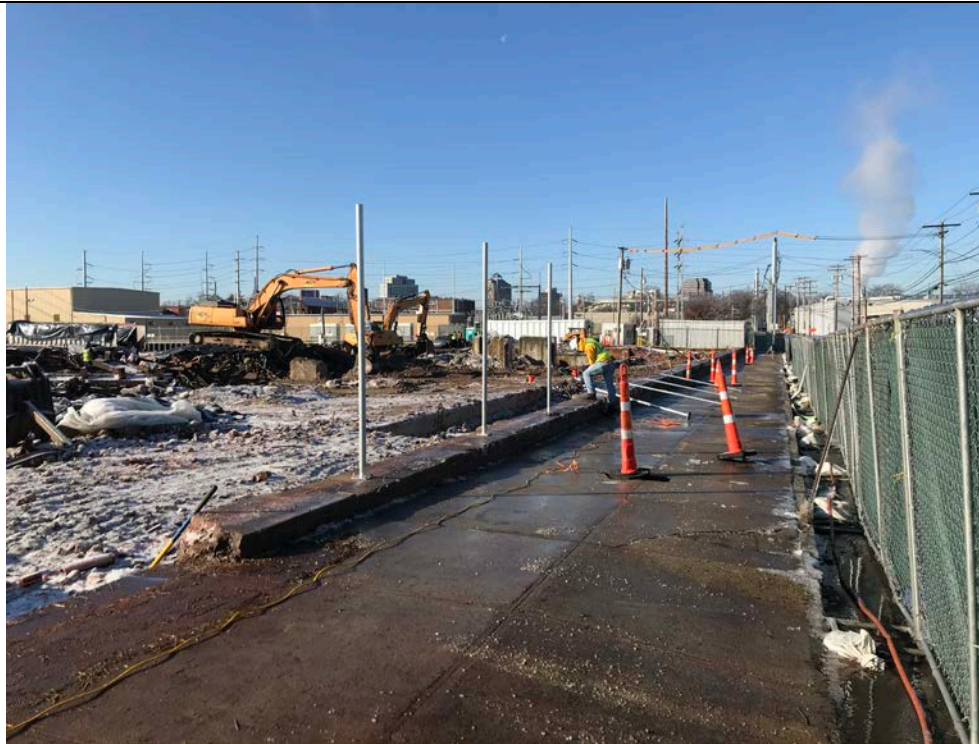
Photo 49: 12/18/2019, Installation of permanent site perimeter fence.

- 12/18/2019 through 12/20/2019 – Installation of permanent 8' chain link fence into the Station B northern foundation wall.

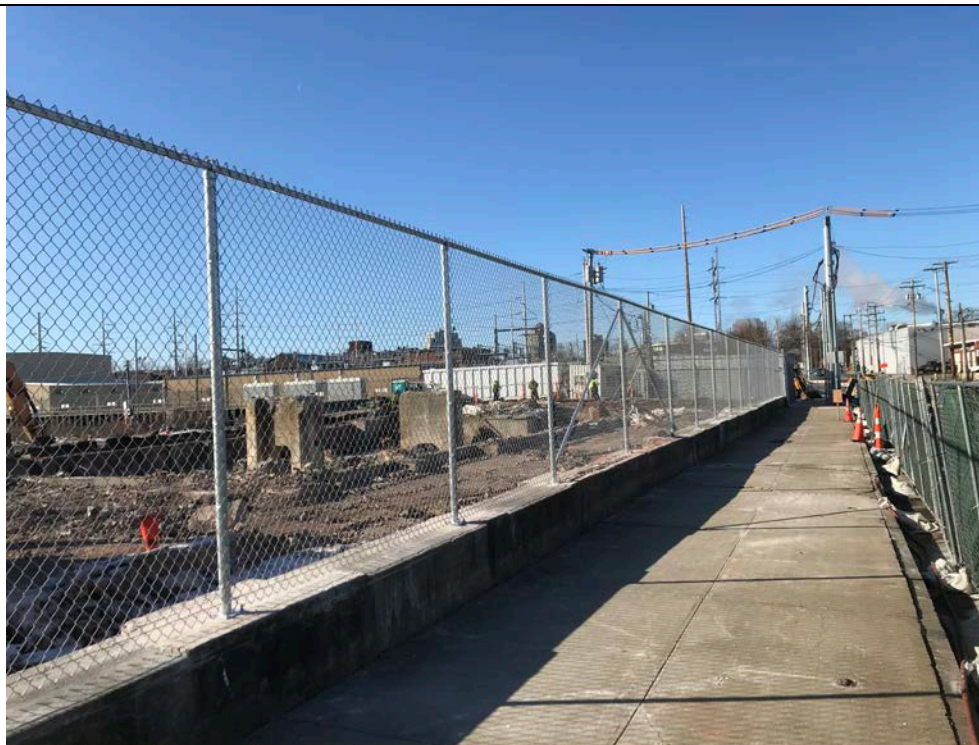
Photo 50: 12/20/2019, Permanent site perimeter fence.

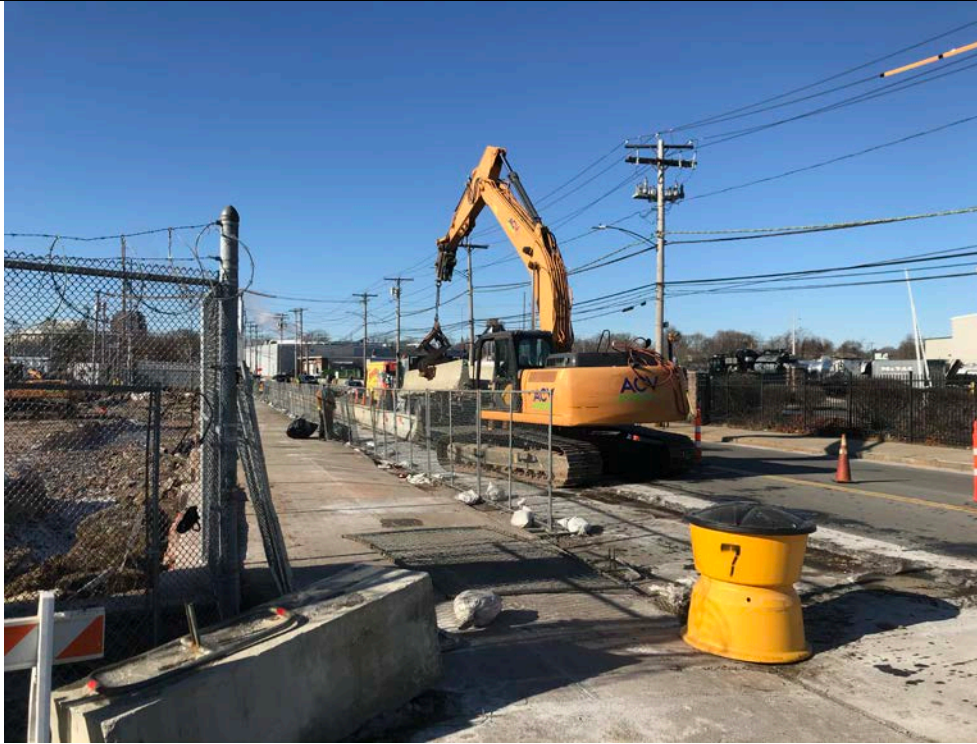
Photo 51: 12/20/2019, Removal of Grand Ave traffic controls.

- 12/20/2019 – Completely cleaned the sidewalk, removed all traffic controls from Grand Ave. Sidewalk and roadway in front of 510 Grand Ave, restriped the road and returned Grand Avenue to full access to the public.

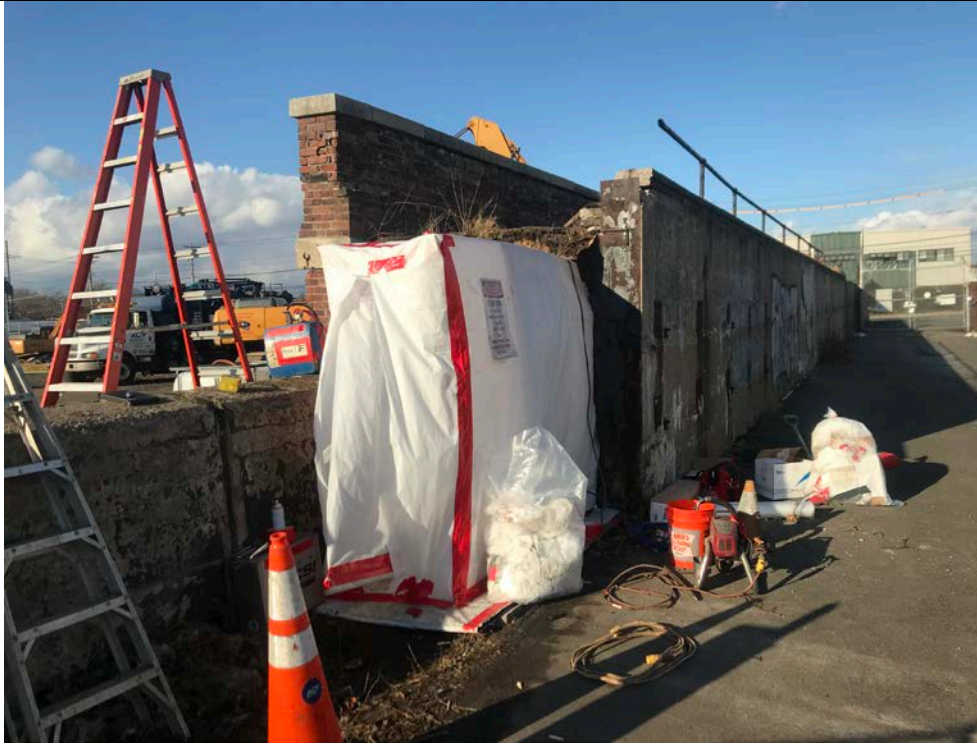
Photo 53: 1/8/2020, Asbestos abatement containment for asbestos containing material, prior to demolition of eastern platform wall.

- 1/8/2020 through 1/13/2020 – Performed asbestos abatement on two previously inaccessible 8" diameter inactive water pipes enclosed by the Station B eastern platform wall. TRC performed project monitoring activities during asbestos abatement work, including pre-commencement inspection of containment areas, air monitoring during asbestos removal, and post abatement re-occupancy inspection and air monitoring of containment areas following completion of asbestos removal.

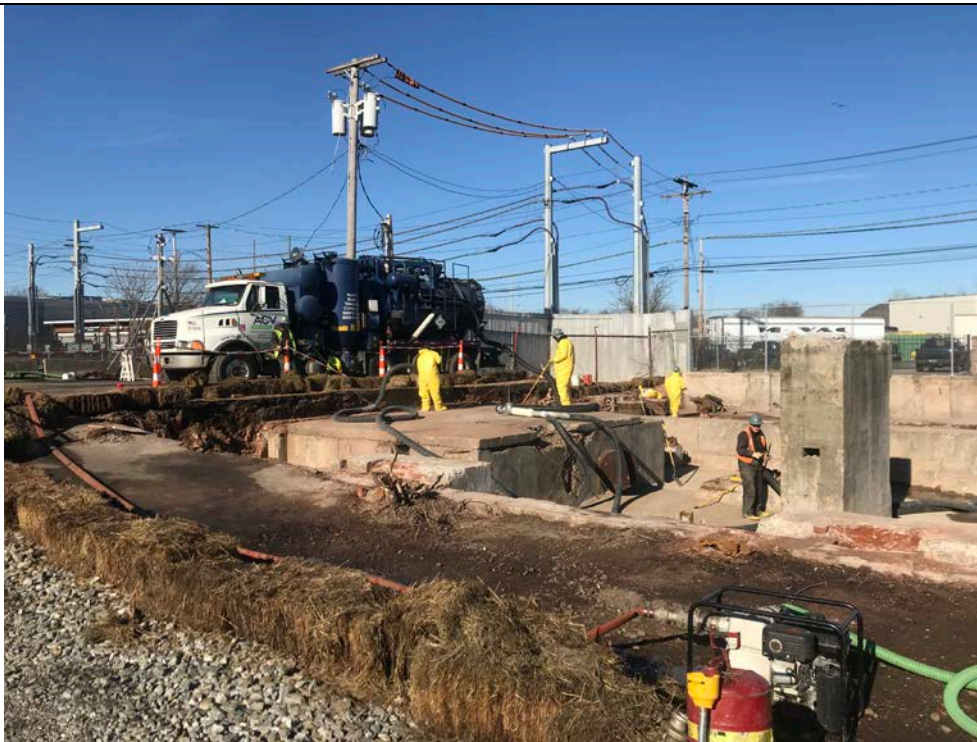
Photo 54: 1/9/2020, Fine cleaning of demolition debris waste in the former Station B basement.

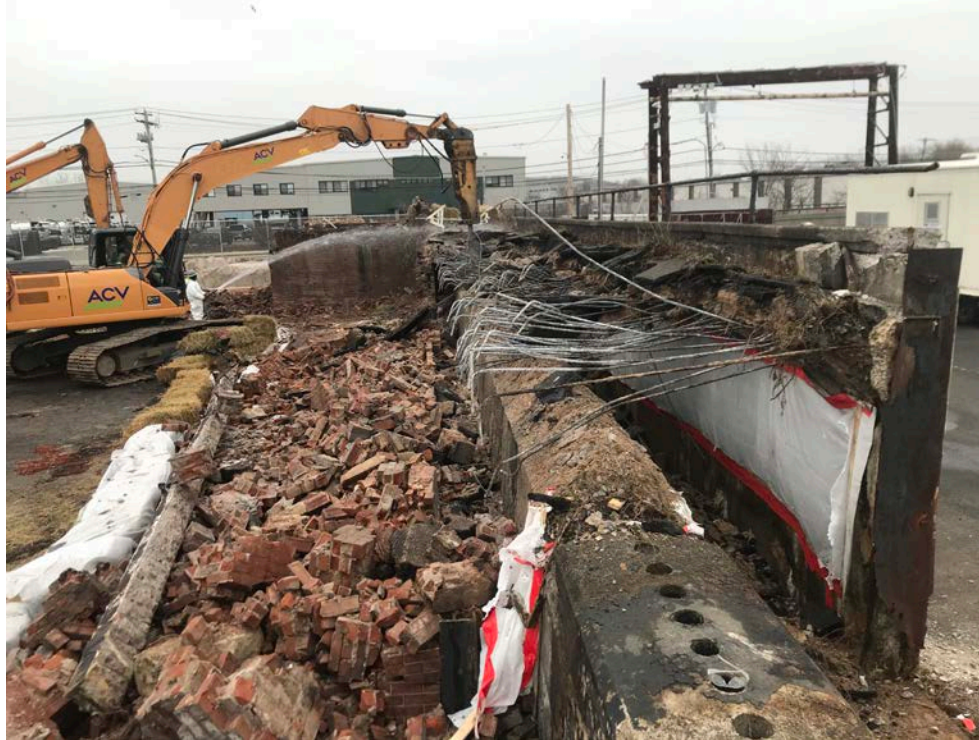
Photo 55: 1/13/2020, Demolition of the eastern platform wall.

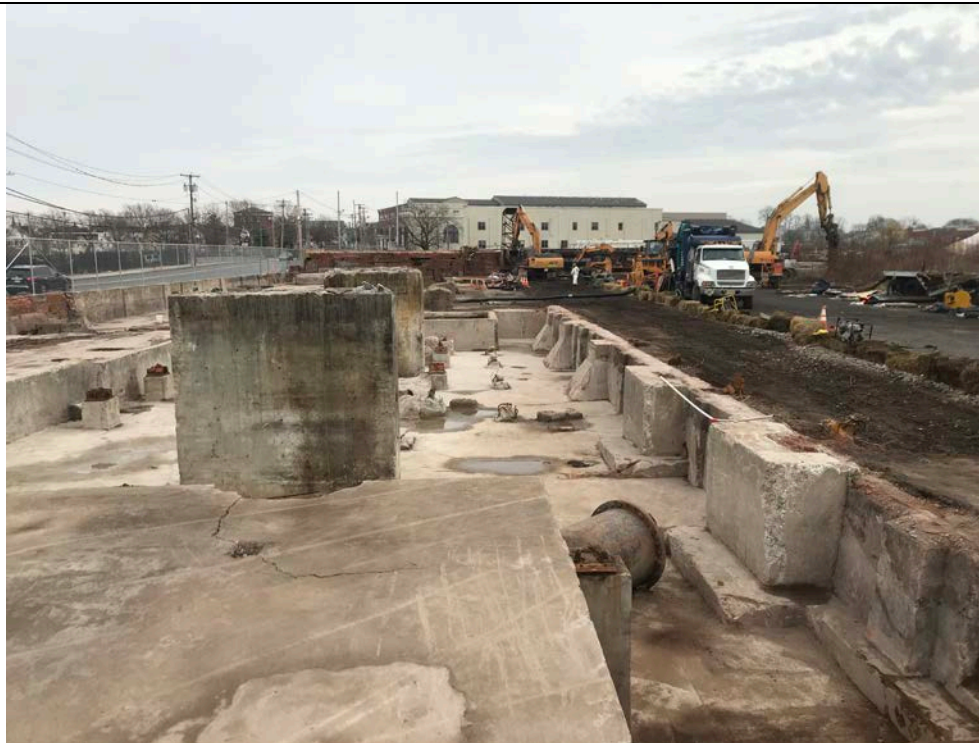
Photo 56: 1/14/2020, Eastern portion of the former Station B basement after fine cleaning of demolition debris waste.

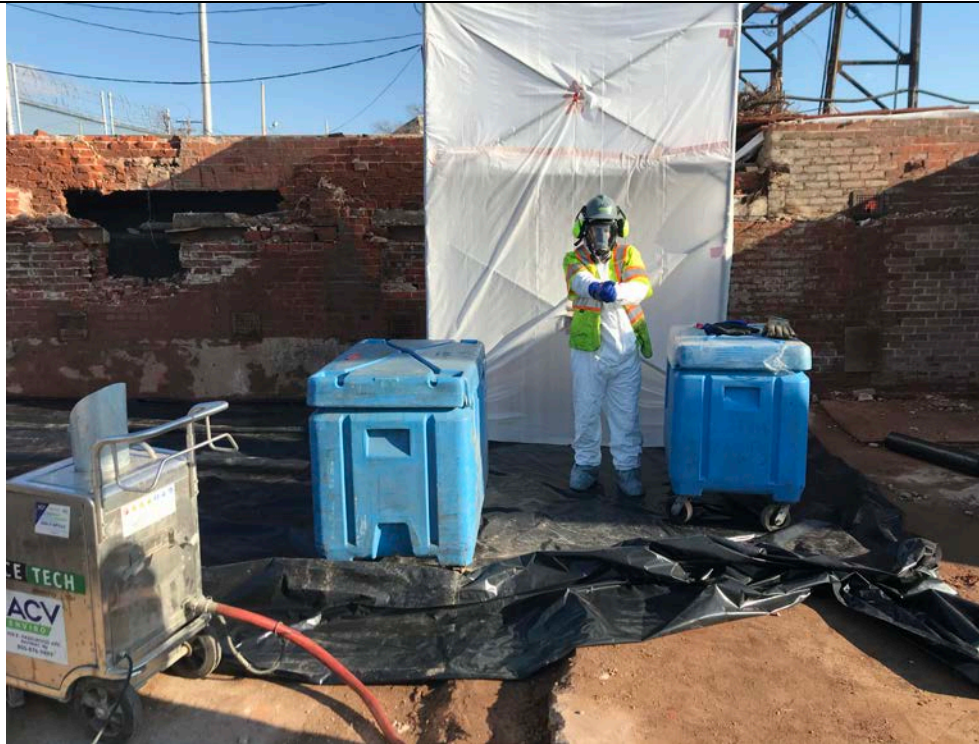
Photo 57: 1/15/2020, Contractor preparing to perform paint removal from permanent structures using ice blasting methods.

- 1/15/2020 thru 2/18/2020 - Excluded PCB Product paint removal from Station B portions of the basement structure to remain. TRC performed a visual inspection to confirm all Excluded PCB Product building materials had been completely removed from within the footprint of Station B in accordance with requirements of the demolition task.

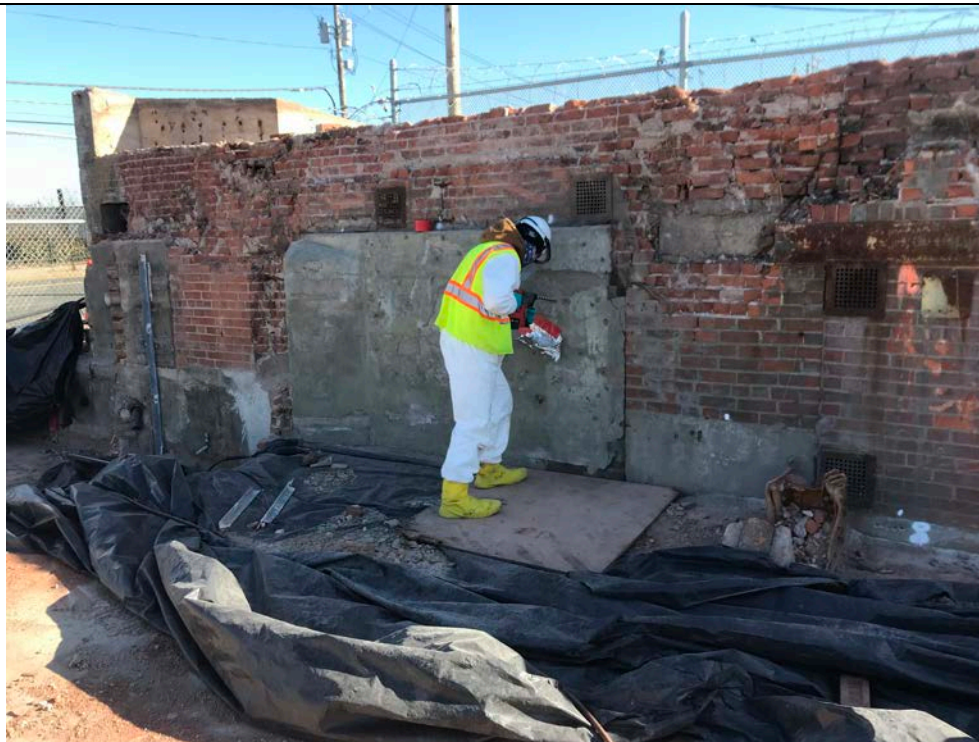
Photo 58: 1/17/2020, Porous media verification sampling for PCB analysis after paint removal.

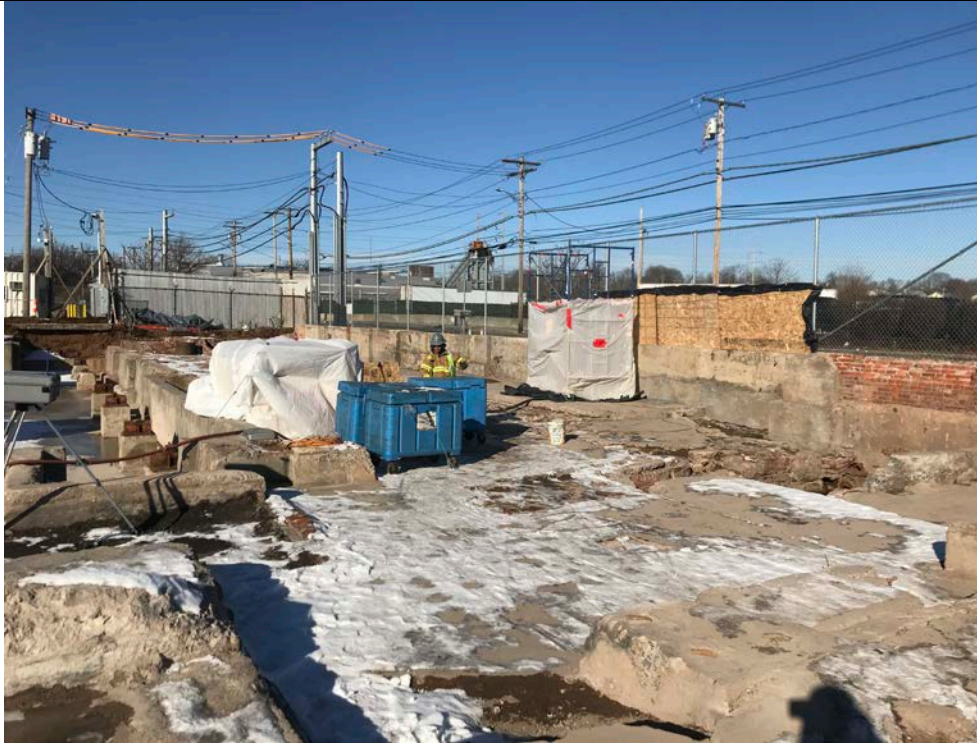
Photo 59: 1/21/2020, Dust suppression containment for paint removal using ice blasting methods.

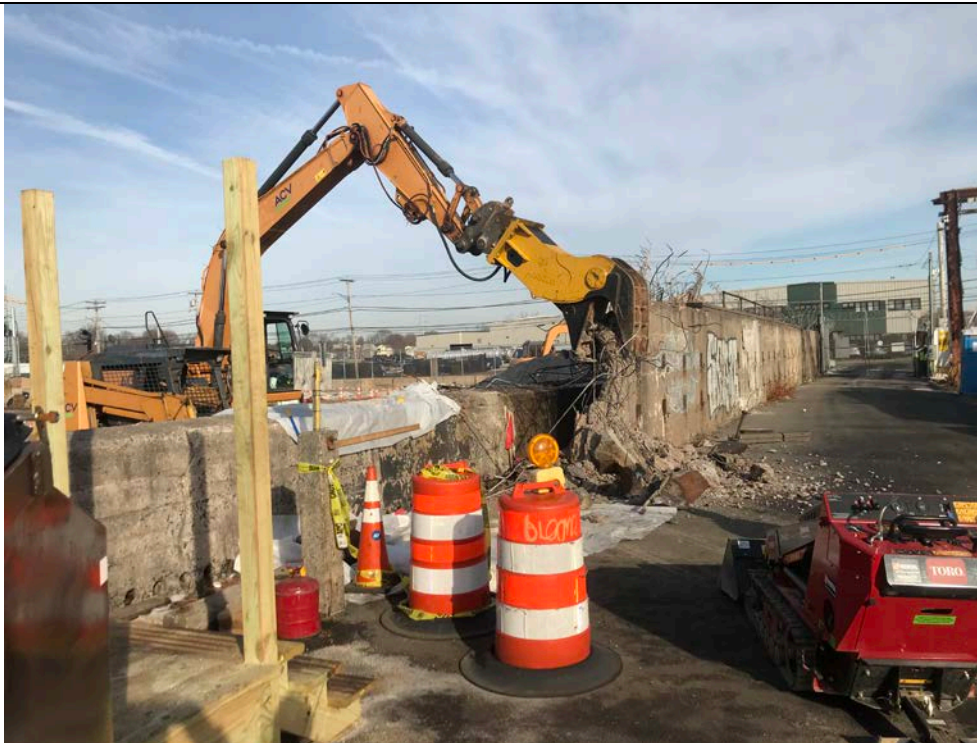
Photo 60: 1/23/2020, Demolition of the concrete portion of the eastern platform wall.

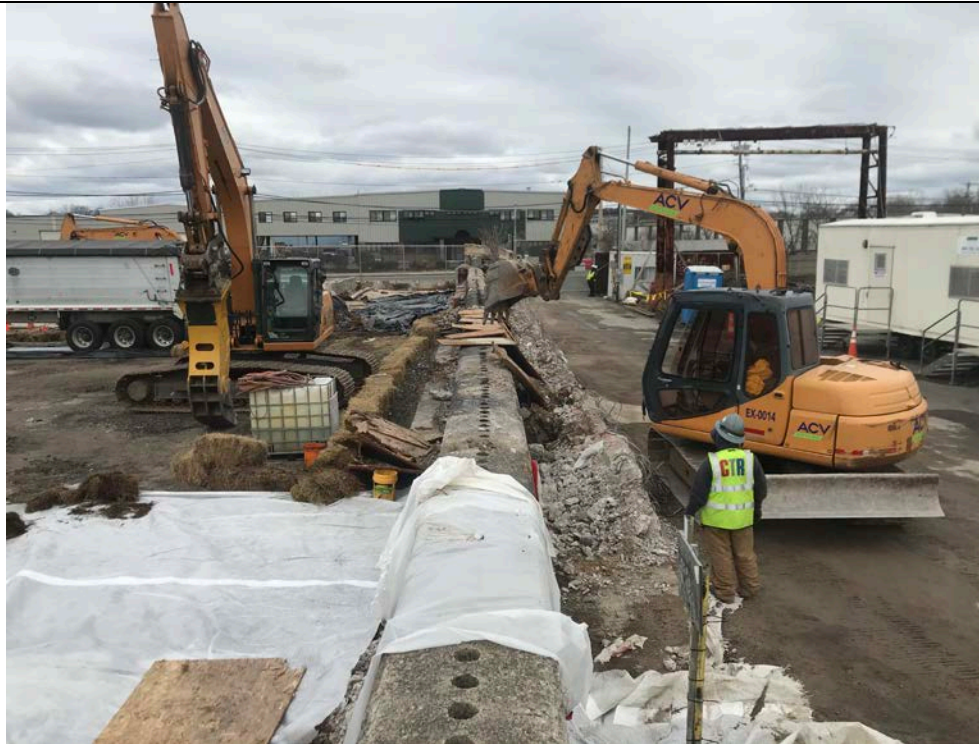
Photo 61: 1/28/2020, Demolition of the concrete portion of the eastern platform wall.

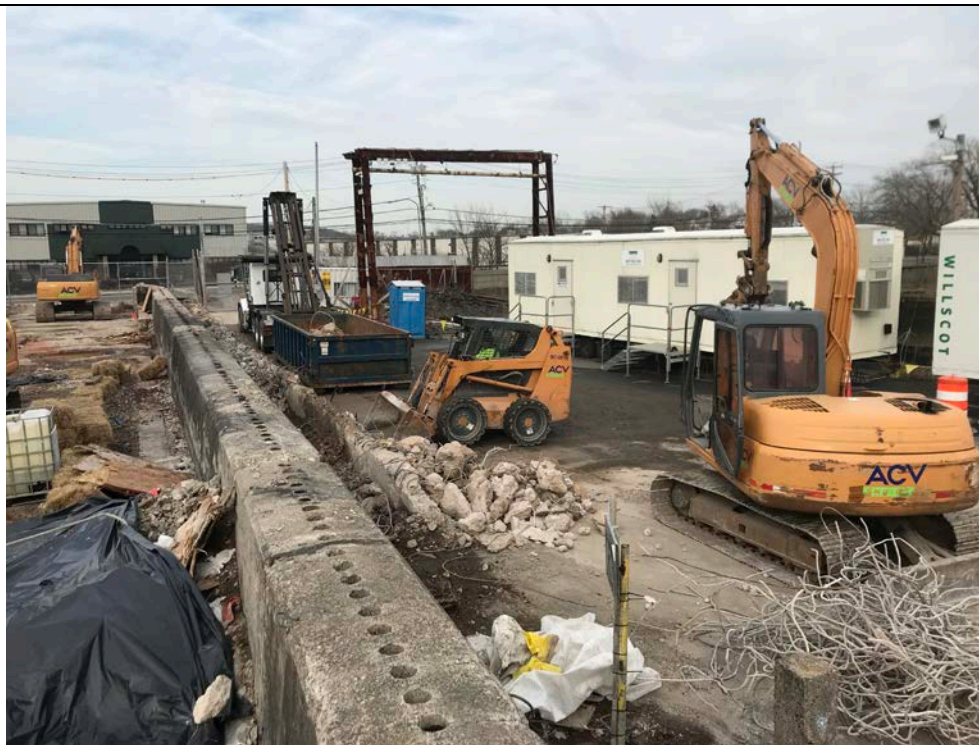
Photo 62: 2/4/2020, Demolition and consolidation of debris from the eastern platform wall.

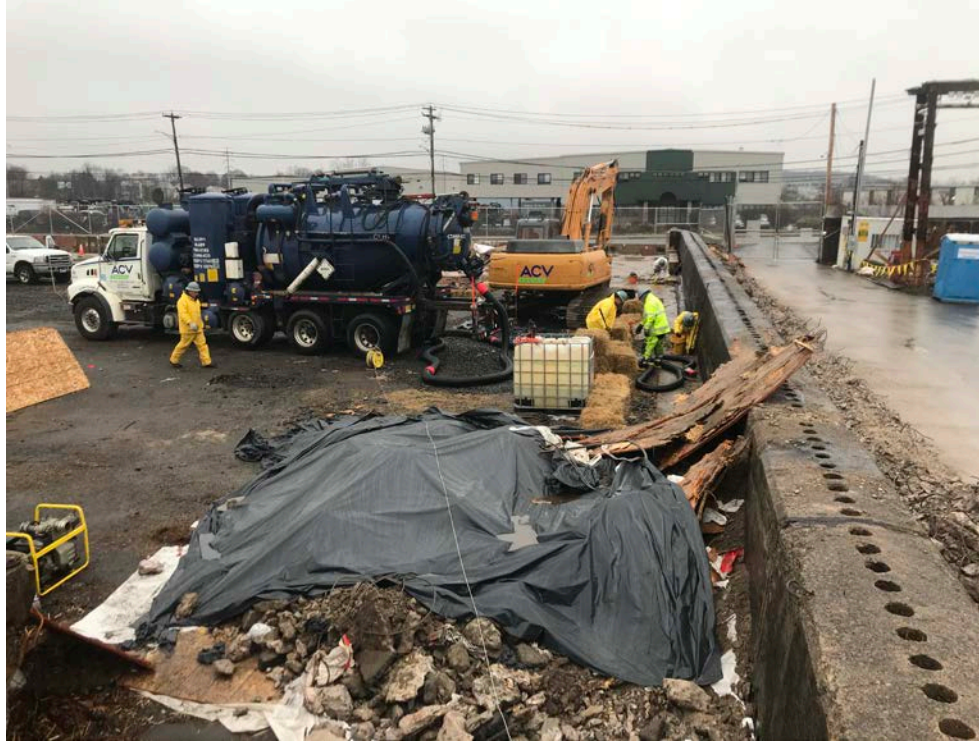
Photo 63: 2/6/2020, Fine cleaning of demolition debris waste near the former eastern platform wall.

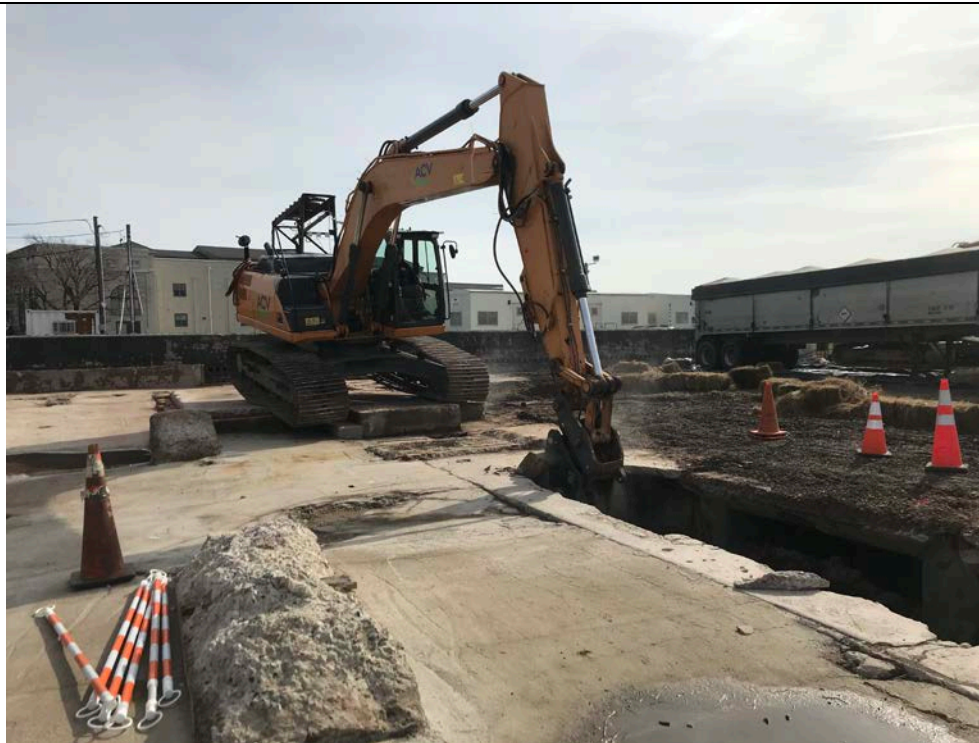
Photo 64: 2/12/2020, Investigation of the Station B cooling discharge tunnel. Demolition of the Station B basement floor slab/tunnel roof.

- 2/3/2020 –All asbestos abatement activities associated with Station B were completed.
- 2/12/2020 through 2/13/2020 – Performed demolition and removal of the reinforced concrete roof of the Station B cooling water discharge tunnel to determine the complete extent of the tunnel structures near the southeastern area of Station B.

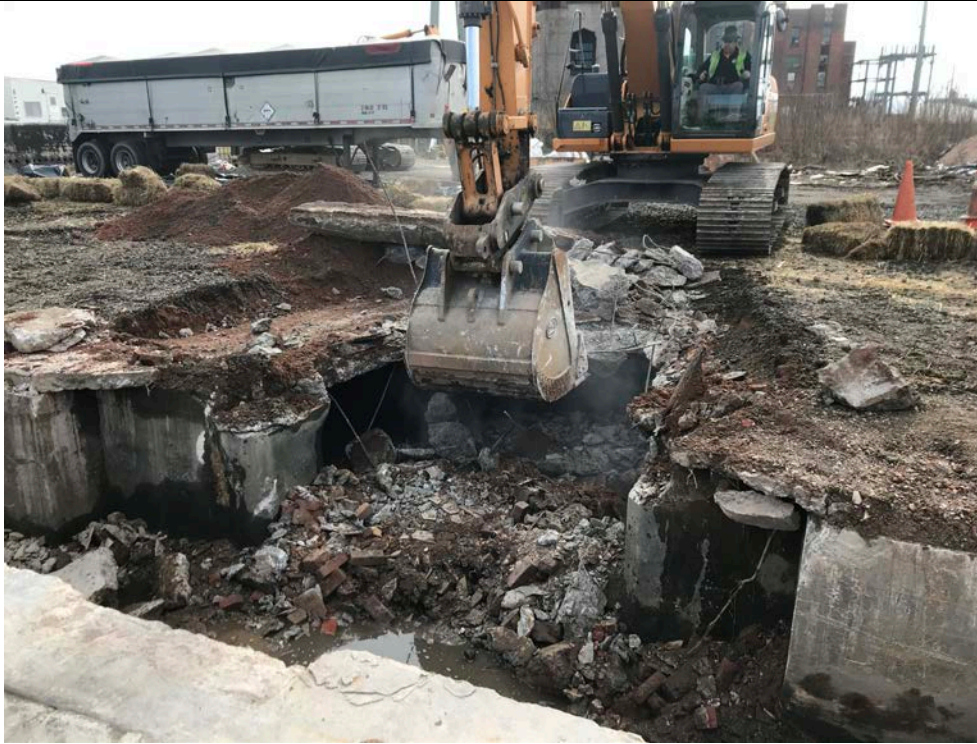
Photo 65: 2/12/2020, Investigation of the Station B cooling discharge tunnel. Demolition of the Station B basement floor slab/tunnel roof.

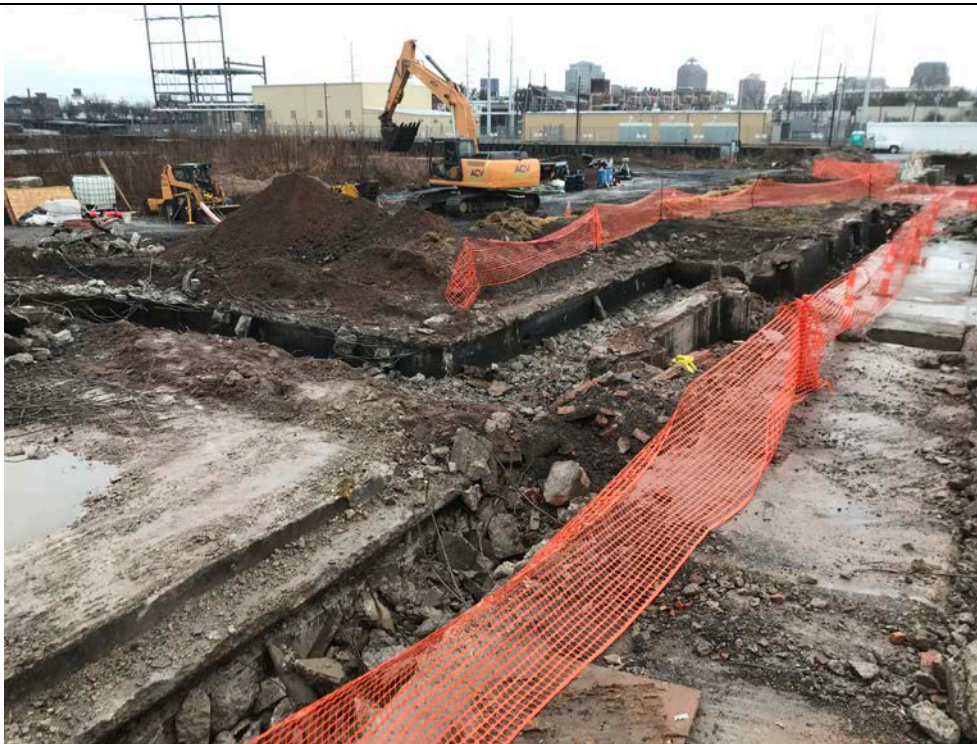
Photo 66: 2/13/2020, Station B cooling discharge tunnel.

- 1/15/2020 – During the demolition of Station B an opening to a previously undiscovered cooling water discharge tunnel. TRC and UI classified this tunnel as Situation #3 and collected the first investigation samples from the tunnel on 1/15/2020, when it was safe to do so. On this date also began the removal of PCB containing paint (>1<50ppm) from steel and concrete foundation structures of the Station B basement which would remain as permeant features on-site after remediation.

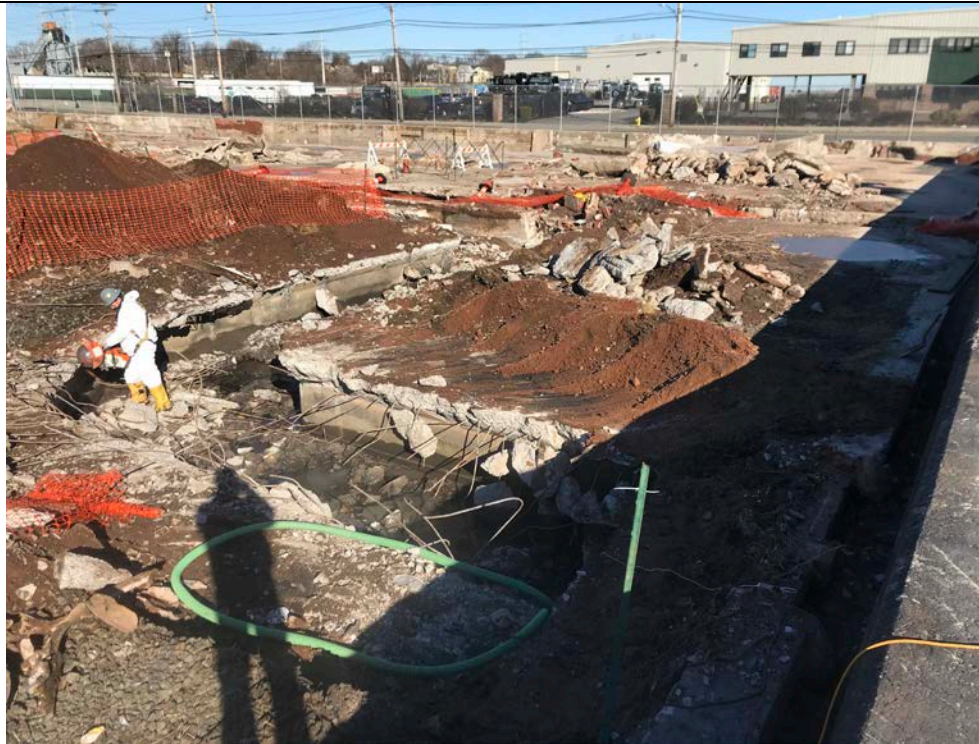
Photo 67: 2/14/2020, Station B cooling discharge tunnel.
