# **SCOPE OF STUDY**

**EASTERN PORTION OF ENGLISH STATION (PARTIAL):  
BOILER 1-12 AREA & BOILER 13/14 AREA  
510 GRAND AVENUE  
NEW HAVEN, CONNECTICUT**

## **The United Illuminating Company**

November 2018

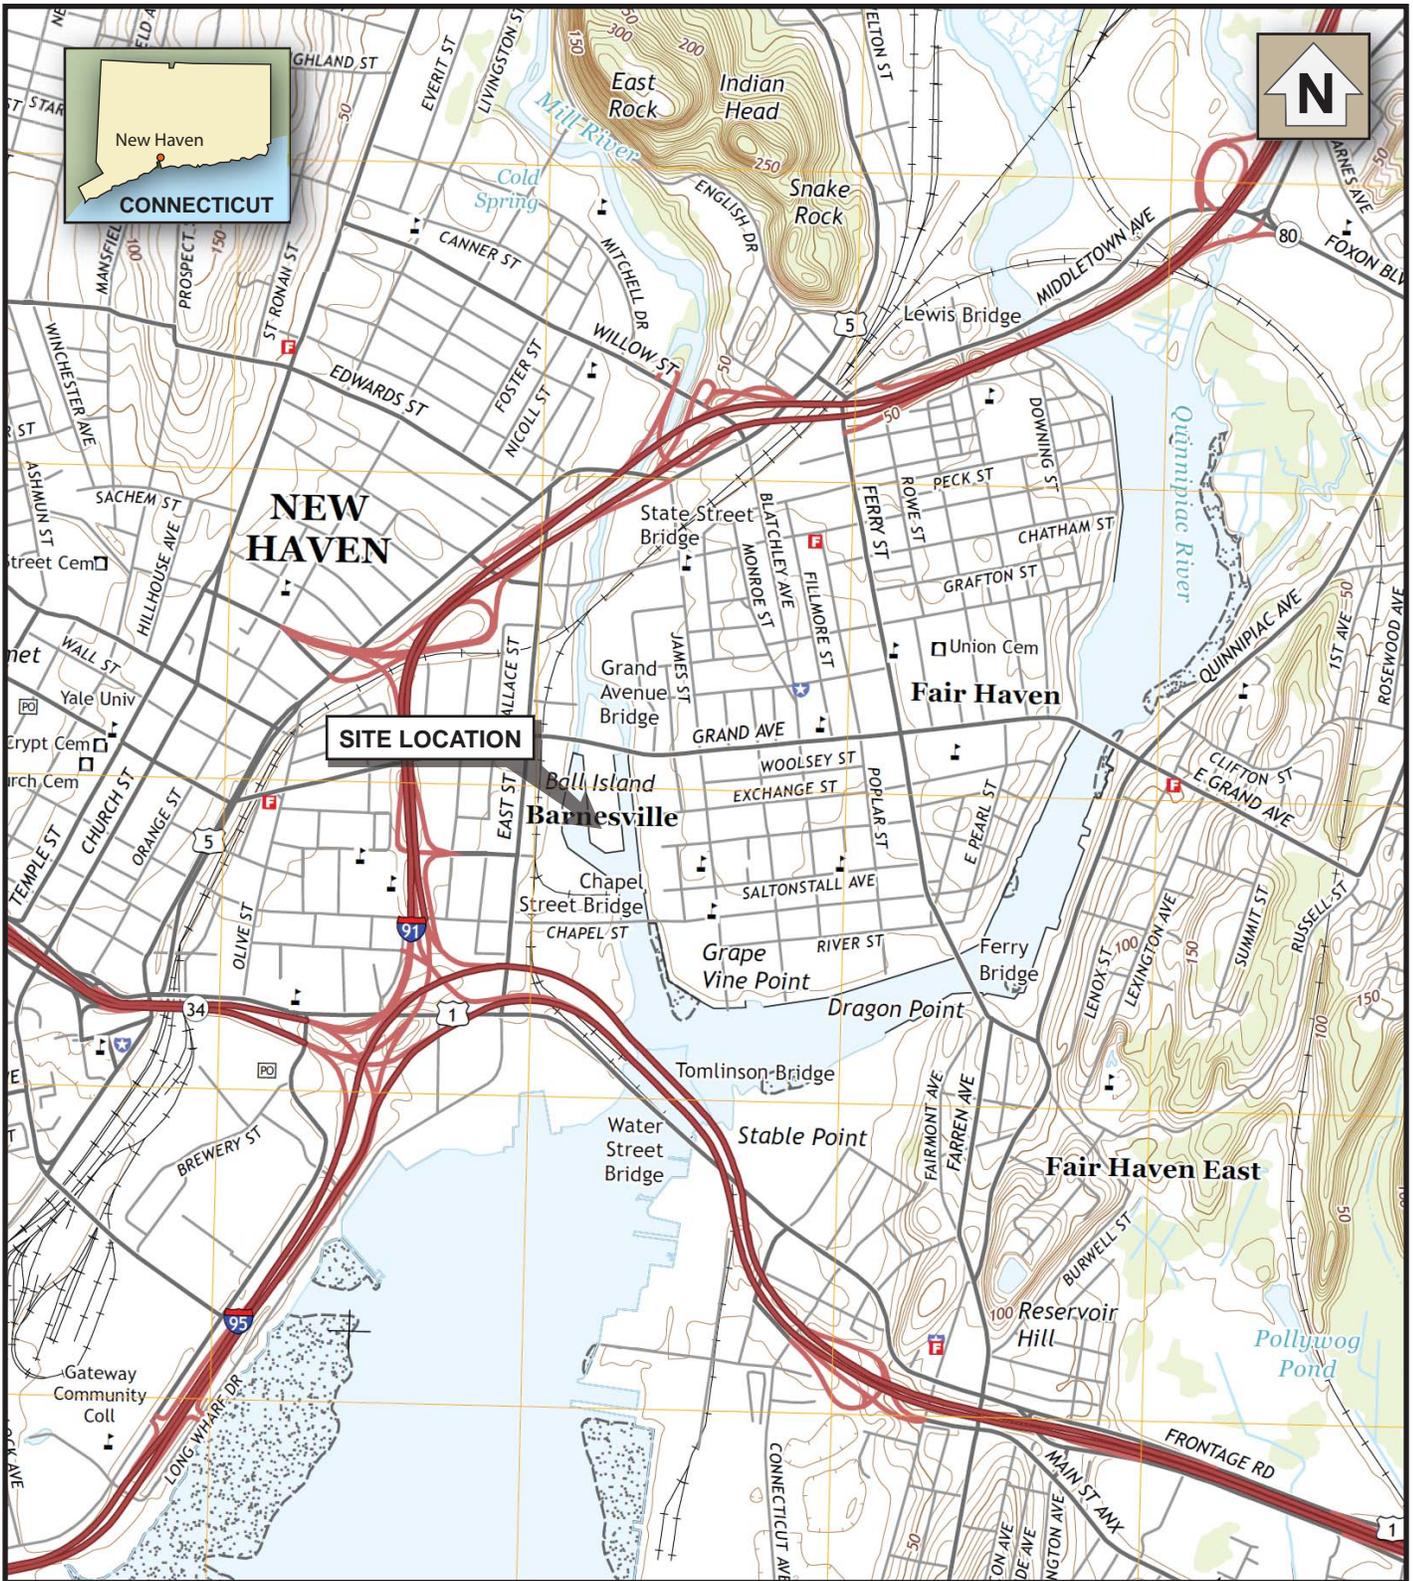
1:24000

BASE CREATED WITH 7.5' USGS TOPOGRAPHIC MAP  
NEW HAVEN, CT 2015

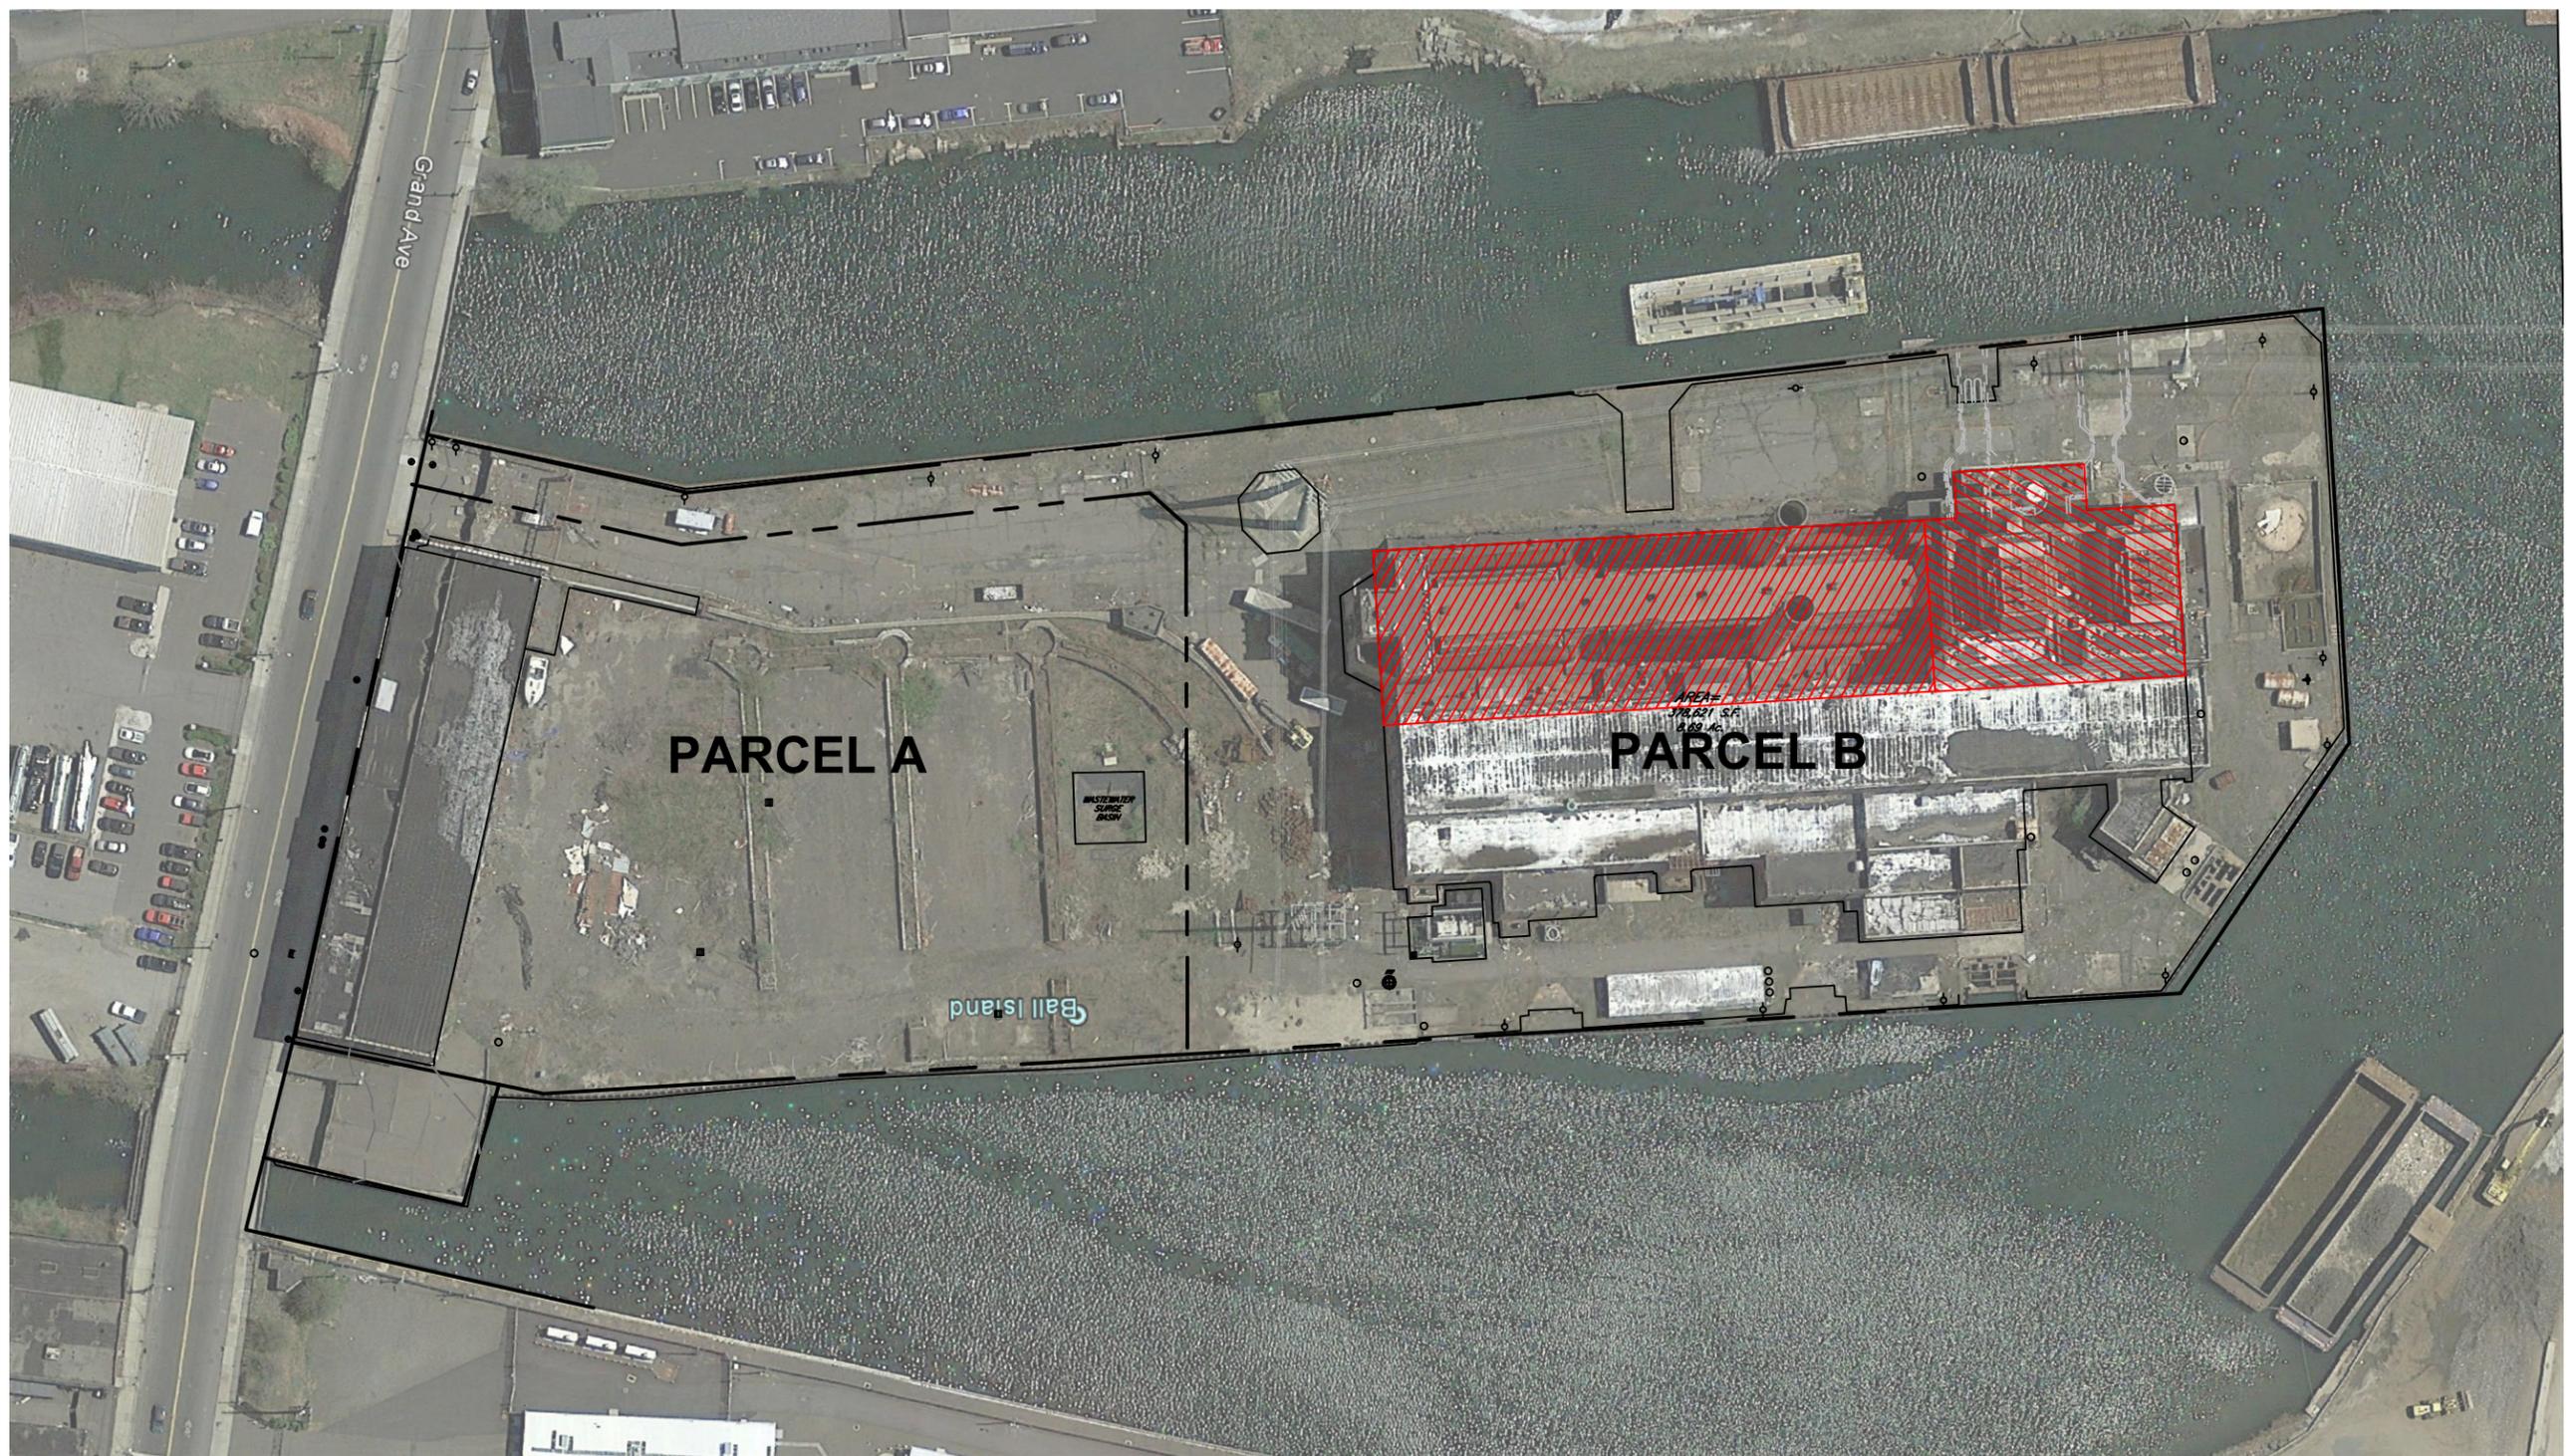
- MAP TITLED "FIGURE 3N, MASS ANALYSIS PCB SAMPLE POINT LOCATIONS-NORTH, PREPARED FOR QUINNIPIAC ENERGY, LLC., ENGLISH STATION, 510 GRAND AVENUE, NEW HAVEN, CT." DATED: 3/1/10, SCALE: 1"=20', BY ADVANCED ENVIRONMENTAL INTERFACE, INC.
- AERIAL IMAGE FROM GOOGLE EARTH PRO, DATE OF IMAGE: 04/20/2016

TRC Environmental Corporation (TRC) has been retained by The United Illuminating Company (UI) to provide Licensed Environmental Professional (LEP) services as they relate to adherence to and completion of all tasks outlined in Partial Consent Order (PCO) COWSPCB 15-001, including the preparation of this Eastern Portion of English Station Building Scope of Study (SOS) which focuses solely on the Boiler 1-12 area and Boiler 13/14 area. On August 4, 2016, the PCO pertaining to environmental matters at the approximate 8.9-acre parcel of land located at 510 Grand Avenue in New Haven, Connecticut known as “English Station” (the “Site”), see Figure 1, became effective. For the purposes of the PCO, the Site includes the two main buildings (both the English Station and Station B buildings), several smaller buildings and all associated structures located on the 510 Grand Avenue parcel of land, as well as the soil, sediment, groundwater and surface water located within the confines of the perimeter of the Site as defined in Exhibit A to the PCO (provided herein as Figure 2).

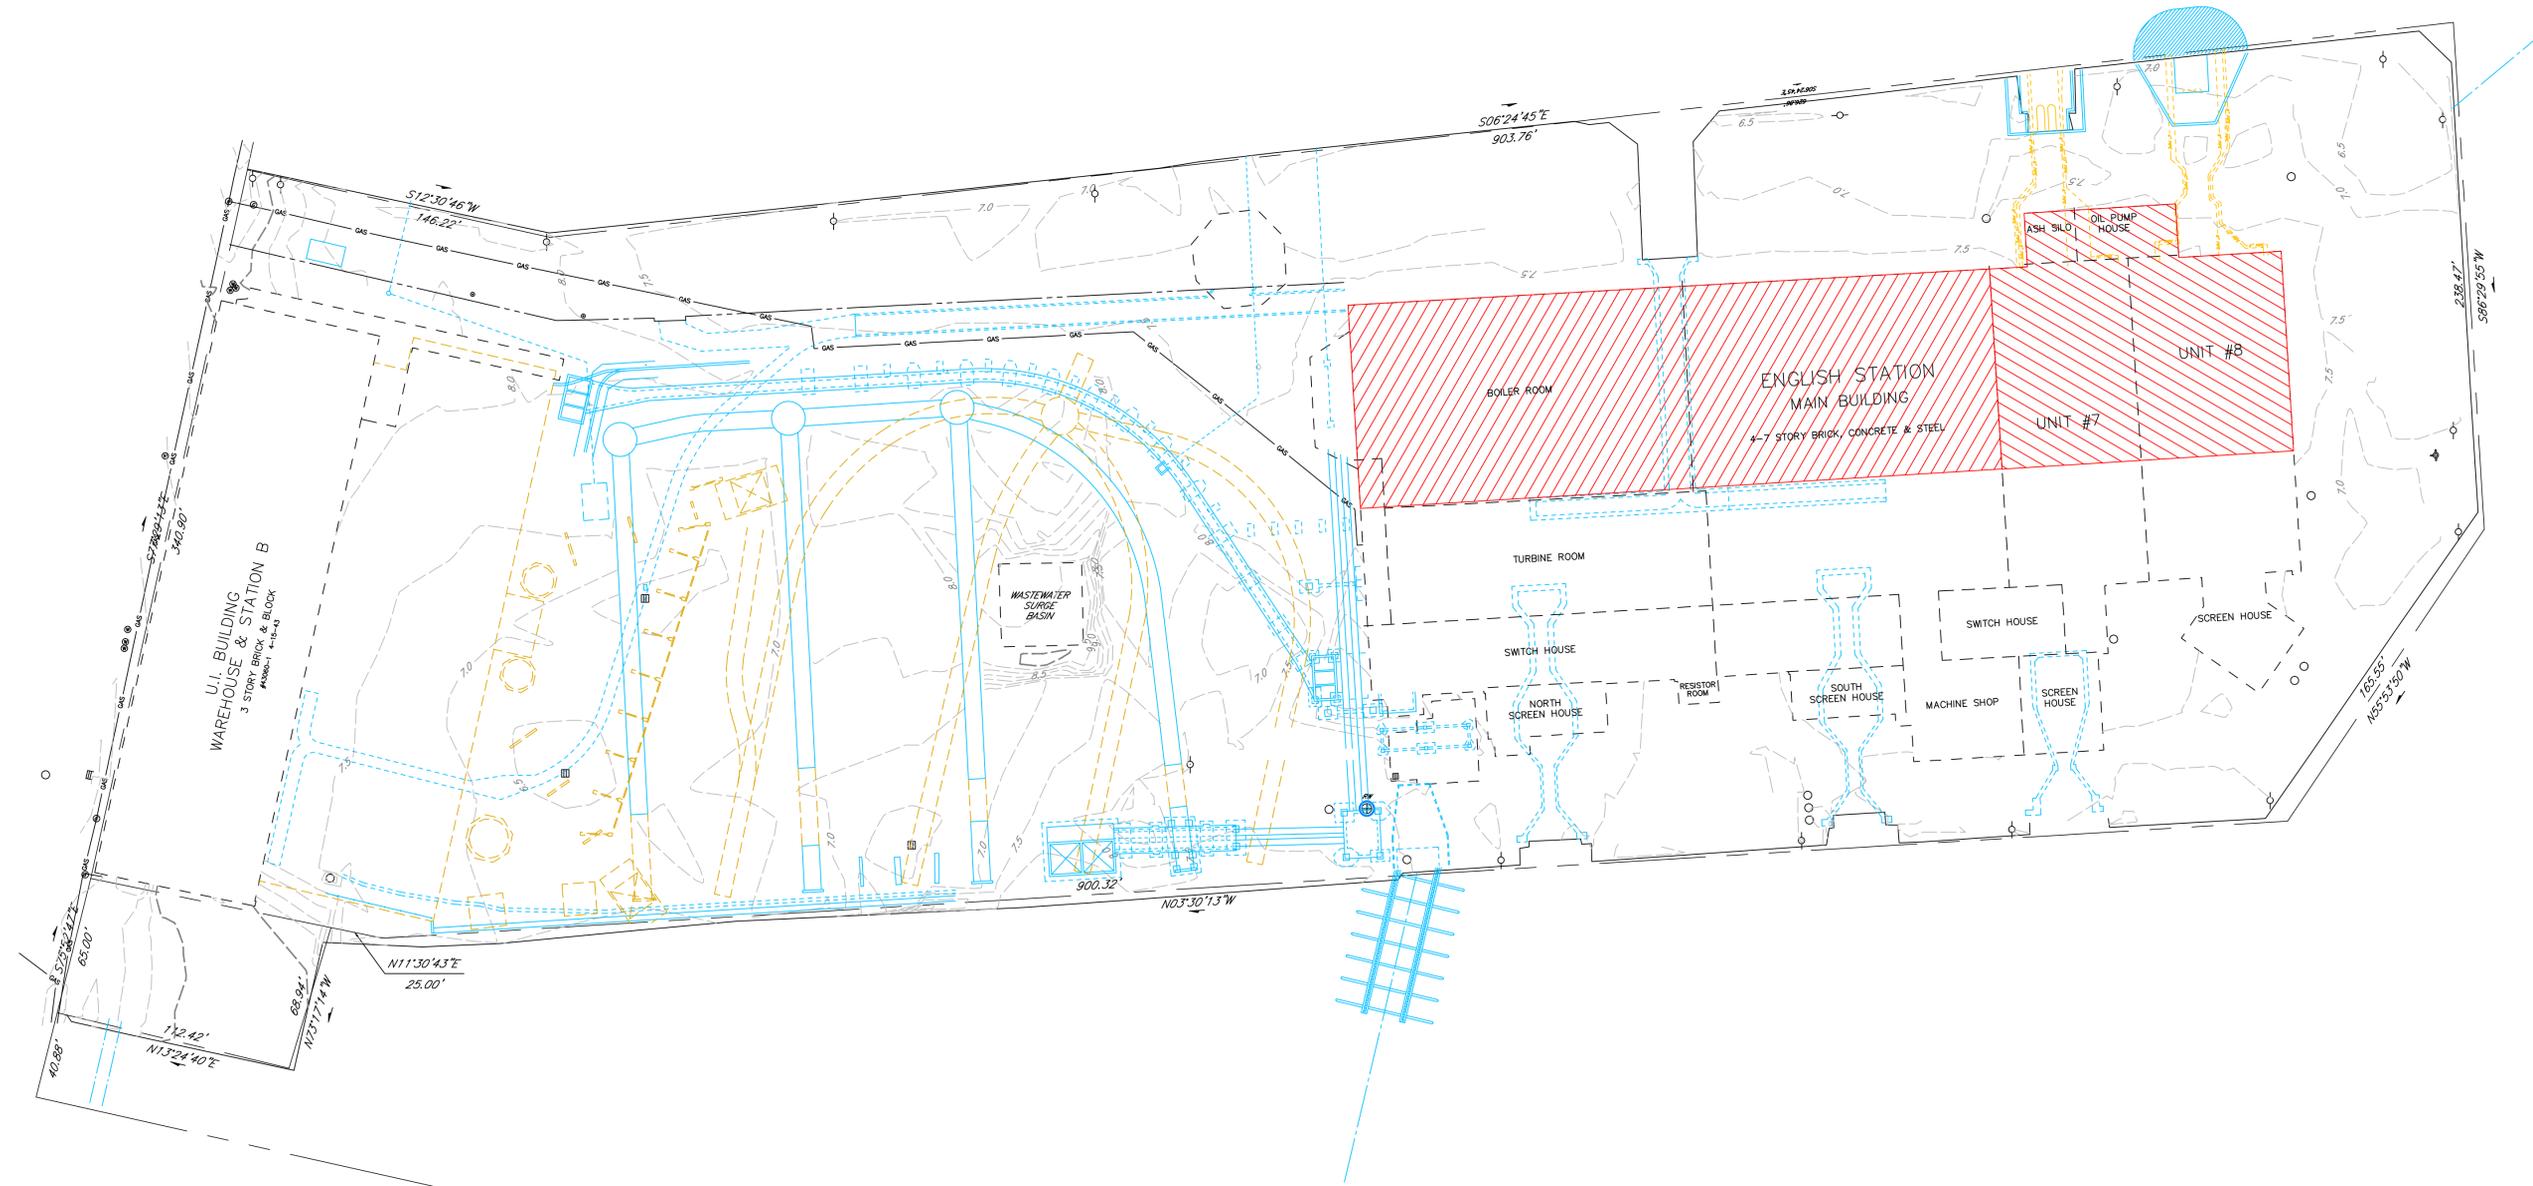
LEGEND	
	SCOPE OF STUDY SUBJECT BOILER #1 - #12 AREA
	SCOPE OF STUDY SUBJECT BOILER #13/14 AREA

As indicated above, the area of focus for this SOS is the Boiler 1-12 & Boiler 13/14 Areas, as shown on Figure 3. The western portion is currently defined as the area to the west of the critical barrier associated with the “make-safe” effort discussed briefly in Section 1.

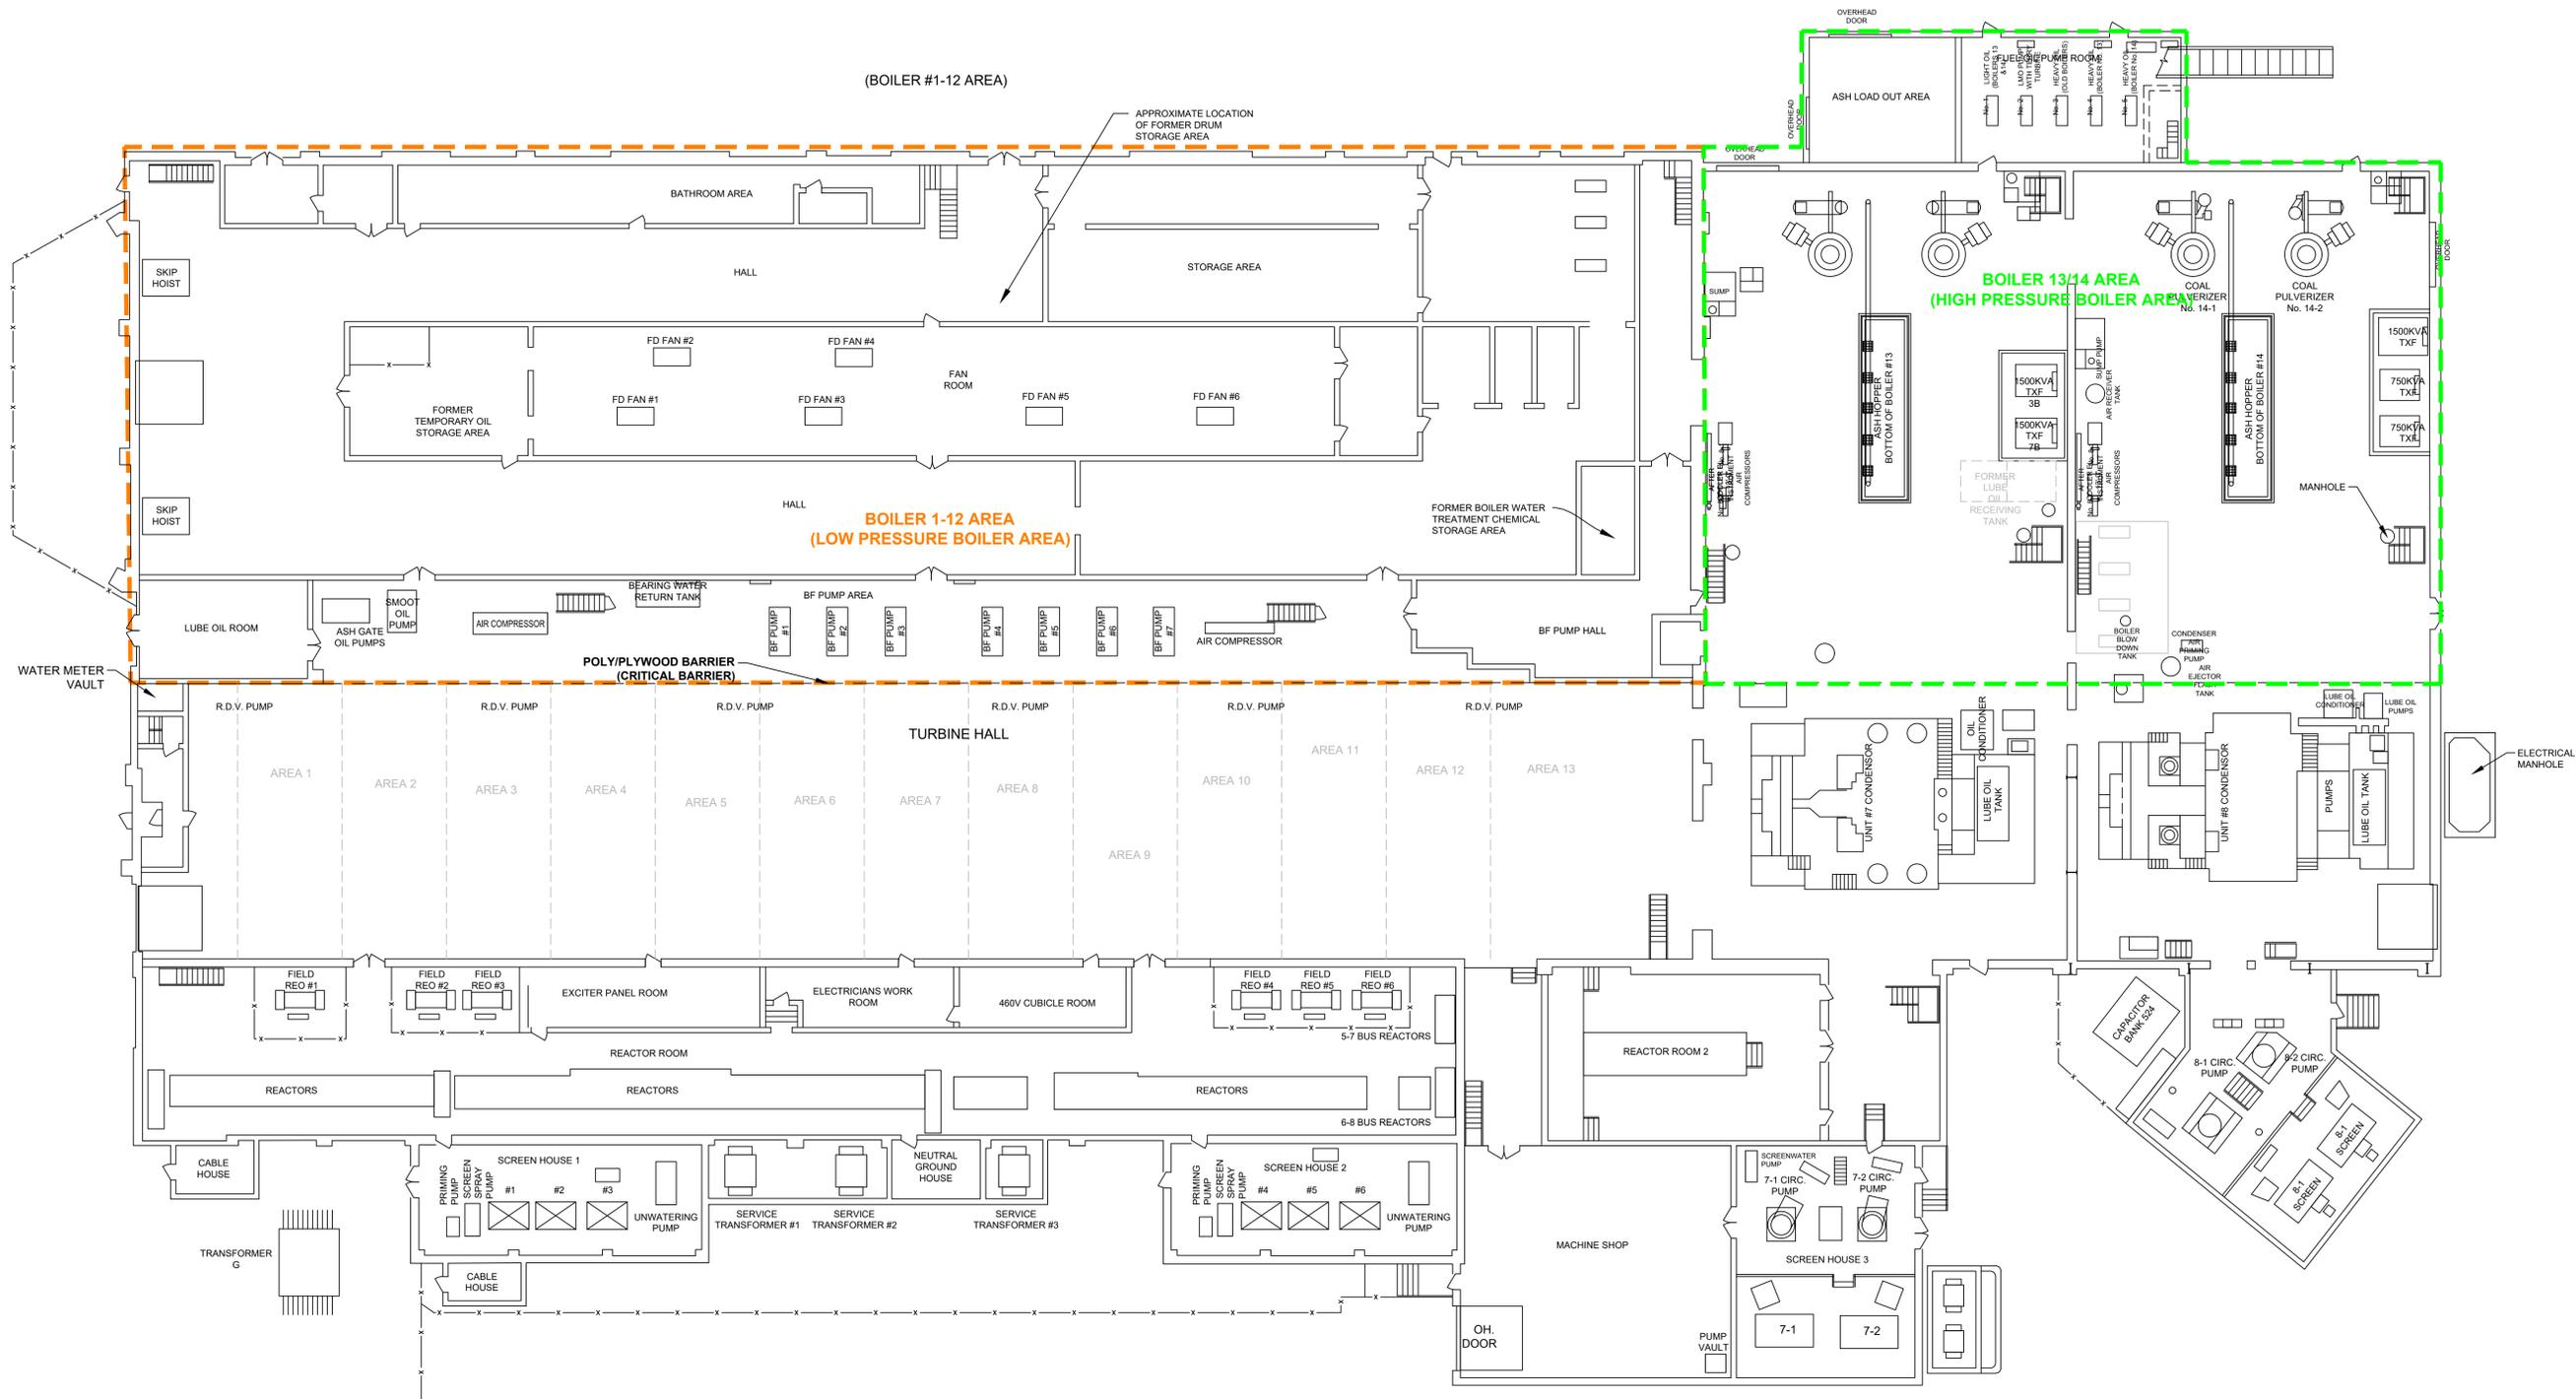
LEVEL 1 - ELEVATION 5'-6"

SOURCE:  
 MAP TITLED "PLAN PREPARED FOR UNITED ILLUMINATING COMPANY, ENGLISH STATION, NEW HAVEN, CONNECTICUT, 1ST FLOOR HIGH & LOW PRESSURE BOILER AREAS, PLATE-1", SCALE: 1"=16', DATED: JAN. 2000, BY GEI CONSULTANTS, INC.

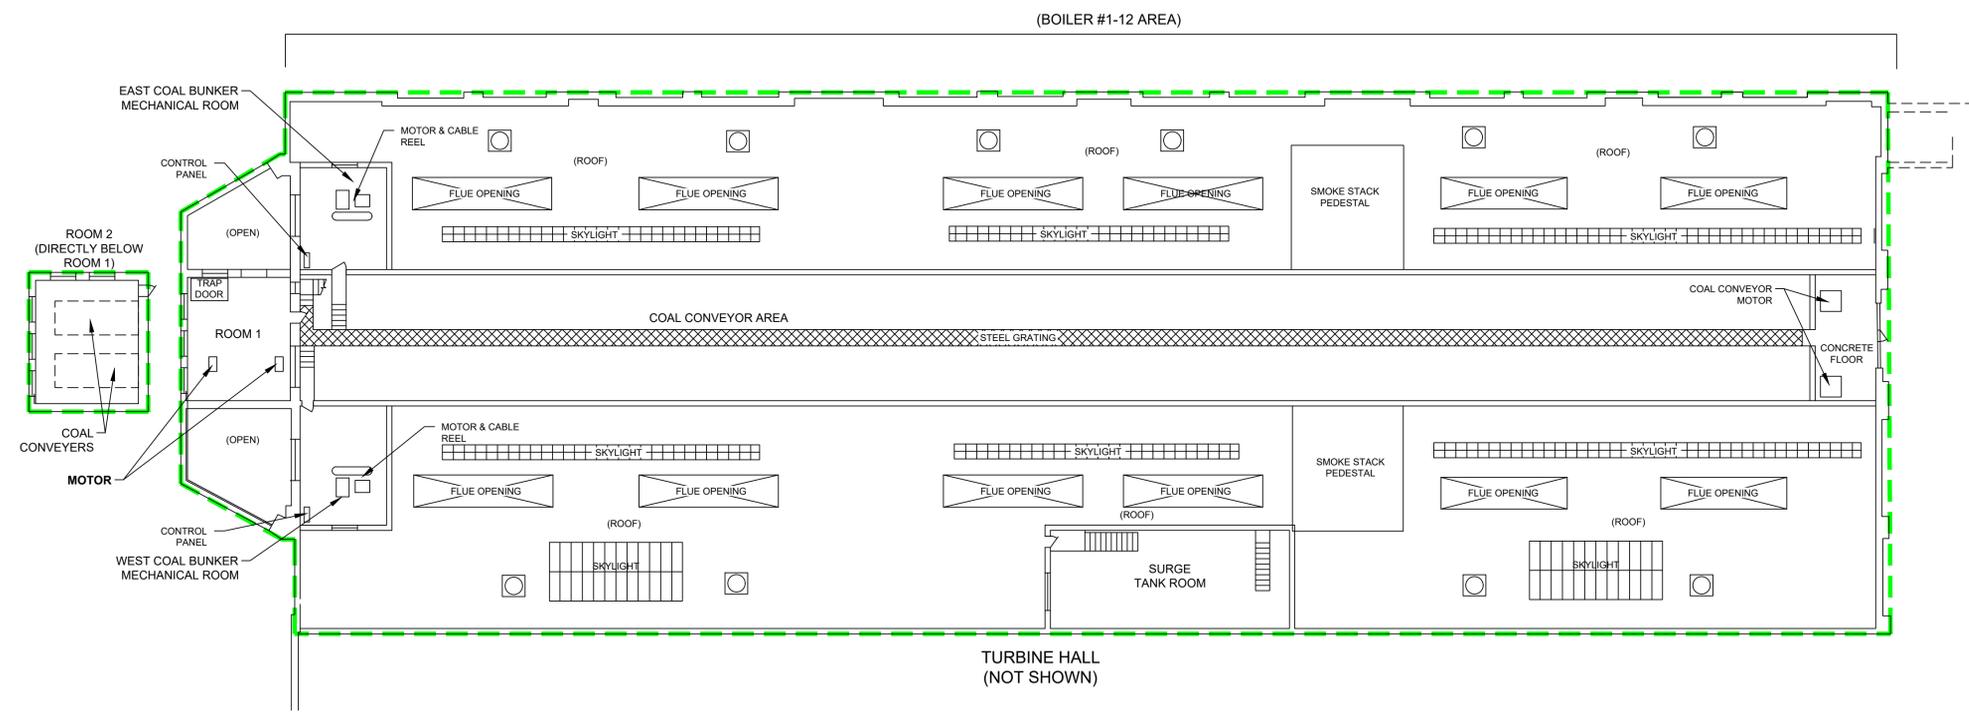
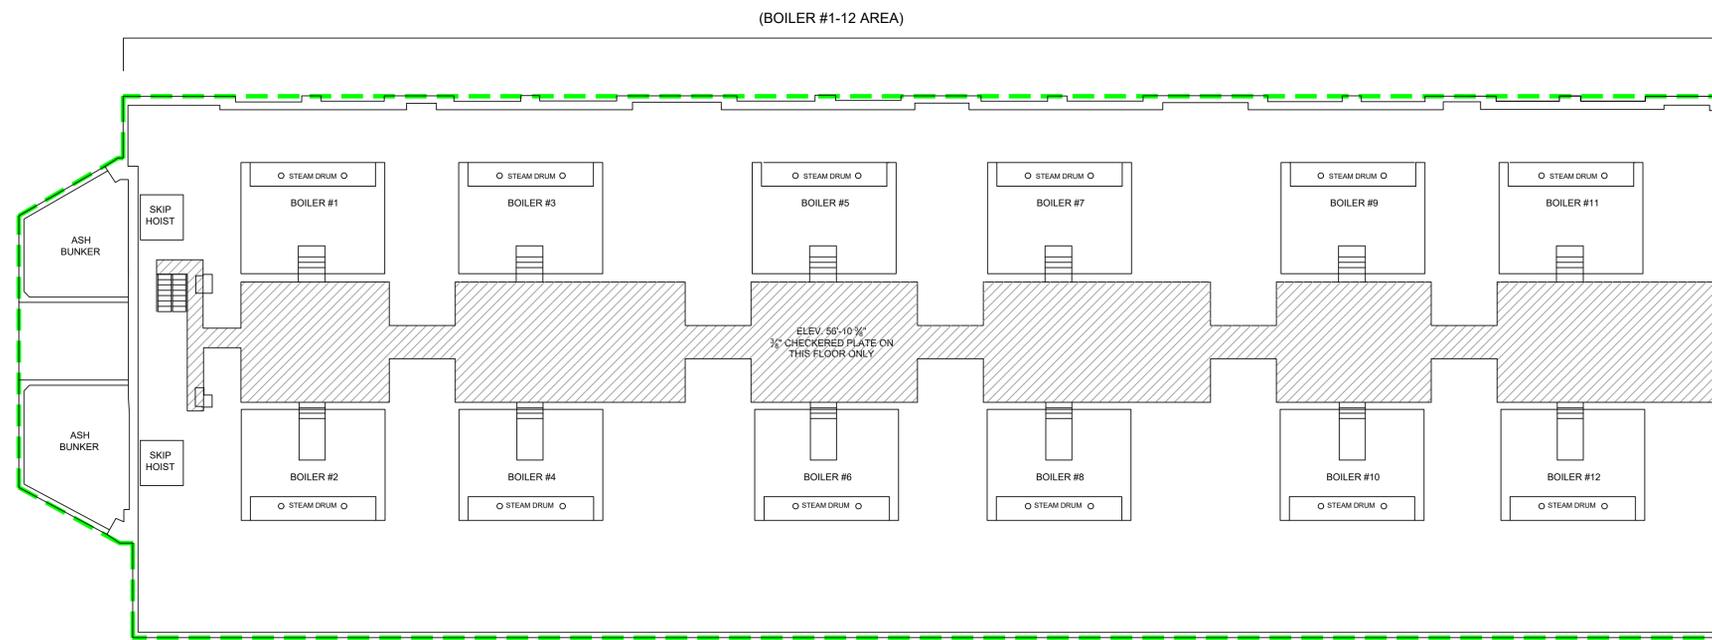
COAL CONVEYOR LEVEL AND UPPER ELEVATED AREAS

MEZZANINE

SOURCE:  
 MAP TITLED "PLAN PREPARED FOR UNITED ILLUMINATING COMPANY, ENGLISH STATION, NEW HAVEN, CONNECTICUT, 1ST FLOOR HIGH & LOW PRESSURE BOILER AREAS, PLATE-1", SCALE: 1"=16', DATED: JAN. 2000, BY GEI CONSULTANTS, INC.

- Coal Conveyor Level & Upper Elevated Areas – which are located above the second floor. These areas are accessible from the stairwell on the North end of the second floor. The coal conveyor level runs the length of the Boiler 1-12 area. Other upper elevated areas (Room 1, Room 2 and West & East Coal Bunker Mechanical Rooms) are all on the north end. Refer to Figure 3. These areas were under containment as part of the “make safe” effort during reconnaissance.
- Exterior Roofs – roofs and other areas only accessible from the roof. There is a surge tank room on the western half of the roof.
- Exterior Building Façade Components (windows, doors, joints, etc.)
- Interior Building Façade Components (windows, doors, vents, etc.)

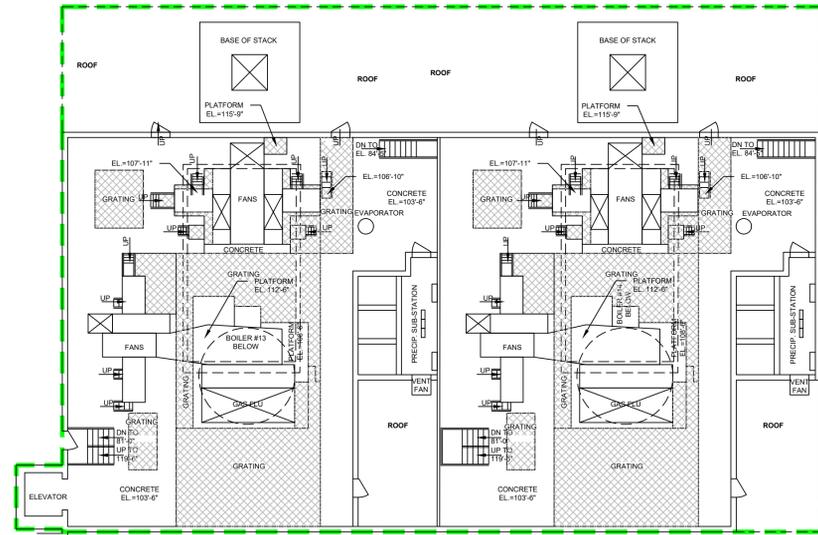
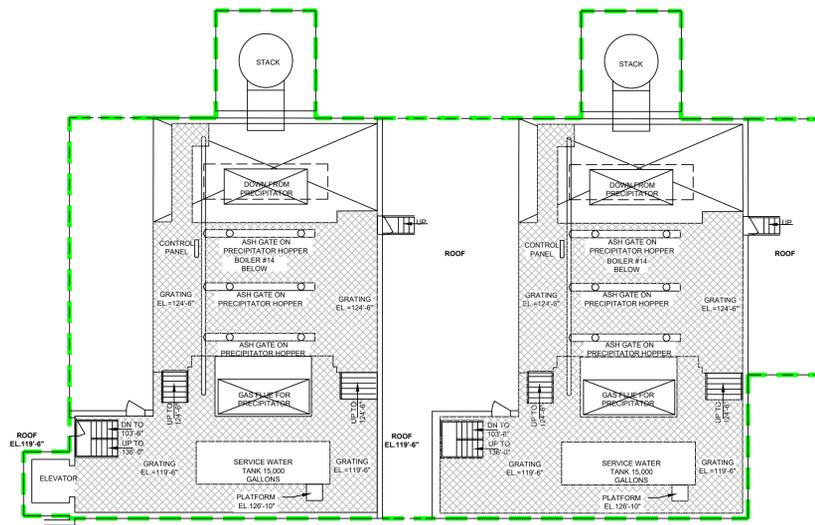
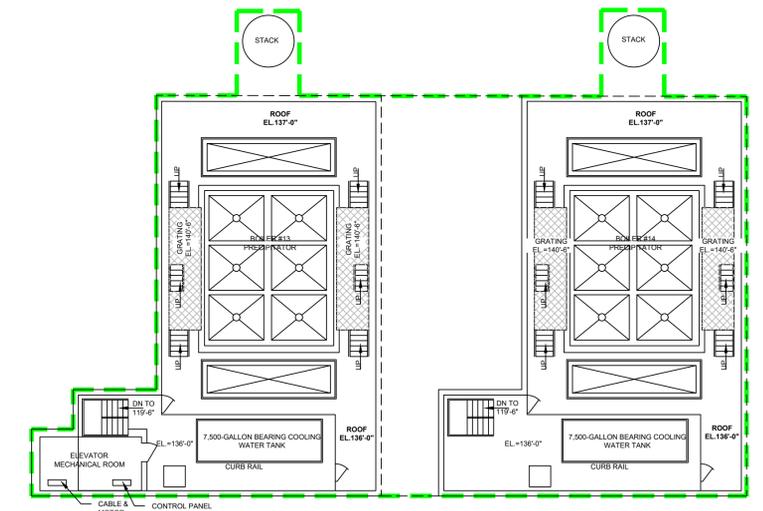
**BOILER 13/14 AREA  
(HIGH PRESSURE BOILER AREA)  
LEVEL 7 - ELEVATION 103'-6"**

**BOILER 13/14 AREA  
(HIGH PRESSURE BOILER AREA)  
LEVEL 8 - ELEVATION 119'-6" & 124'-6"**

**BOILER 13/14 AREA  
(HIGH PRESSURE BOILER AREA)  
LEVEL 9 - ELEVATION 136'-0" & 137'-0"**

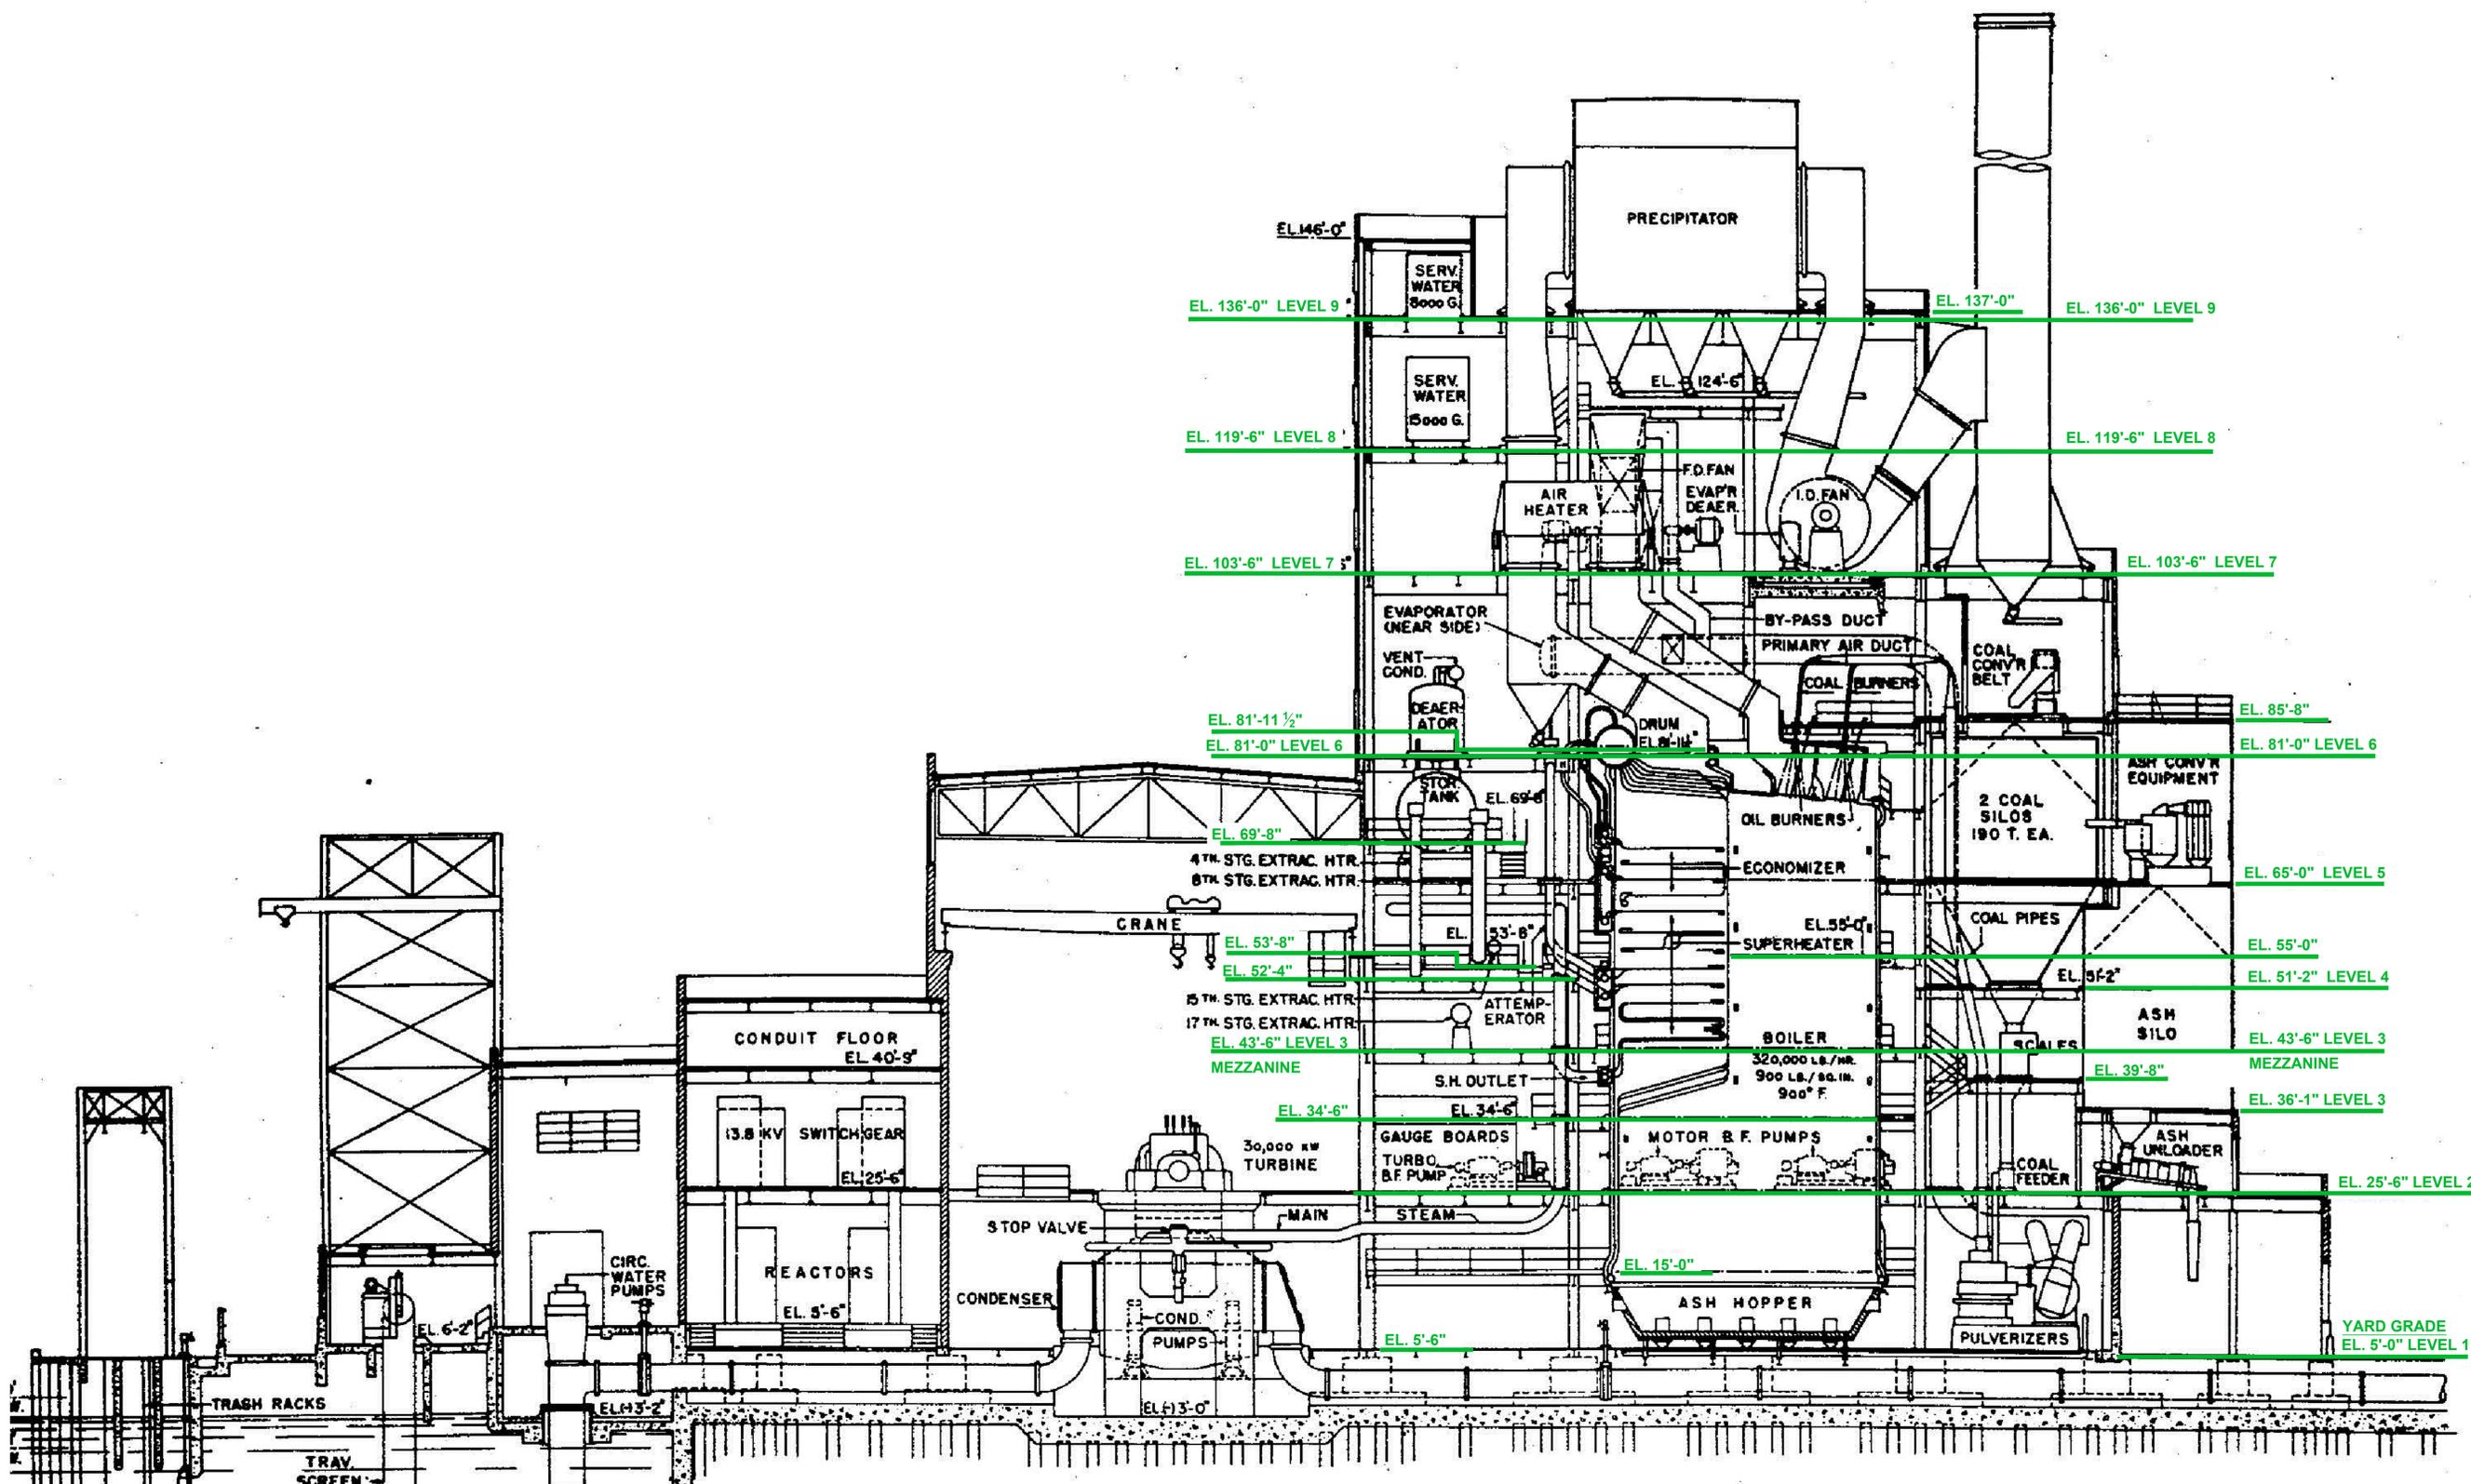
SOURCE:  
 MAP TITLED "ENGLISH STATION EXTENSION, UNIT  
 No. 7, THE UNITED ILLUMINATING COMPANY, NEW  
 HAVEN, CONNECTICUT, FIG. 1-3", BY WESTCOTT &  
 MAPES, INC.
